## Product Improvement Campaign

No: C1006210

Re: V68.1 EEC Reprogramming

Product Improvement Campaign C1006210 – V68.1 EEC Reprogramming

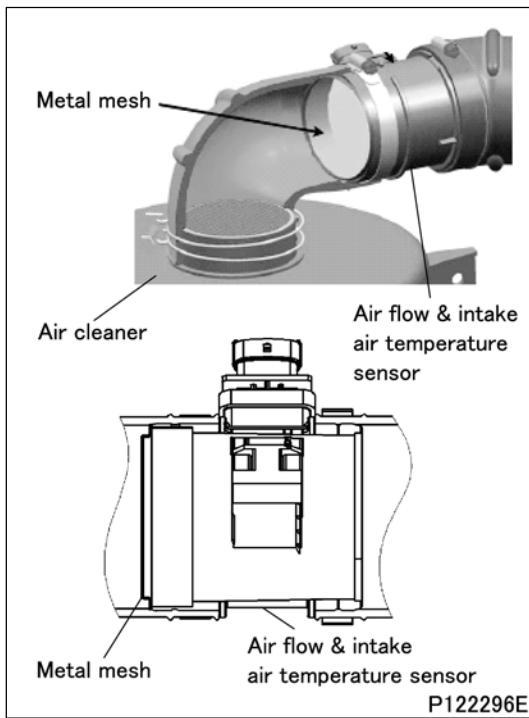
Check that there is no dirt or deformation in the metal mesh.

- Attach the metal mesh to the air hose by direction of illustration.

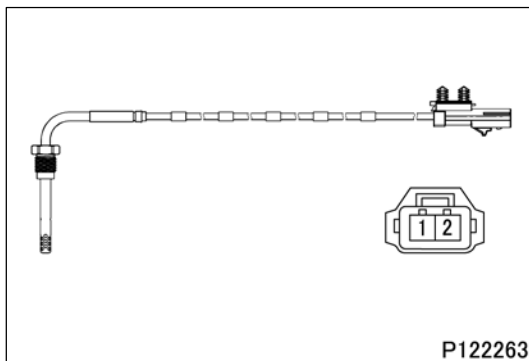
- Remove the SCR temperature sensor 1 and 2 and do visual check and if it is dirty then you should clean it.
- Using a known temperature reference source, measure the resistance between terminals 1 and 2.

Standard value	-18°C [-0.4° F]	187 Ω
	-12°C [10° F]	191 Ω
	-7°C [19° F]	195 Ω
	-1°C [30° F]	200 Ω
	0°C [32° F]	201 Ω
	4°C [39° F]	204 Ω
	10°C [50° F]	208 Ω
	16°C [61° F]	212 Ω
	21°C [70° F]	217 Ω
	27°C [81° F]	221 Ω
	32°C [90° F]	225 Ω
	38°C [100° F]	229 Ω
	50°C [122° F]	239 Ω
	100°C [212° F]	276 Ω
150°C [302° F]	313 Ω

- If the measurement is out of reference value, replace the sensor.
- Measure resistance between each pin to sensor body. Resistance should be greater than 1 MΩ (open circuit).

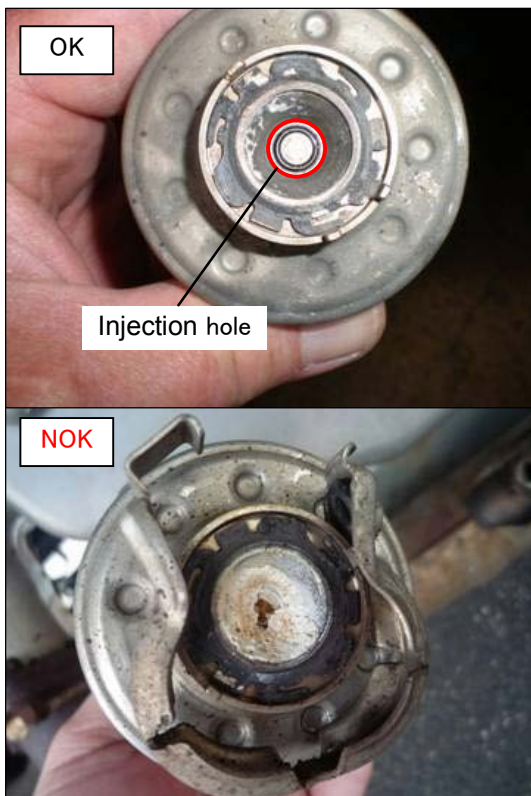
Gasket between dosing module and intermediate pipe (ME556058)

- Verify that the injection hole in the DEF dosing module is free from any deposits. Replace the DEF dosing module if the injection hole is blocked.
- Clean the DEF dosing module if other places than the injection hole are deposited, please use distilled water.
- When at the actuator test (Actuation) function of FUSO Diagnostics there is no abnormality, there is no problem even with when there is a deposit.
