Technical Service Bulletin

94 Rear lid tail lamp lighting does not switch over to bumper (DTC 03073)

94 13 17 2033675/2 May 22, 2013. Supersedes Technical Service Bulletin Group 94 number 13-16 dated April 29, 2013 for reasons listed below.

Model(s)	Year	VIN Range	Vehicle-Specific Equipment
Q5	2009-2014	All	NA
Q7	2007-2014	All	NA

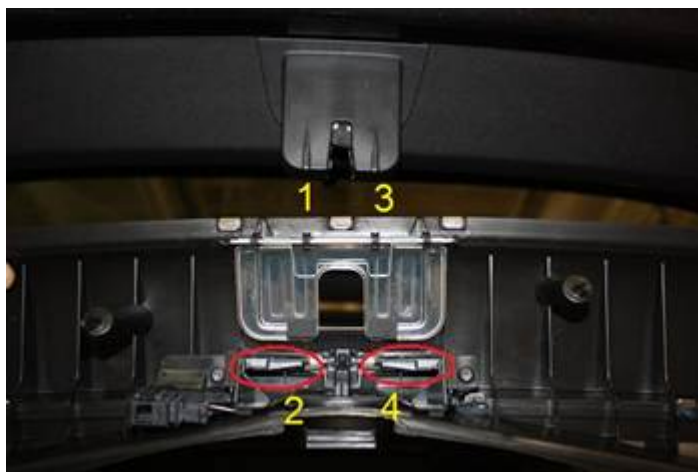
In order for the taillight lighting to switch between the rear lid and the bumper when the lid is operated, the paddle switches on the rear sill trim must contact the opposing lid latch points uniformly.

- Paddle switch G526 (Figure 1, 2) must contact lid latch point 1 (Figure 1, 1), as shown in the image at right.
- Paddle switch G525 (Figure 1, 4) must contact lid latch point 3 (Figure 1, 3), as shown in the image at right.

Figure 1. Inside vehicle view of rear lid latch showing location of G526 (2) and G525 (4) on rear sill trim, and contact points (1 and 3).

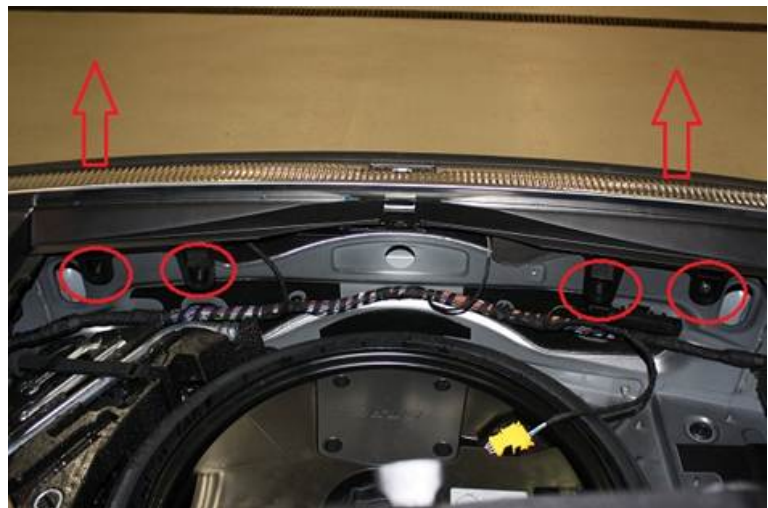
Figure 2. Rear cargo area trim plate removal in the Audi Q7. The T25 Torx® screws to be removed are circled in red.

- In the Audi Q7: Remove the four T25 Torx® screws (Figure 2), then carefully pull up on the plate.
- In the Audi Q5: The plate is not held by screws. Carefully lift the plate straight up, noting the four clips retained in the trim.

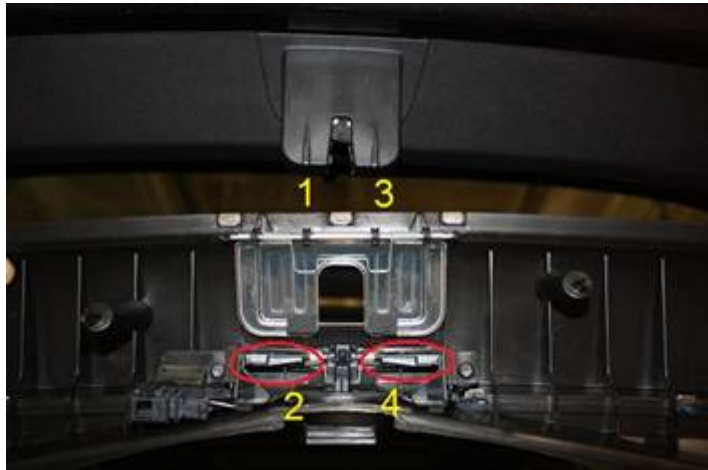
Figure 7. Inside vehicle view of rear lid latch showing location of G526 (2) and G525 (4) on rear sill trim, and contact points (1 and 3).

3. Adjust the striker plate until the lid latch is evenly drawn in to actuate the G526 and G525 paddle switches (Figure 7, 2 and 4). Center the striker plate latch to the lid latch.

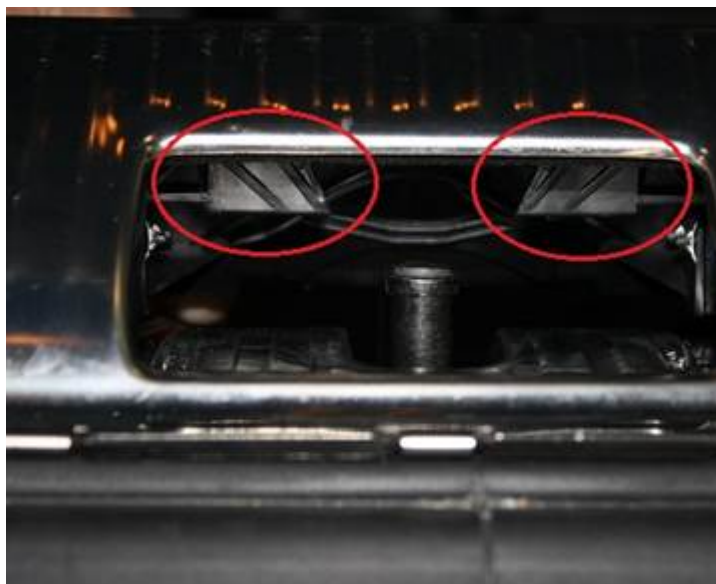
Figure 8. Overhead view of paddles contacted by rear lid latch.

Tip: Moving the striker plate latch towards the front of the vehicle will bring the lid latch closer to actuating the paddle switches (Figure 8).
