SB-10052256-9984

Date 5.2013 Group **371** No. **045** Release **01** Page 1(4)

Battery Cable Lug, Failure  
 VN, VHD

## FSB 371-045, Battery Cable Lug, Failure

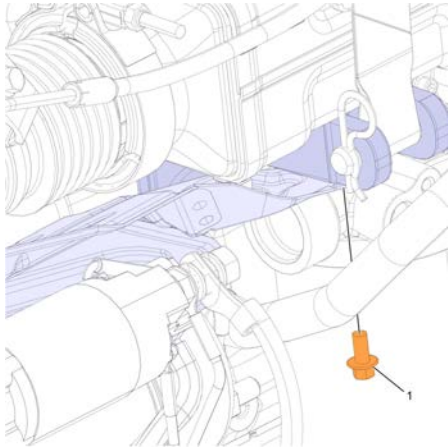
W2080360

1. Screw

- 1 Secure the vehicle for service by parking it on a flat level surface, applying the parking brake, chocking the rear wheel, and placing the transmission in neutral.
- 2 Disconnect all cables from the negative (ground) battery terminals to prevent personal injury from electrical shock and prevent damage to electrical components.
- 3 Remove the fastener from the heat shield bracket.

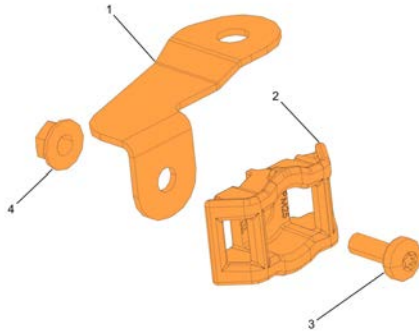
W2080361

1. Bracket
2. Saddle
3. Socket Screw
4. Nut

- 4 Preassemble the bracket and the saddle.

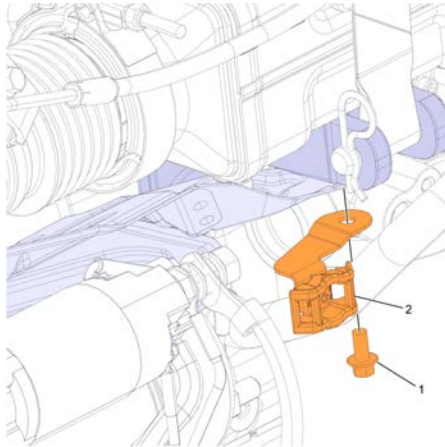
W2080362

1. Socket Screw  
2. Saddle

- 5 Install the bracket onto the vehicle and secure.

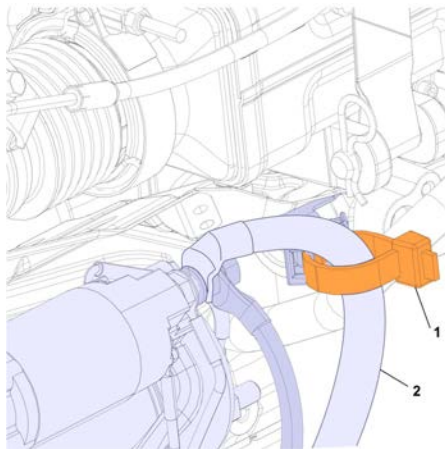
W2080364

1. Cable Tie  
2. Positive Battery Cable

- 6 Install the cable tie around the saddle and positive battery cable going to the starter solenoid.

**Note:** Battery cable may need to be loosened/retightened from back of starter solenoid in order to reach the saddle. Tighten to  $26 \pm 1.5$  Nm ( $19.2 \pm 1.1$  ft lb).
