SB-10052257-7537

Battery Starter Lug Failure
CXU, GU

FSB 371-045, Battery Cable Lug, Failure

(May 2013)

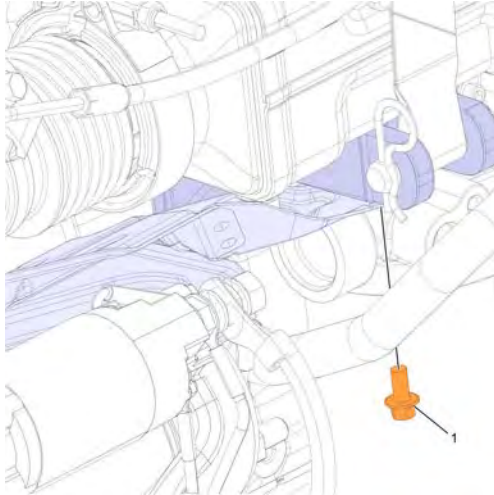
W2080360

1. Screw

- 1 Secure the vehicle for service by parking it on a flat level surface, applying the parking brake, chocking the rear wheel, and placing the transmission in neutral.
- 2 Disconnect all cables from the negative (ground) battery terminals to prevent personal injury from electrical shock and prevent damage to electrical components.
- 3 Remove the fastener from the heat shield bracket.

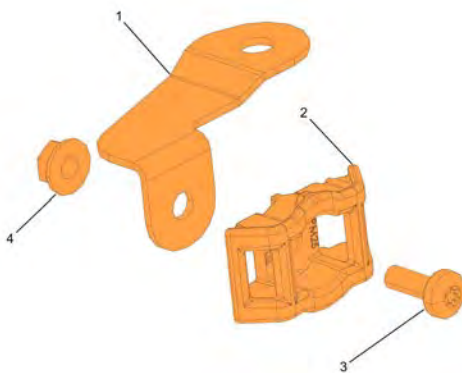
W2080361

- 1 Bracket
- 2 Saddle
- 3 Socket Screw
4. Nut

- 4 Preassemble the bracket and the saddle.

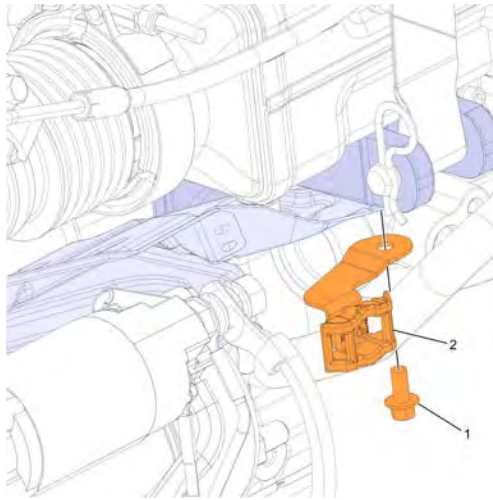
W2080362

1. Socket Screw
2. Saddle

- 5 Install the bracket onto the vehicle and secure.

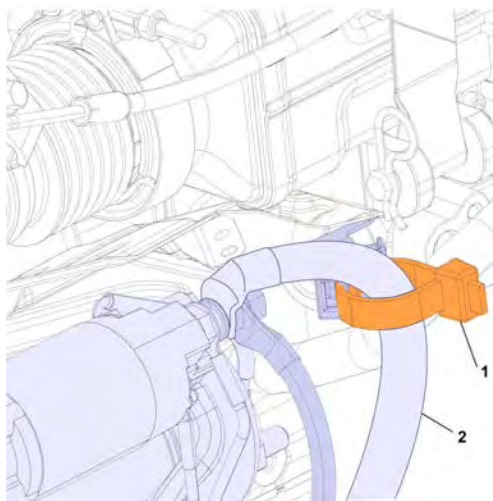
W2080364

1. Cable Tie
2. Positive Battery Cable

- 6 Install the cable tie around the saddle and the positive battery cable going to the starter solenoid.

Note: Battery cable may need to be loosened/retightened from back of starter solenoid in order to reach the saddle. Tighten to 26 ± 1.5 Nm (19.2 ± 1.1 ft lb).
