Field Service Bulletin Trucks

SB-10052257-9765

Battery Starter Lug Failure
CXU, GU

FSB 371-045, Battery Cable Lug, Failure

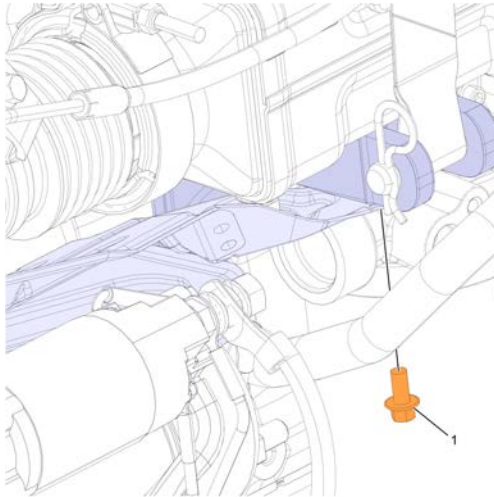
W2080360

1. Screw

- 1 Secure the vehicle for service by parking it on a flat level surface, applying the parking brake, chocking the rear wheel, and placing the transmission in neutral.
- 2 Disconnect all cables from the negative (ground) battery terminals to prevent personal injury from electrical shock and prevent damage to electrical components.
- 3 Remove the fastener from the heat shield bracket.

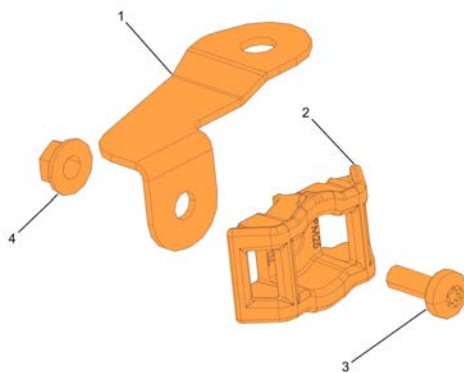
W2080361

- 1 Bracket
- 2 Saddle
- 3 Socket Screw
4. Nut

- 4 Preassemble the bracket and the saddle.

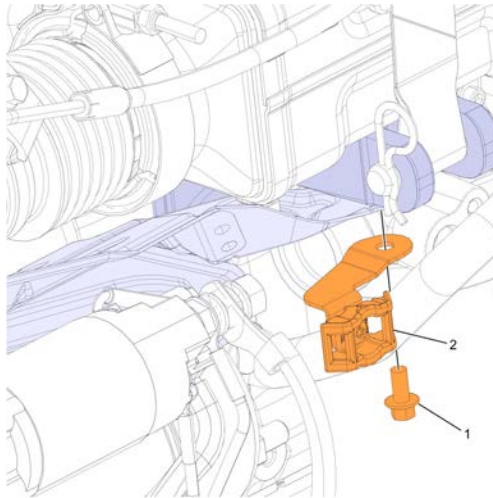
W2080362

1. Socket Screw
2. Saddle

- 5 Install the bracket onto the vehicle and secure.

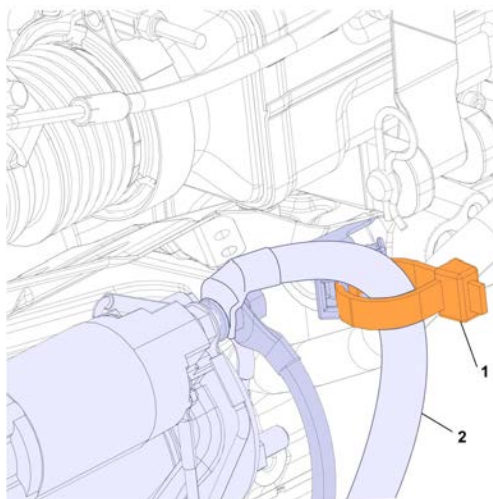
W2080364

1. Cable Tie
2. Positive Battery Cable

- 6 Install the cable tie around the saddle and the positive battery cable going to the starter solenoid.

Note: Battery cable may need to be loosened/retightened from back of starter solenoid in order to reach the saddle. Tighten to 26 ± 1.5 Nm (19.2 ± 1.1 ft lb).
