SERVICE BULLETIN		
Clas sification:	Reference:	Date:
EL13-015	NTB13-057	May 23, 2013

2013 ALTIMA SEDAN; LANE DEPARTURE WARNING AND BLIND SPOT WARNING SYSTEMS SERVICE INFORMATION

APPLIED VEHICLE: 2013 Altima Sedan (L33) equipped with LDW and BSW systems

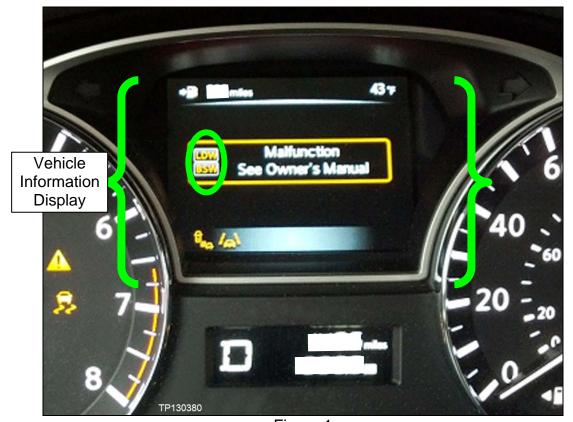
Figure 1

Message "Malfunction – See Owner's Manual" with LDW / BSW icons showing in the Vehicle Information Display (including but not limited to what shows in Figure 1)
