Technical Service Bulletin

01 MIL on, no start or rough running (DTC P0087 - Rail fuel pressure too low or DTC P0088 - Rail fuel pressure too high)

01 13 96 2023360/4 May 13, 2013. Supersedes Technical Service Bulletin Group 01 number 13-79 dated March 20, 2013 for reasons listed below.

Model(s)	Year	VIN Range	Vehicle-Specific Equipment
Audi A3	2010 - 2013	All	2.0 TDI clean diesel Engine
Audi Q7	2009 – 2013	All	3.0 TDI clean diesel Engine
Audi A8	2014	All	3.0 TDI clean diesel Engine

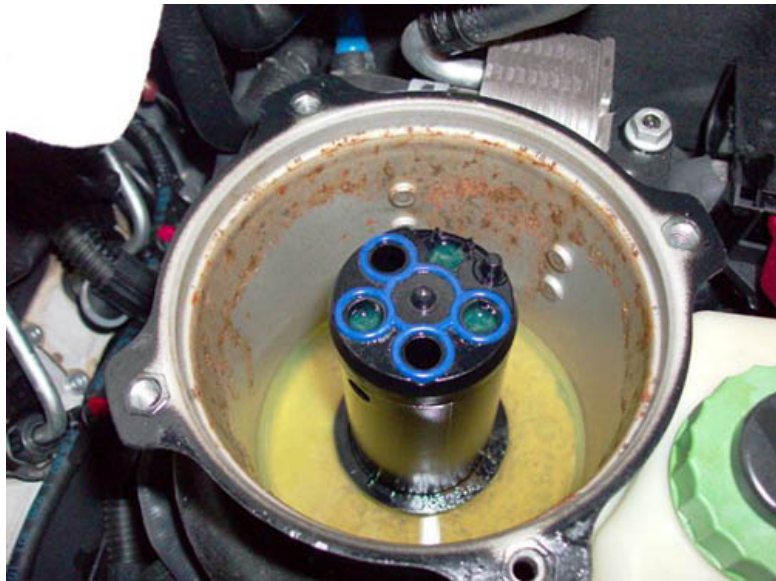
If there is any indication of fuel contamination, metal shavings/debris, or rust inside the fuel filter housing (Figures 1 and 2), open a ticket with the Technical Assistance Center (TAC) **before** attempting any repair.

Figure 2. Example of rust in fuel system caused by water contamination.

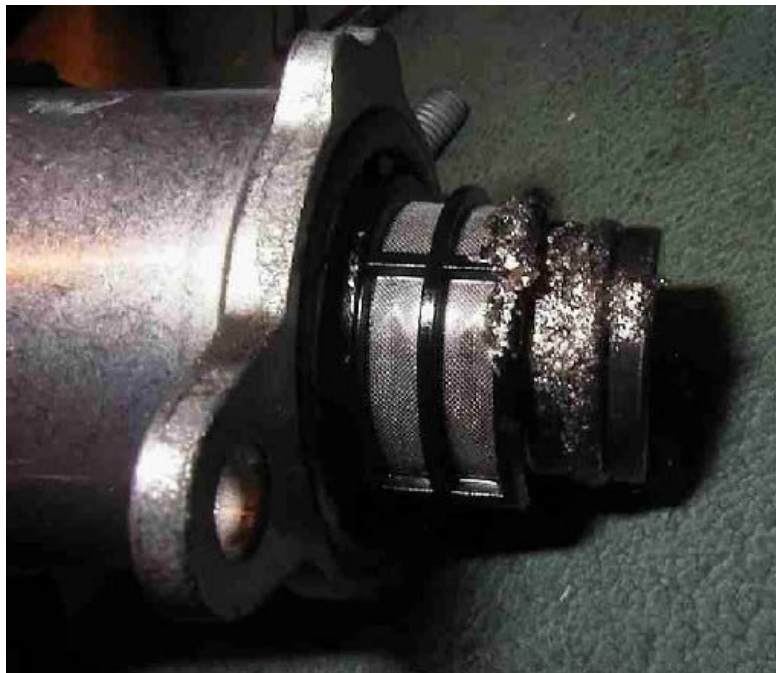
If there is any indication of fuel contamination, metal shavings/debris, or rust inside the N290 valve (Figures 3 and 4), open a ticket with the Technical Assistance Center (TAC) **before** attempting any repair.

Figure 4. Metallic debris on screen of N290 metering valve.
