NUMBER: 23-022-13

Wet Carpet At Right And/Or Left Front Floor

2013

Caravan / Town and Country (Includes International Markets)

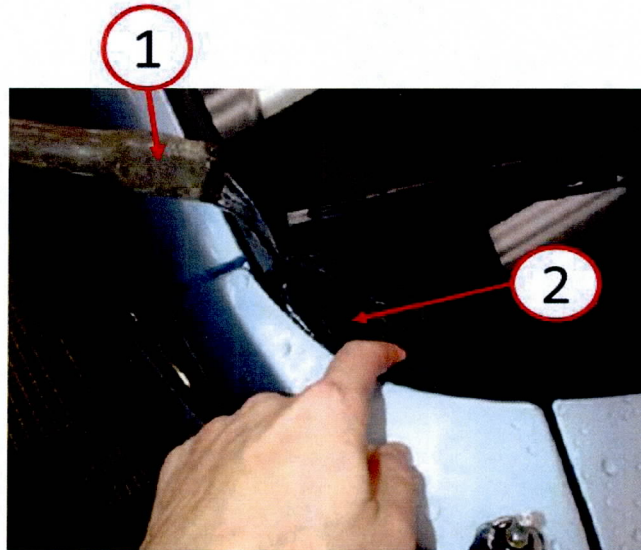
Fig. 1 Water Leak Test

- 1 - Water Hose
 - 2 - Cowl Screen/Windshield/Fender Area
-

1. Inspect the left and right front carpet near the cowl trim panel. Was either side wet?
 - a. Yes>>> Proceed to [Step #3](#).
 - b. No>>> Proceed to [Step #2](#).
2. Apply a steady flow of water at the cowl screen/fender/windshield area ([Fig. 1](#)) for 60 seconds and evaluate the kick panel area ([Fig. 2](#)). Did water begin to enter the vehicle?
 - a. Yes>>> Reinstall the cowl trim panel. Refer to the detailed procedures available in DealerConnect> TechCONNECT under: Service info> 23-Body> Interior> Panel, Cowl Trim> Installation. Proceed to [Step #3](#).
 - b. No>>> Continue further diagnosis, this bulletin does not apply.

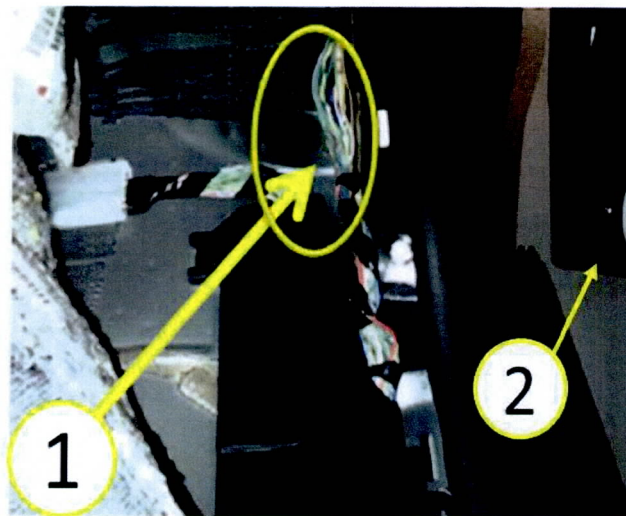
Fig. 2 Front Floor

Wet carpet at right and/or left front floor.

- 1 - Suspect Leak Area
 - 2 - Right Front Door
-

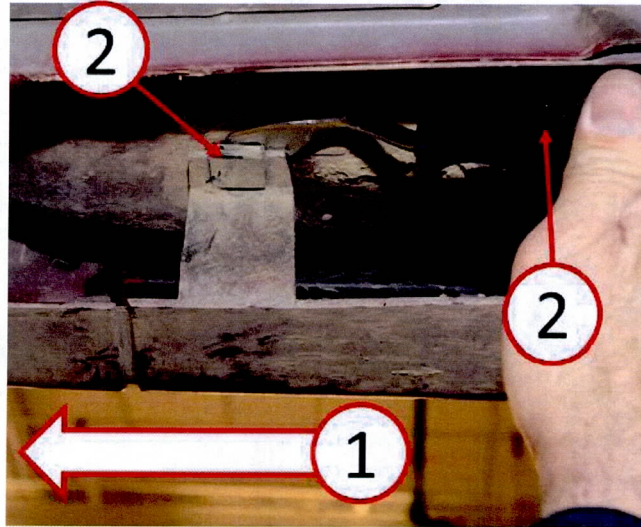
Fig. 3 Right Rear Sill Cladding

- 1 - Front Of The Vehicle
 - 2 - Front Rear Sill Cladding Clip
 - 3 - Clip Removal Tool
-

3. Raise the vehicle on a suitable hoist. Refer to the detailed service procedures available in DealerCONNECT > TechCONNECT under: Service Info > 04- Vehicle Quick Reference > Hoisting > Standard Procedure > Hoisting.
4. Remove the front rear sill cladding clip on the left and right side (Fig. 3). Position the rear sill cladding to access the mounting hole (Fig. 4).

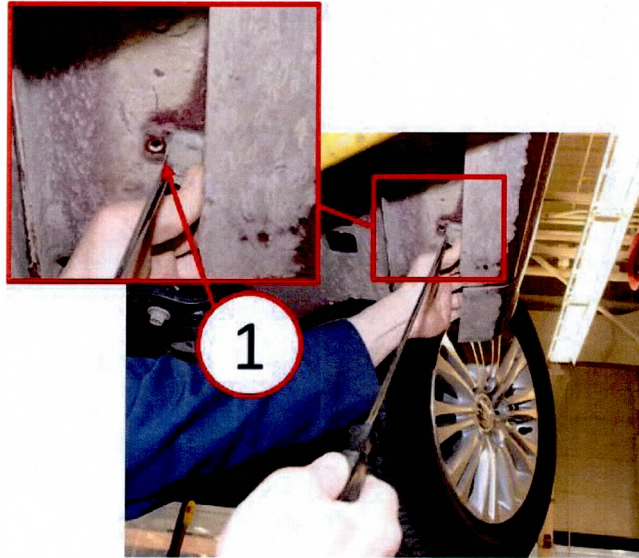
Fig. 4 Mounting Hole

1 - Mounting Hole
