## Flasher Replacement CHU, CXU, GU, TD

### FSB 364-036, Flasher Replacement

(June 2013)

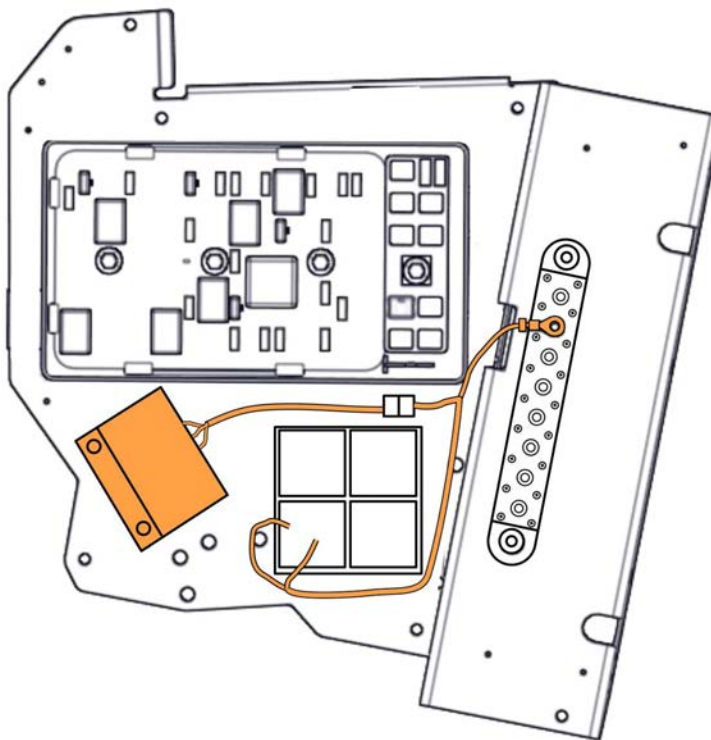
W3082443

Mack is removing the flasher 20971013 from production and the aftermarket due to the durability issues of the flasher. The 20971013 flasher will be replaced by 25162061 in the aftermarket. This will increase the reliability of the flasher circuit and the vehicle. Follow the procedure to replace the flasher if needed.

- 1 - 25162061 Flasher
- 2- 25099161 Screw
- 1 - 25173632 Harness
