# Technical Service Bulletin

## 01 MIL on (DTC P2006(00) or P2007(00) stored in ECM)

01 13 06 2033919/5 June 18, 2013. Supersedes Technical Service Bulletin Group 01 number 13-05 dated June 7, 2013 for reasons listed below.

Model(s)	Year	VIN Range	Vehicle-Specific Equipment
A6/A7, S4, S5, S5 Cabrio, Audi Q7, Audi Q5	2013	All	3.0 FSI Engine

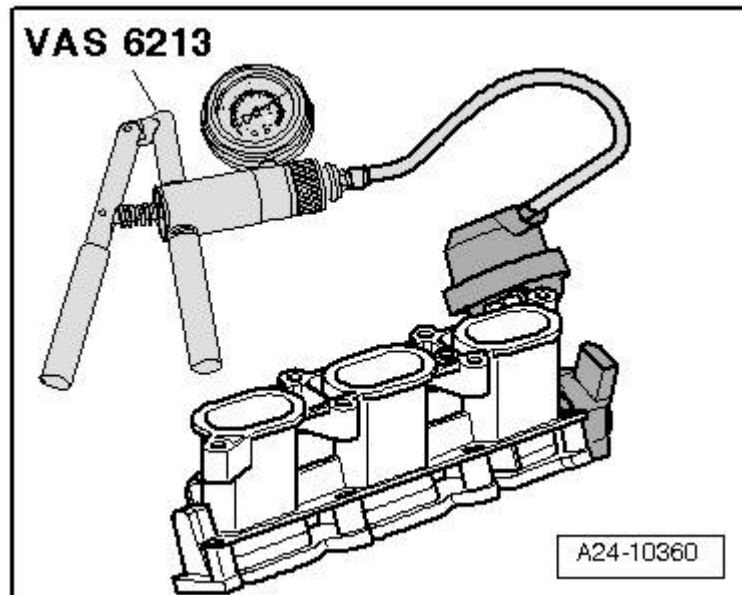
Figure 1. Vacuum pump VAS 6213

1. Identify the defective vacuum actuator. Use Guided Fault Finding (GFF), or use the vacuum pump (Figure 1) to determine which actuator is defective.

2. Replace the defective actuator using instructions from ElsaWeb. Do not replace the entire intake runner.
