TING/POP/CLICK NOISE—FRONT HALFSHAFT	TSB 13-5-14
---	--------------------

FORD:
2011-2013 Taurus, Explorer, Flex

LINCOLN:
2011-2013 MKS, MKT

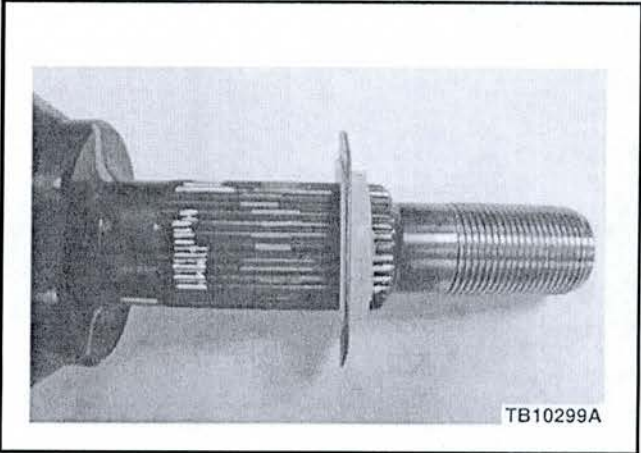
Figure 2 - Article 13-5-14

Some 2011-2013 Explorer, Flex, Taurus, MKT and MKS vehicles may exhibit a noise that could be described as ting, pop or click noise from the front wheel area when accelerating from a stop or when shifting between drive/reverse and/or reverse/drive.

1. Separate halfshaft from wheel hub. Refer to Workshop Manual (WSM), Section 205-04.
 - a. Do not remove halfshafts from transmission or power transfer unit (PTU).
2. Install one (1) thrust washer, metal surface first, over the halfshaft splines until the metal ring is flat against the wheel bearing mating surface. The nylon surface should face outward toward the hub/splines. (Figures 1 and 2)
