SERVICE BULLETIN

Classification: AT13-017	Reference: NTB13-086	Date: September 10, 2013
-----------------------------	-------------------------	-----------------------------

2013 - 2014 ALTIMA V6 SEDAN AND PATHFINDER; JUDDER DURING LIGHT ACCELERATION

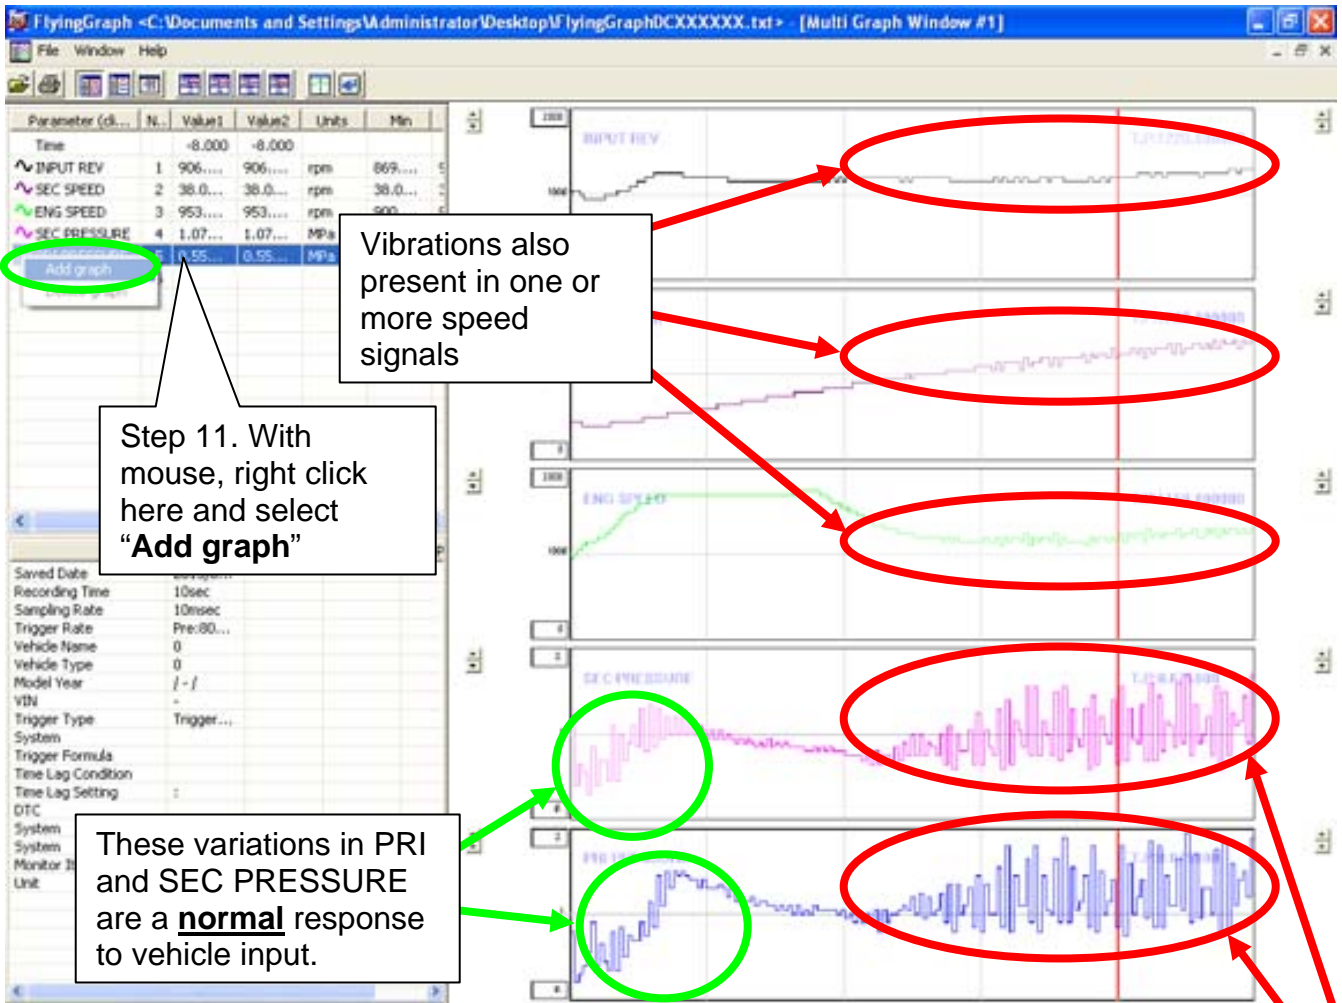
Figure 13

Repetitive Pressure Vibration in PRI and/or SEC Pressure signals.

13. During data review, if your data shows a Repetitive Pressure Vibration in either **PRI PRESSURE** or **SEC PRESSURE**, and also shows an irregular (non-smooth) line in one or more speed signals (**ENG SPEED**, **INPUT REV**, **SEC SPEED**) as indicated in Figure 13, replace the CVT to resolve (Figure 13 shows Repetitive Pressure Vibrations circled in red).

- **Do not** replace the torque converter assembly if the data review shows Repetitive Pressure Vibration as described above.
- If a judder is present and the recorded data review shows that the data lines are smooth with no oscillations as shown in Figure 14 above refer to Torque Converter Replacement on page 17.

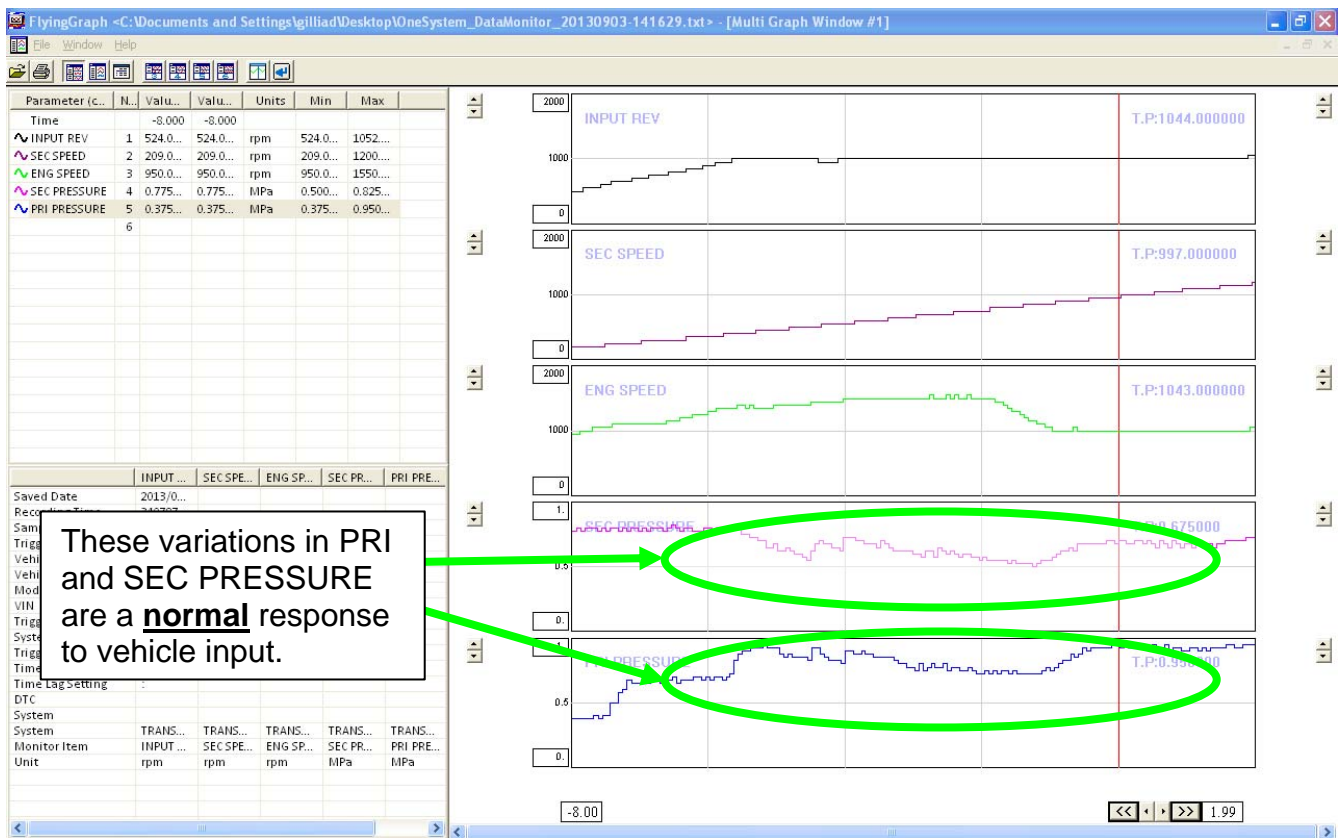
NOTE: Figure 14 shows **INPUT REV**, **SEC SPEED**, **ENG SPEED**, **PRI PRESSURE** and **SEC PRESSURE** from a vehicle that does not have a judder present.

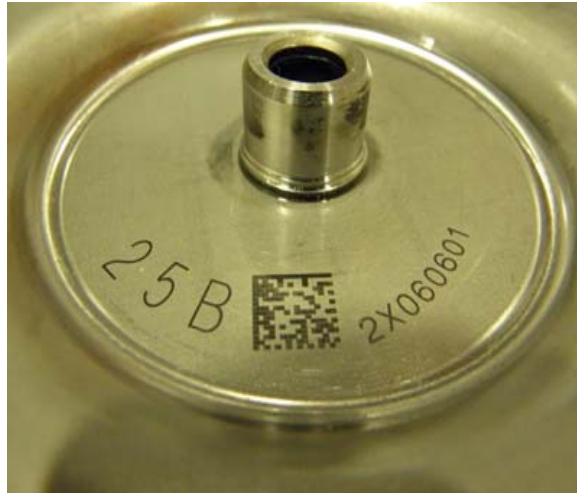
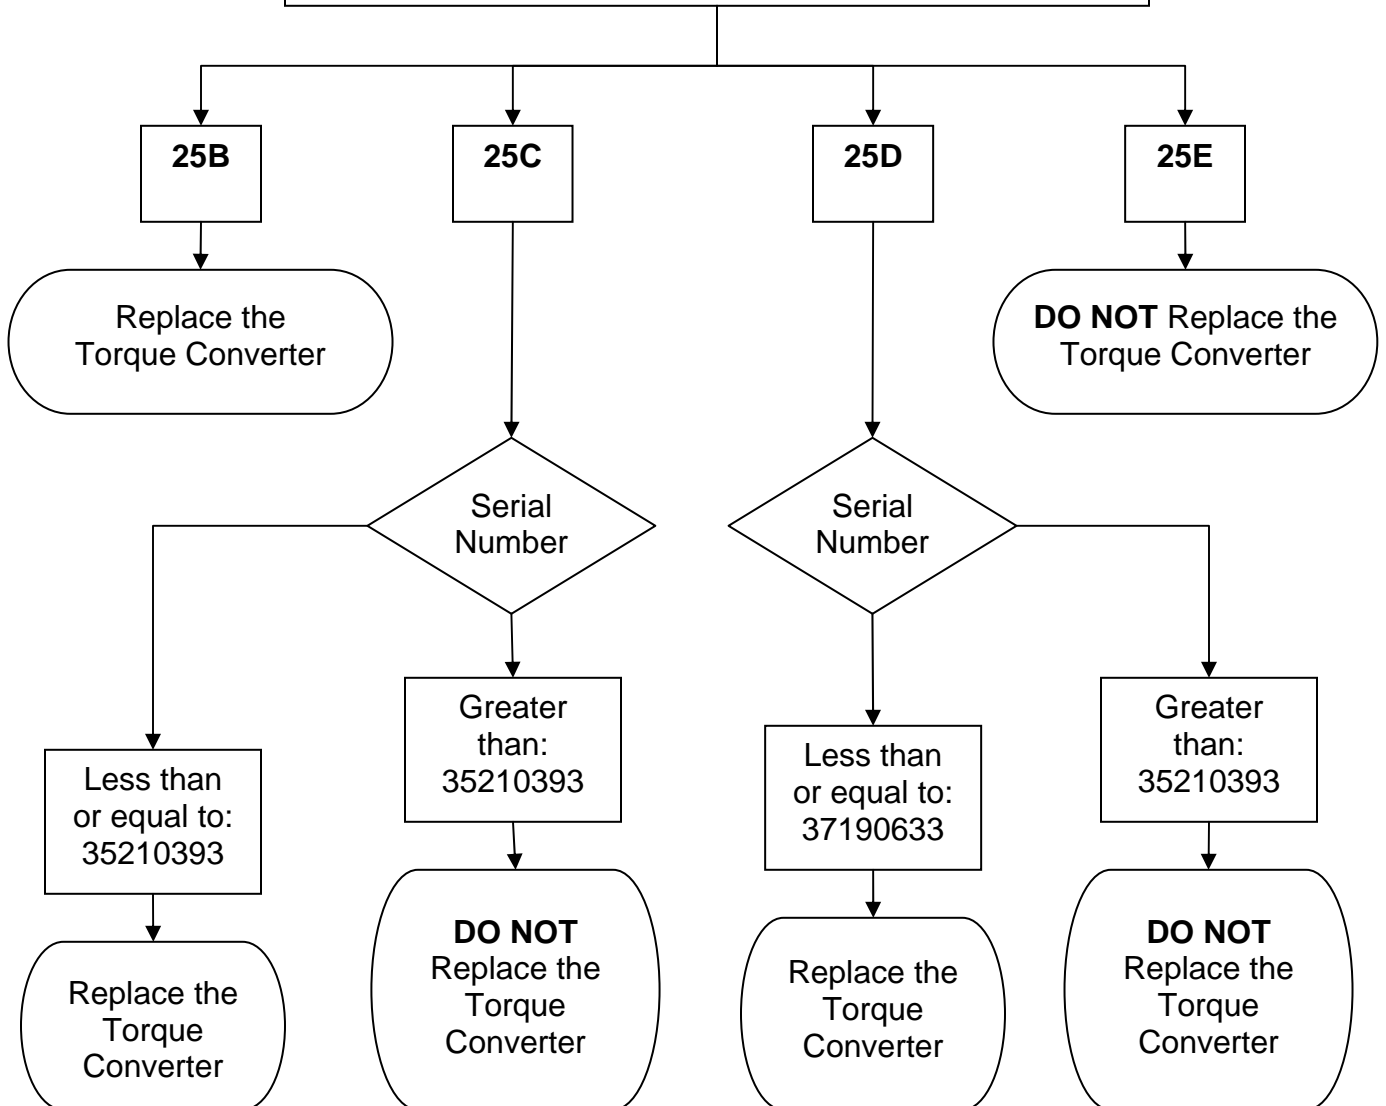
FLOW CHART B

Check the stamping on the outside of the torque converter

- If a judder is present, recorded data review does not indicate pressure vibration and the torque converter in the CVT is already "D" level or greater (see **FLOW CHART B** on page 17), refer to ASIST or the appropriate section of the ESM for further diagnostic assistance.

1. Replace the torque converter with the new one listed in the Parts Information:
 - Refer to the TM section of the appropriate Service Manual for replacement information.
