EC13-010

August 5, 2013

2012 – 2013 M HYBRID; MIL "ON" WITH DTC P0300, P0301, P0302, P0303, P0304, P0305, OR P0306 STORED

APPLIED VEHICLES: 2012 – 2013 M Hybrid (HY51)

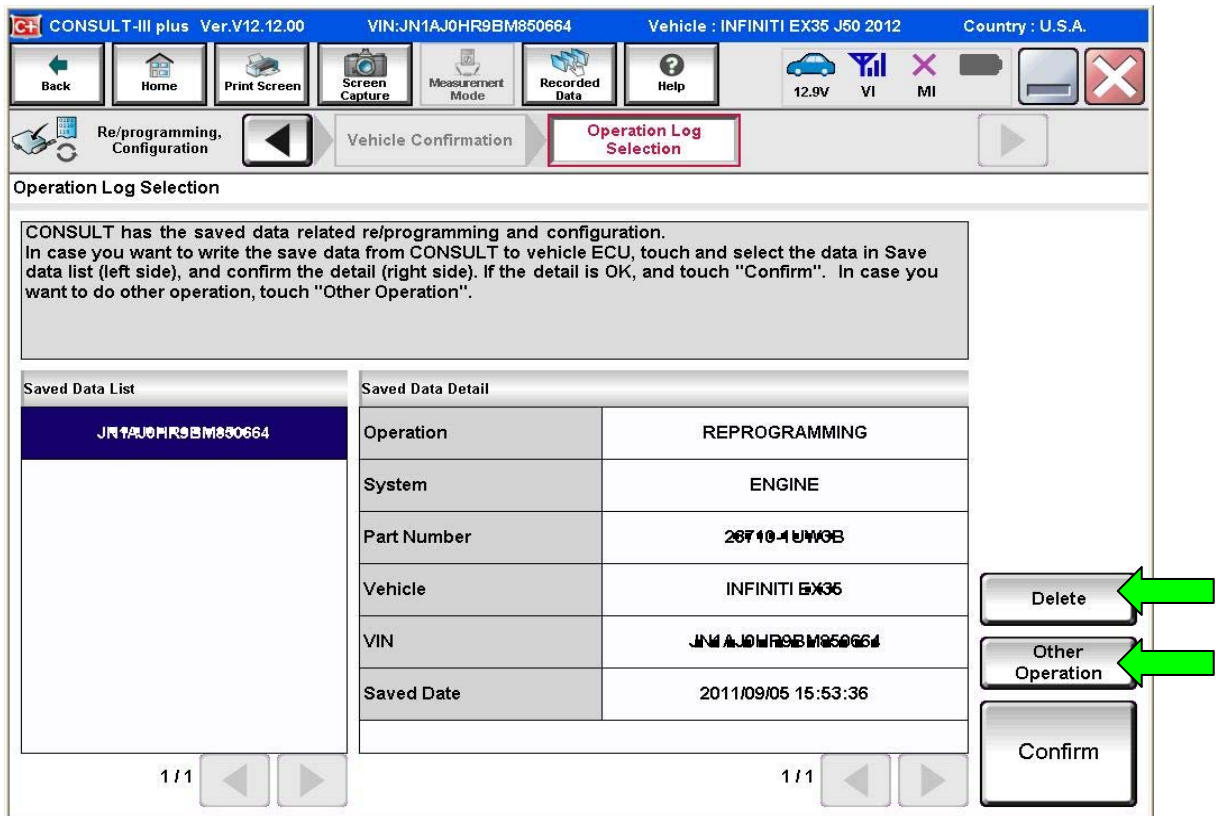
Figure 1a

During the initial "Reprogramming Confirmation" set-up, if you get this screen (Figure 1a):

- Select **Delete**, then
- Select **Other Operation**, then
- Continue with the reprogramming procedure.

NOTE: If reprogramming does not complete, this screen can display for reprogramming recovery. Do not select Delete if this screen displays during reprogram recovery.

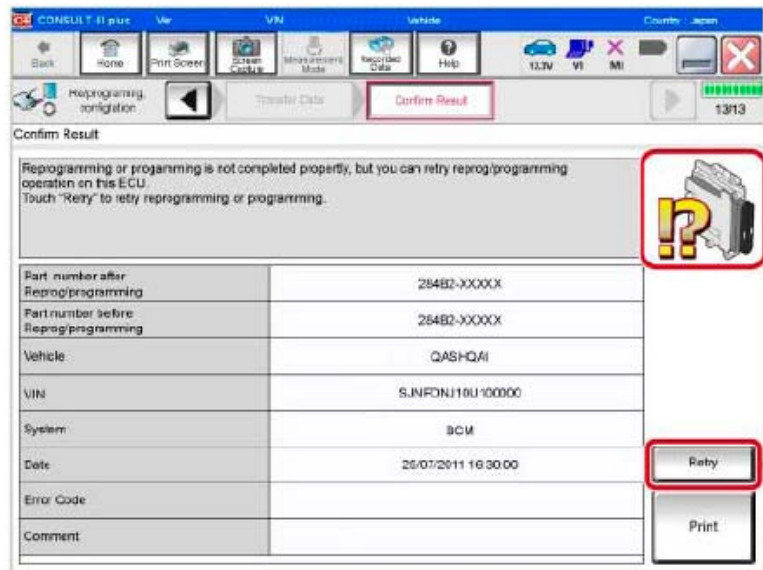
Figure 5

If reprogramming does not complete and the “!?” icon displays as shown in Figure 5:

- Check battery voltage (12.0 - 15.5 V).
- Ignition is ON, engine OFF.
- External Bluetooth® devices are OFF.
- All electrical loads are OFF.
- Select **retry** and follow the on screen instructions.
- “Retry” may not go through on first attempt and can be selected more than once.

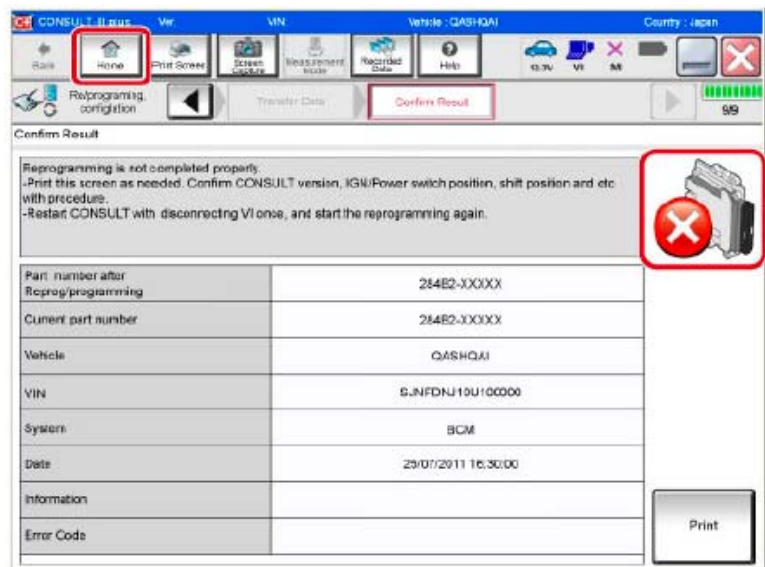
Figure 6

If reprogramming does not complete and the “X” icon displays as shown in Figure 6:

- Check battery voltage (12.0 - 15.5 V).
- CONSULT A/C adapter is plugged in.
- Ignition is ON, engine OFF.
- Transmission is in Park.
- All C-III plus / VI cables are securely connected.
- All C-III plus updates are installed.
- Select **Home**, and restart the reprogram procedure from the beginning.
