GROUP Engine	MODEL 2011-2012MY Sportage (SL) Turbo
	NUMBER 130 (Rev 1, 01/17/2014)	DATE July 2013
TECHNICAL SERVICE BULLETIN		
SUBJECT: ECM UPGRADE – REFLASH AND EWGA ADJUSTMENT PROCEDURE (SA 149)

**SUBJECT: ECM UPGRADE – REFLASH AND EWGA ADJUSTMENT
PROCEDURE (SA 149)**

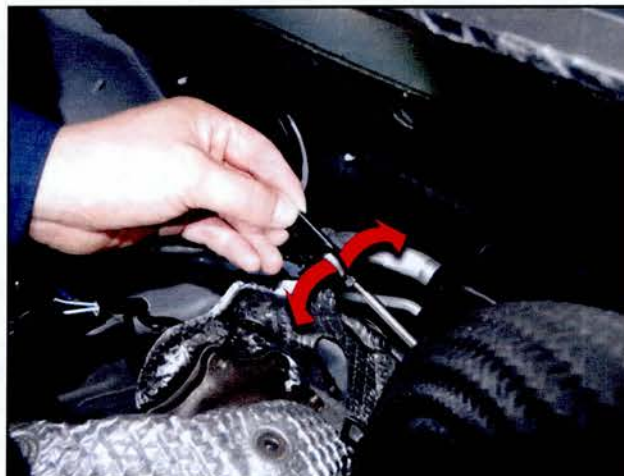
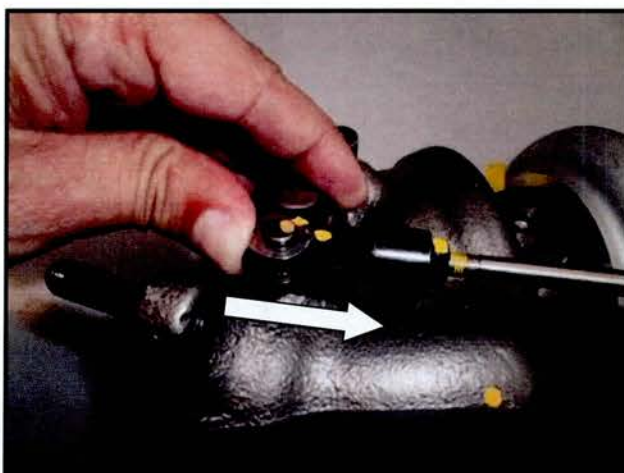
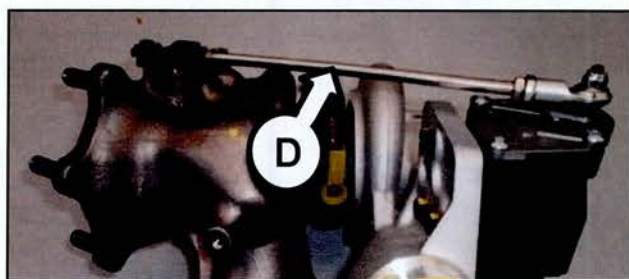
Verify the EWGA is in the fully closed position by applying pressure on the EWGA lever to accurately measure the output.

Specification: 4.1V (Cold Engine)

- Adjust the rod end by rotating it clockwise or counterclockwise until specification is within range (See Tables A and B below). Then, temporarily install the rod end and tighten the rod end lock nut. Check the **Adaptation Value for the Lower Mechanical Stop of Boost Pressure**, using GDS.

If unable to achieve proper voltage, it may be necessary to rotate the EWGA rod (D) to achieve proper voltage.
