Service Bulletin

Subject: DRIVER SIDE SEATBACK RECLINING POSITION CHANGES BY ITSELF WHEN CUSTOMER EXITS THE VEHICLE	Bulletin No: 09-020/13
	Last Issued: 07/11/2013

2013-2014 CX-5 with VINs lower than JM3 KE***** 338025 (produced April 1, 2013)

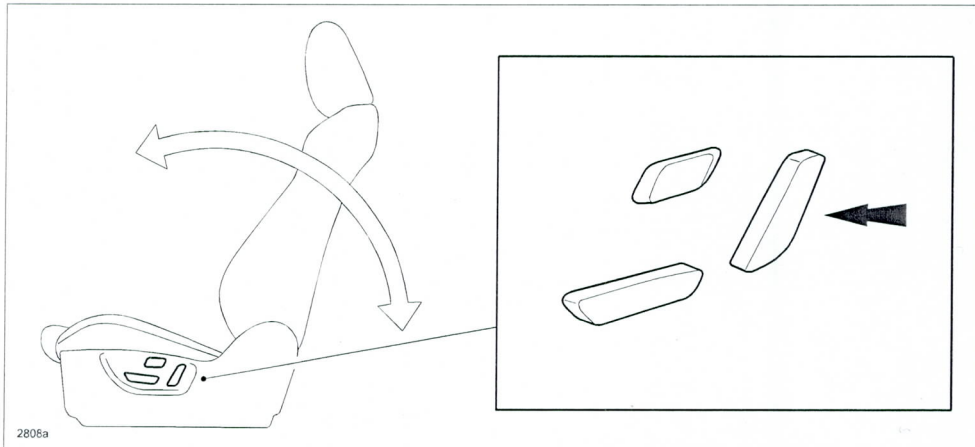
Some customers may complain that the driver side seatback reclining position seems to change by itself. This may be caused unknowingly by the customer when they exit the vehicle. The customer's leg may be contacting the recliner switch and changing the seatback reclining position.

The configuration of the recliner switch has been changed to eliminate this concern.

1. Verify the customer concern.
2. Replace the recliner switch with a modified new part according to the instructions on MS3 online or the Workshop Manual (section 09-13 FRONT SEAT SIDE COVER REMOVAL/INSTALLATION).
3. Verify the repair.
