T-SB-0147-13

Telescopic Lever Detent Clip Replacement

Service Category Steering

YEAR(S)	MODEL(S)	ADDITIONAL INFORMATION
2005 – 2012	Avalon

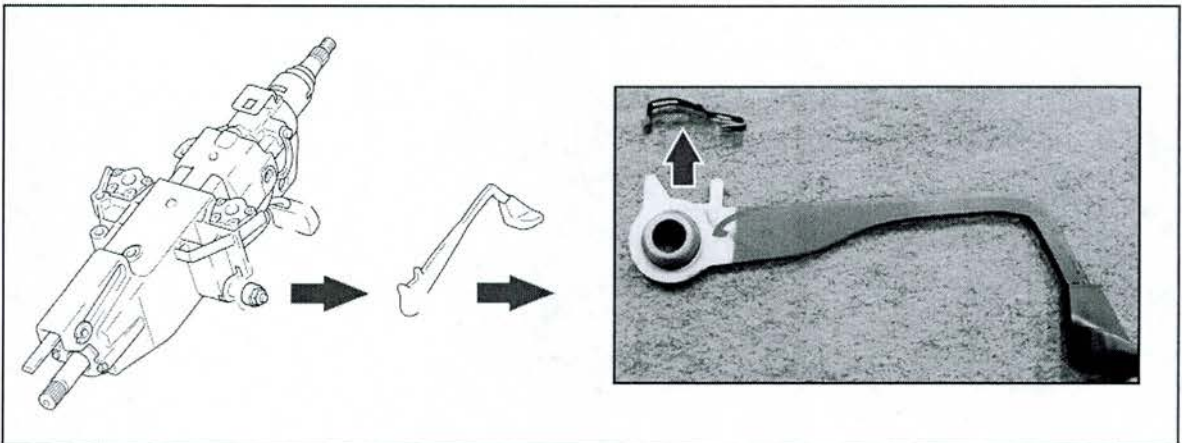
Figure 7.

Some 2005 – 2012 model year Avalon vehicles may exhibit a looseness when securing the telescopic adjustment lever on the steering column. A new adjustment lever Detent Clip has been developed to address this condition. Please follow the procedure in this bulletin to replace the telescopic lever Detent Clip.

10. Remove the Detent Clip from the lever.
