Date 10.13    Group **284**    No. **047**    Release **02**    Page 1(10)

Oil Level Sensor Harness Wire Splice  
VAH, VHD, VN, VT

**FSB 284-047, Oil Level Sensor Harness Wire Splice**

(October 2013)

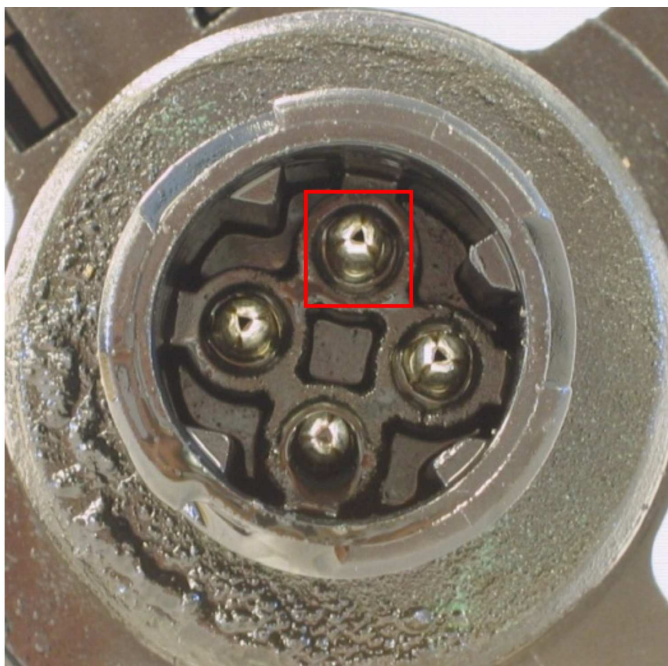
W2085817

Some VOLVO vehicles built between January 2004 and September 19, 2013 may experience an oil level sensor failure that leads to oil contamination into the engine wire harness. A new anti-wicking pigtail splice kit, part number 85137983, is now available. Follow the procedure below if wicking is observed. Chassis with build date September 20, 2013 and later have the new solid pin connector and no action is required. The oil level sensor part number 21521353 with hollow pin type connector is now replaced with the new solid pin type connector oil level sensor part number 22022794. The new solid pin connector does not allow oil to wick into the engine harness.

Old Style Hollow Pin Connector

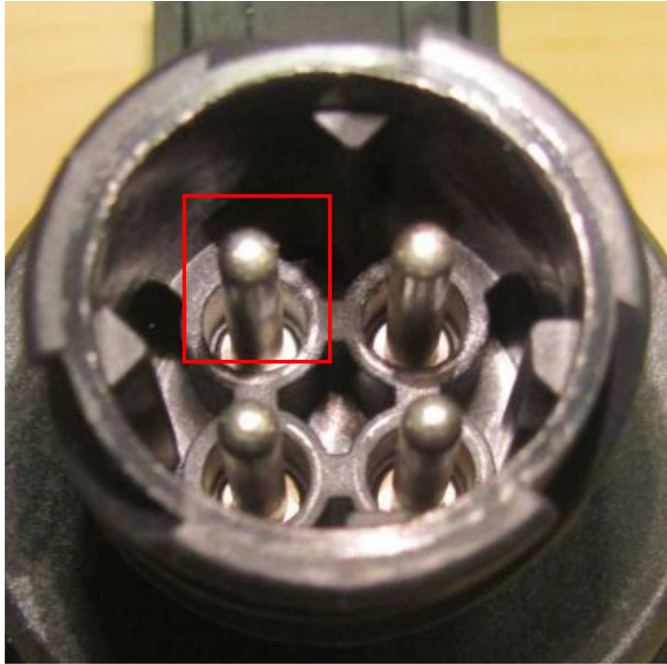
W2085818

#### New Style Solid Pin Connector

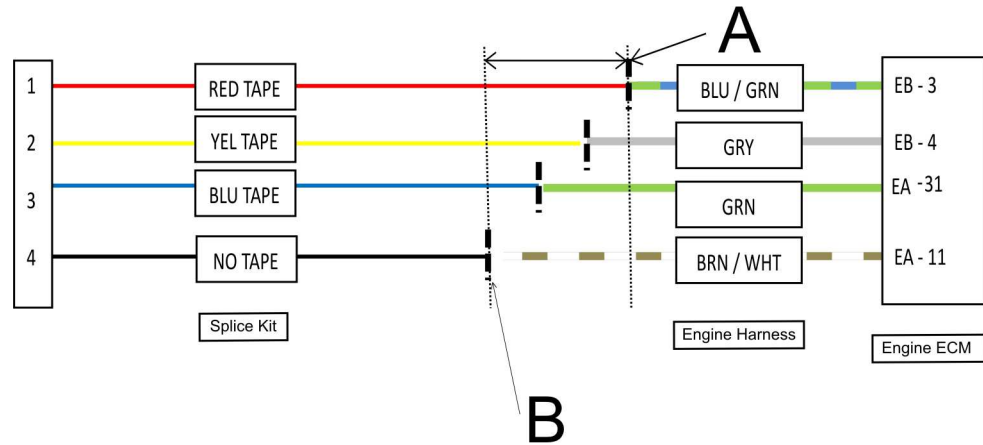
W3085820

A.	Length of cut harness plus 75 mm (3 in) to allow the splice stagger
B.	Length of initial harness cut

10 Stretch the wires together and clip one wire from the splice kit to the same length as the wires on the contaminated harness. Cut the rest of the wires in the splice kit in a staggered pattern at increasing lengths. The length from the shortest wire to the longest wire should be approximately 75 mm (3 in). Install the previously removed loom over the splice kit connector.
