SB-10054050-9468

Technical Information Bulletin

13-036

Routing Bracket on T300's with Hydraulic Brakes

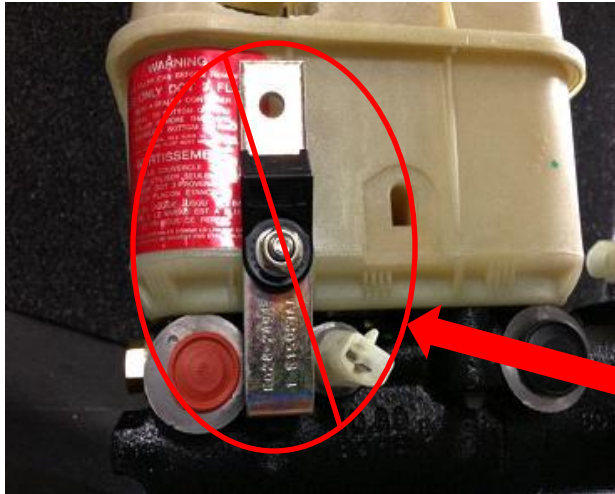
Hydraulic Reservoir Routing

Beginning in April, a standoff was added to the reservoir mounting bolt on T300's with hydraulic brakes. The brake supplier does not approve the use of the reservoir mounting bolt to mount a bracket.

**REMOVE**

1. Identify if the hydraulic brake chassis has a standoff bracket attached to the brake fluid reservoir mounting bolt.
2. Remove the reservoir mounting bolt that attaches the standoff bracket to the master cylinder. Be careful not to hit the nearby plastic Pressure Differential Switch as it can be damaged by wrench contact.
3. Remove the standoff bracket assembly.
4. Reinstall the reservoir mounting bolt and torque the bolt to 37.3 ± 3.4 Nm (27.5 ± 2.5 ft-lbs).
5. Re-secure the bundle that was attached to the standoff bracket.
