Charging System Voltage (Cummins ISX)  
 VN Models

**FSB 322-002, Charging System Voltage**

(November 2013)

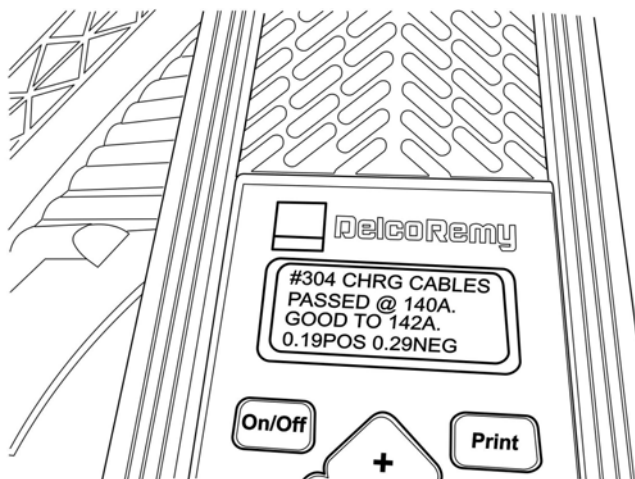
W3083778

On some vehicles, the Intellicheck tester can erroneously indicate excessive voltage drop in the charging system. If the Intellicheck tester indicates too high a voltage drop, perform these steps to determine if corrective action is needed:

Sample calculation  $A + B = \leq 0.60 \text{ V}$

Example:  $0.19 + 0.29 = 0.48$  (**Passed**) No further action required.

- Clean and tighten all power connections on the alternator, batteries and cables.
- Repeat the test with the Intellicheck tester and record the voltage drop reading for positive and negative.
- Add the two readings: **If the total is 0.60 V or less then the voltage drop is acceptable** no further action is needed.

If the total is greater than 0.60 V then perform the following procedure:
