**AWD—LEAK FROM PTU—BUILT ON OR BEFORE  
1/25/2013**

**TSB 13-9-16**

**FORD:**  
2013 Taurus, Explorer

**LINCOLN:**  
2013 MKS

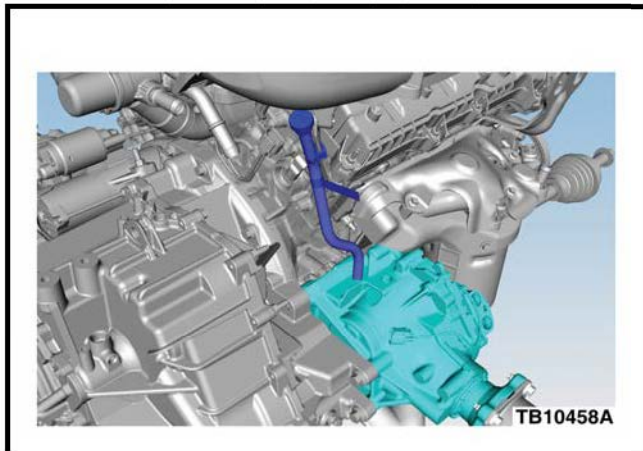
Figure 1 - Article 13-9-16

Some 2013 Explorer, Taurus, and MKS vehicles equipped with all wheel drive (AWD) and built on or before 1/25/2013 may exhibit power transfer unit (PTU) fluid leak. This concern may be due to a PTU vent hose which is missing or disconnected.

1. Raise vehicle on a hoist. Refer to Workshop Manual (WSM), Section 100-02.
2. Inspect for a disconnected or missing PTU vent hose..
3. Is the hose missing or disconnected?
  - a. Yes - install new hose or attach hose, as required. Refer to illustrations for hose routing.
    - (1) Twin Independent Variable Cam Timing (Ti-VCT) engine (Figure 1)
