**SB-10054544-8673**

**IB12-N-001C**

**NO CRANK/NO START, NO SCAN TOOL COMMUNICATION – EXTREME  
COLD WEATHER**

- 2007-2015MY Isuzu N-Series  
Equipped with 5.2L (4HK1) Diesel Engine and Diesel Particulate Filter (DPF)

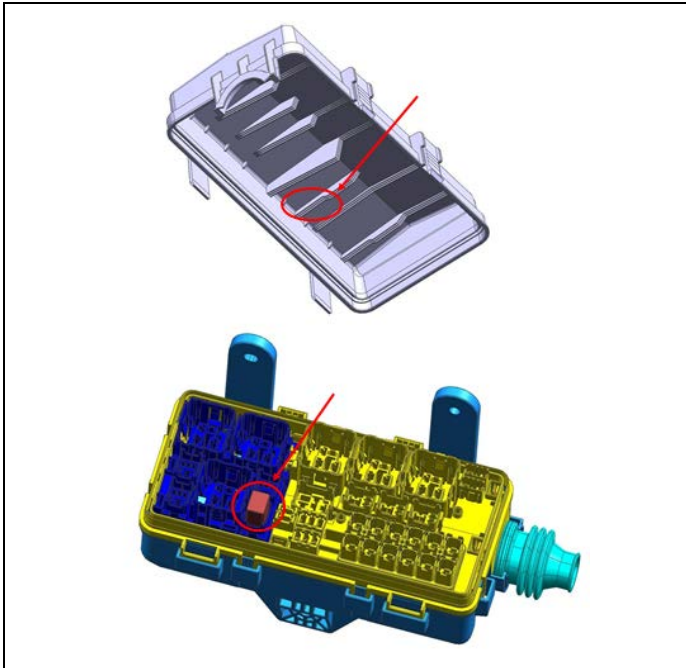
Some customers may experience a no crank/no start condition when ambient temperatures fall to or below -20°C/-4°F. Vehicles equipped with a Multi Information Display (MID) will show the error code P1464. In most cases, this condition is the result of a stuck ECM Main Relay (X-30). This condition can be confirmed by connecting IDSS. If IDSS cannot communicate with the vehicle, the ECM has not powered up due to the frozen X-30 Relay.

**Figure 1** – Locate X-30 relay and relay cover rib

1. Remove relay box cover.
2. Remove the original ECM Main Relay in location X-30.
3. Install the new relay at location X-30.
4. Locate the relay box cover rib as shown in Figure 1.

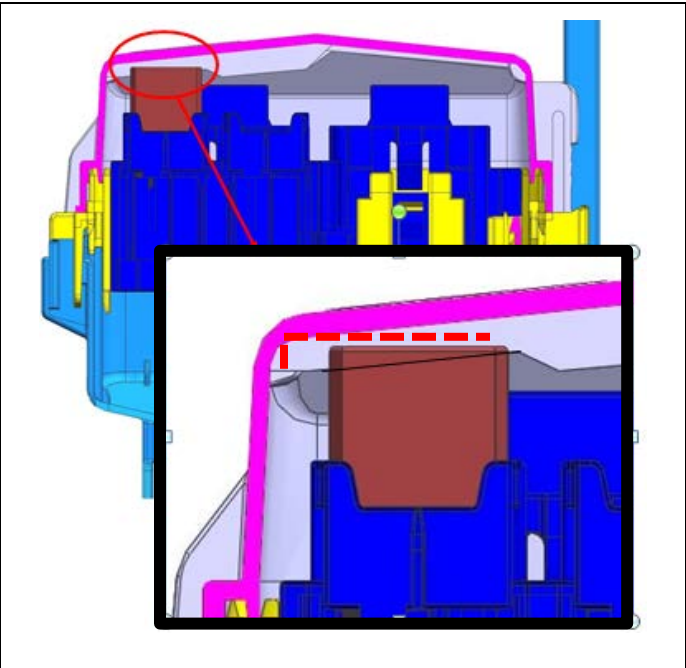
**Figure 2** – Cut at dashed line

5. Trim the relay cover rib approximately 3mm to provide clearance for the new relay.
6. Install the relay cover and confirm it seals properly. If the cover does not close properly, trim additional material from the cover until it seals.
