BULLETIN NUMBER:
IB12-N-001A

No Crank/No Start, No Scan Tool Communication – Extreme Cold Weather

- 2007-2014MY Isuzu N-Series
Equipped with 5.2L (4HK1) Diesel Engine and Diesel Particulate Filter (DPF)

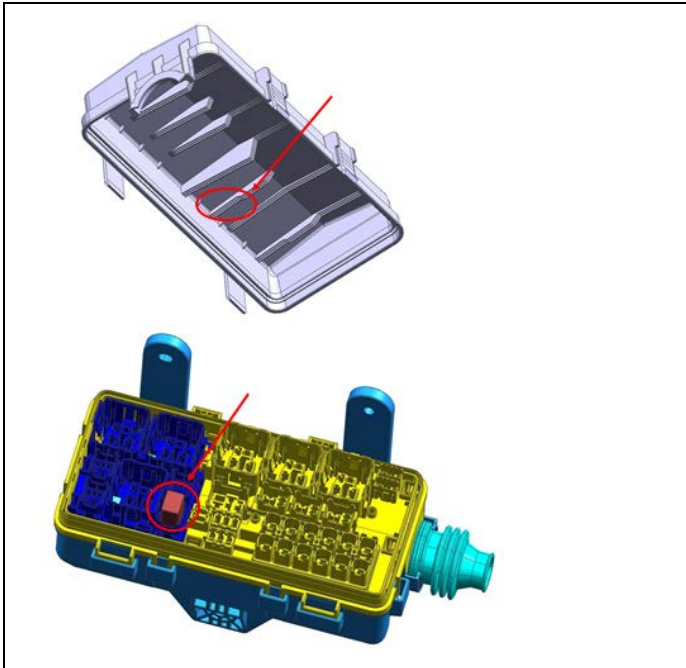
Some customers may experience a no crank/no start condition when ambient temperatures drop to or below -20 degrees C. Vehicles equipped with Multi Information Display (MID) will show the error code P1464. In most cases, this condition is the result of a stuck ECM Main Relay (X-30). This condition can be confirmed by connecting IDSS. If IDSS cannot communicate with the vehicle, the ECM has not powered up due to the frozen X-30 Relay.

Figure 1
Locate X-30 relay and relay cover rib

1. Remove relay box cover.
2. Remove the original ECM Main Relay in location X-30.
3. Install the new relay at location X-30.
4. Locate the relay box cover rib as shown in figure 1.

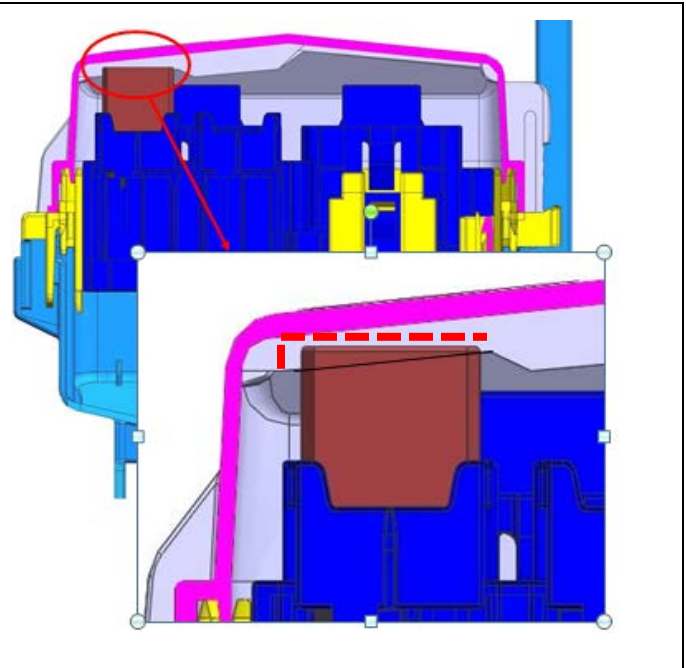
Figure 2
Cut at dashed line

5. Trim the relay cover rib approximately 3 mm to provide clearance for the new relay.
6. Install the relay cover and confirm it seals properly. If the cover does not close properly, trim additional material from the cover until it seals.
