### Technical Information Bulletin

#### ECM Mount Modification{7000}

Media Number -TIBU7306-00

CT660 (S/N: TRK1-UP; TKL1-UP; TJS1-UP; TGT1-UP; TSW1-UP; TSY1-UP)

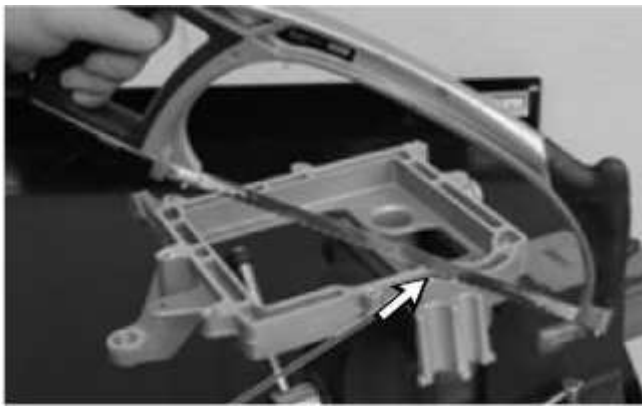
Illustration 1

The engine harness can rub on the harness mounting location of the ECM mount.

1. Using a hack-saw or other acceptable method, cut off harness support bracket from bottom of ECM bracket.
