ITB14-004

January 24, 2014

## VOLUNTARY SERVICE CAMPAIGN 2014 Q50 INFINITI InTouch SOFTWARE UPDATE

**CAMPAIGN I.D. #:** P4205  
**APPLIED VEHICLES:** 2014 Q50 (V37)  
2014 Q50 Hybrid (V37)

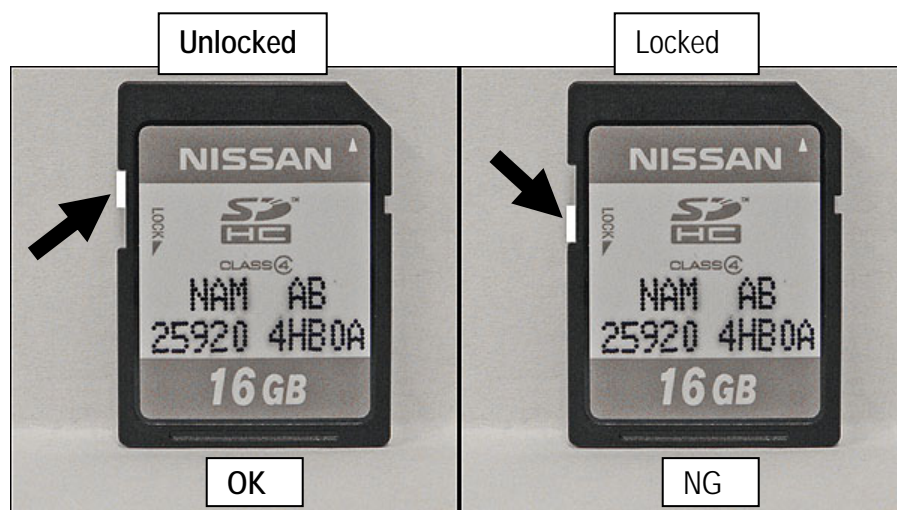
Figure 1

**IMPORTANT:** For vehicles equipped with Navigation, make sure the lock tab on the Map SD card is in the UNLOCKED position (see Figure 1), or the software update cannot be performed:

- Locate the SD card slot in the center console box and remove the MAP SD card.
- Verify:** Make sure the MAP SD card is UNLOCKED.
- Re-insert the SD card and make sure it is locked in. The label on the SD card should not be visible.

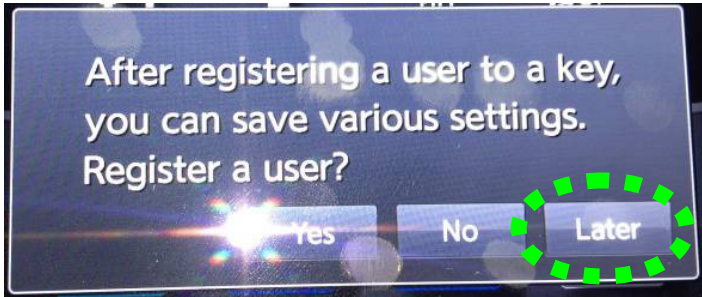
Q. What do I do if the below screen appears?

A. Select "Later" and then continue with the procedure. This is covered in step 2 of the procedure but this message can appear at other times in the update process.
