ITB14-004a

February 14, 2014

VOLUNTARY SERVICE CAMPAIGN 2014 Q50 INFINITI InTouch SOFTWARE UPDATE

APPLIED VEHICLES: 2014 Q50 (V37)
2014 Q50 Hybrid (V37)

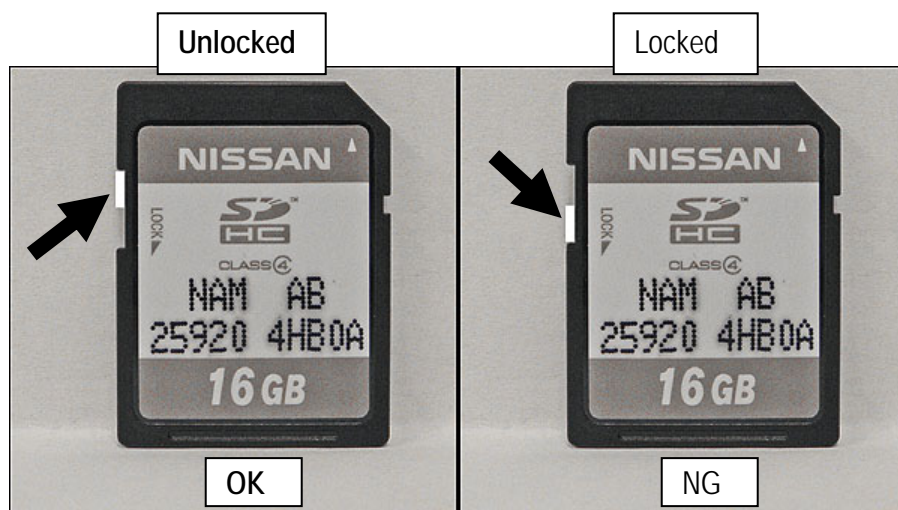
Figure 1

IMPORTANT: For vehicles equipped with Navigation, make sure the lock tab on the Map SD card is in the UNLOCKED position (see Figure 1), or the software update cannot be performed:

- Locate the SD card slot in the center console box and remove the MAP SD card.
- Verify:** Make sure the MAP SD card is UNLOCKED.
- Re-insert the SD card and make sure it is locked in. The label on the SD card should not be visible.

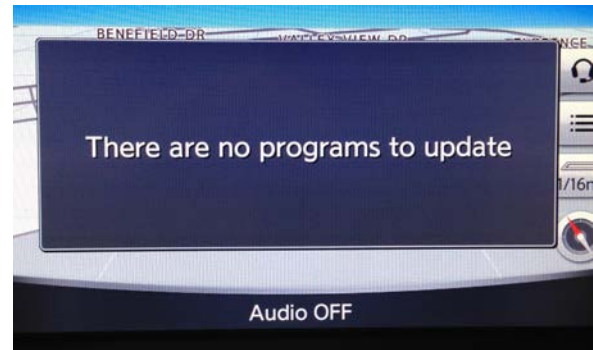
- Make sure you are using “V50E USB Flash Drive” (see Figure A on page 2).
- USB ports are located in the center console box.
- Either USB port is OK use.
- **After about 15 seconds the upper display will automatically show the update screen (Figure 19)**
- If the screen in Figure 19a displays, the systems already has all current versions. No further actions is needed.

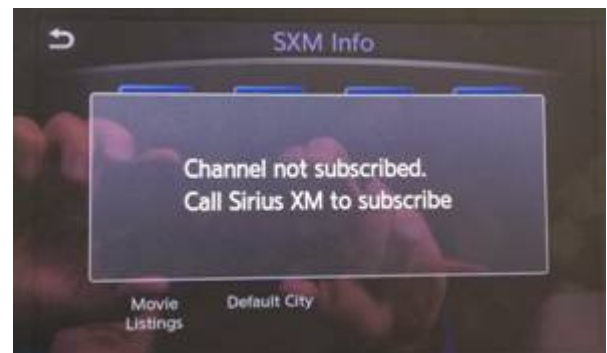
Figure 44

- If you see this error message (Figure 44), continue with the procedure and perform the SiriusXM refresh.

29. Turn the radio ON and tune to SiriusXM channel "0".

30. Write down the 8 digit SiriusXM Radio ID displayed on the screen.

31. Tune to SiriusXM channel "1" and leave the radio ON.

32. Refresh service at www.siriusxm.com/refresh or by calling SXM Automated Activation Hotline at 1-855-697-3373.

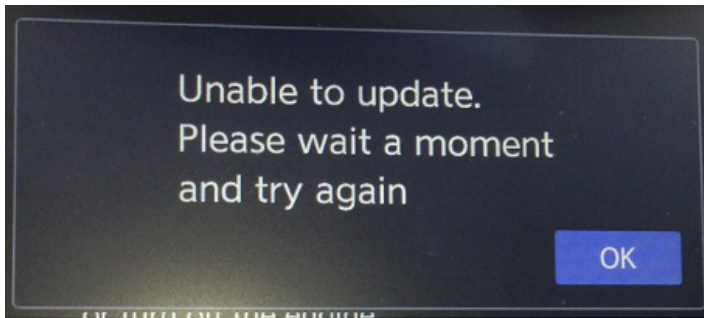
Q. What do I do if the below screen appears?

A. This screen may appear while performing software update for other InTouch systems (steps 8-12). If it does:

1. Remove USB Flash Drive, turn the ignition OFF, and wait 30 seconds.
2. Remove the map SD card and make sure the tab is in the unlocked position.

3. Insert Map SD card back into its slot.
4. Go to Step 8 and continue through the rest of the procedure from that point.

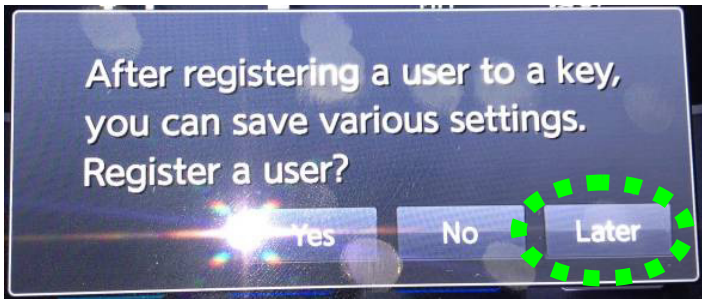
Q. What do I do if the below screen appears?

A. Select "Later" and then continue with the procedure. This is covered in step 2 of the procedure but this message can appear at other times in the update process.
