ITB14-009a

January 27, 2014

VOLUNTARY SERVICE CAMPAIGN 2014 Q50; DIRECT ADAPTIVE STEERING SYSTEM CONTROL MODULE REPLACE, REPROGRAM, AND RECALIBRATE

CAMPAIGN ID #: P4204

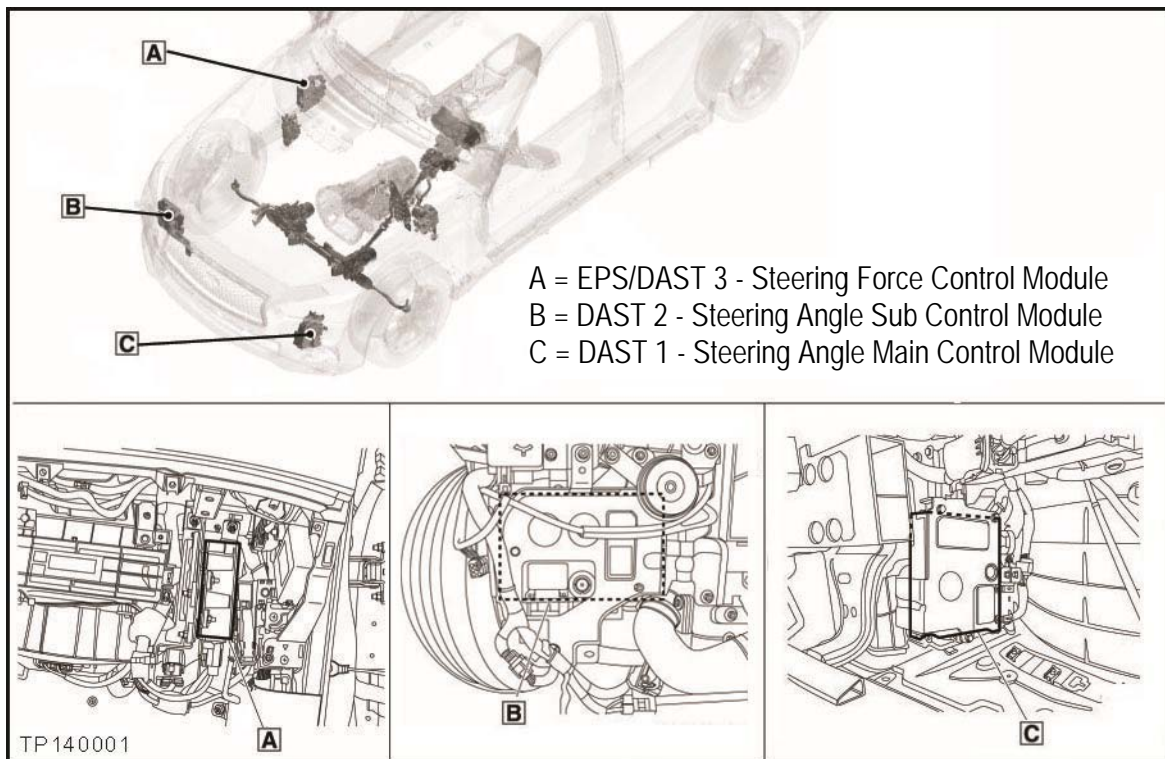
Figure R1

1. Replace all three DAST Control Modules (see Figure R1):

DAST 1 - Steering Angle Main Control Module.

DAST 2 - Steering Angle Sub Control Module.

EPS/DAST 3 - Steering Force Control Module.

- For R&R information, refer to the Service Manual > Section STC > Direct Adaptive Steering > Steering Angle Main Control Module.

- For R&R information, refer to the Service Manual > Section STC > Direct Adaptive Steering > Steering Angle Sub Control Module.

NOTE: The washer bottle does not need to be removed. Suspend it with string while replacing DAST 2 control module.

- For R&R information, refer to the Service Manual > Section STC > Direct Adaptive Steering > Steering Force Control Module.
