ITB14-009 January 24, 2014

VOLUNTARY SERVICE CAMPAIGN 2014 Q50; DIRECT ADAPTIVE STEERING SYSTEM CONTROL MODULE REPLACEMENT, REPROGRAM, AND CALIBRATION

CAMPAIGN ID #: P4204

APPLIED VEHICLES: 2014 Q50 Hybrid (V37)

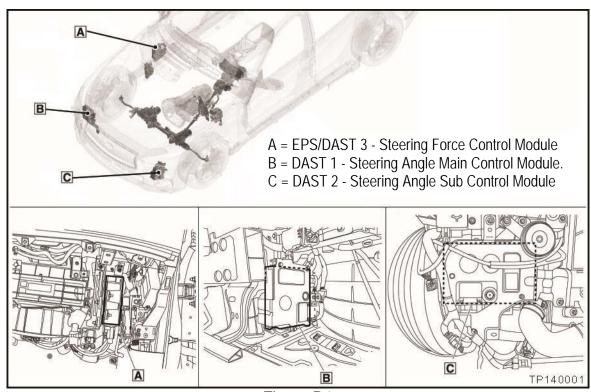
Figure R1

1. Replace all three DAST Control Modules (see Figure R1):

DAST 1 - Steering Angle Main Control Module.

DAST 2 - Steering Angle Sub Control Module.

EPS/DAST 3 - Steering Force Control Module.

For R&R information, refer to the Service Manual > Section STC > Direct Adaptive Steering > Steering Angle Main Control Module.

For R&R information, refer to the Service Manual > Section STC > Direct Adaptive Steering > Steering Angle Sub Control Module.

NOTE: The wash bottle does not need to be removed. Suspend it with string while replacing DAST 2 control module.

For R&R information, refer to the Service Manual > Section STC > Direct Adaptive Steering > Steering
 Force Control Module.
