ITB14-006a

January 27, 2014

## VOLUNTARY SERVICE CAMPAIGN 2014 Q50; DIRECT ADAPTIVE STEERING REPROGRAM

CAMPAIGN ID #: P4201

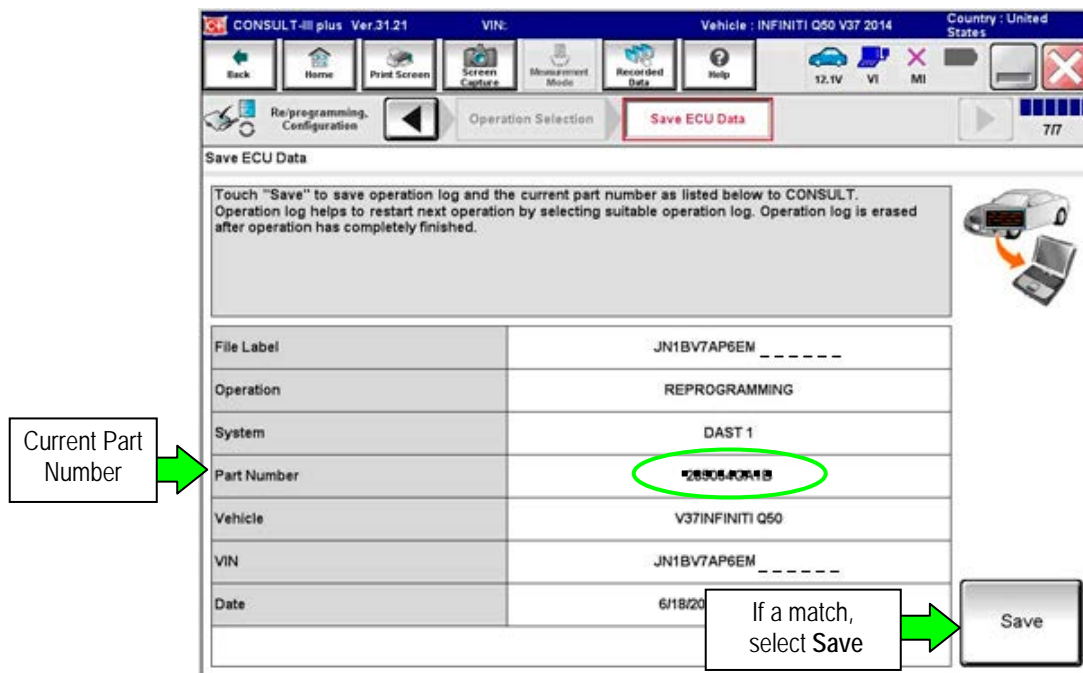
Figure 8

A. Find the DAST Part Number and write it on the repair order.

**NOTE:** This is the current DAST Part Number. DAST 1 is shown; DAST 2 and DAST 3 are similar.

B. Compare the P/N you wrote down to the numbers in the **Current Part Number** column of Table A below:

- If there is a match, reprogramming applies. Continue with the reprogramming procedure.
- If there is not a match, reprogramming does not apply.

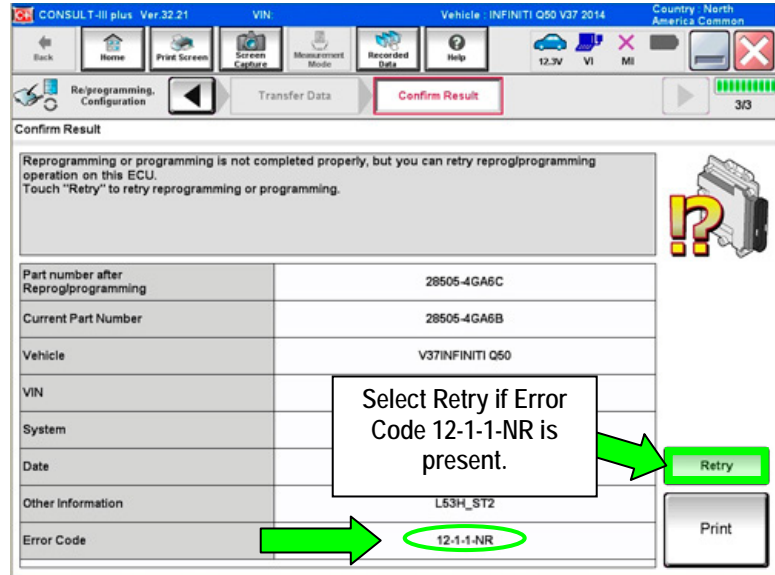
Figure 16

If reprogramming does not complete and the “!?” icon displays as shown in Figure 16:

- Check battery voltage (12.0–13.5 V).
- Ignition is ON, engine OFF (not READY).
- External Bluetooth® devices are OFF.
- All electrical loads are OFF.
- Select retry and follow the on screen instructions.
- “Retry” may not go through on the first attempt and can be selected more than once.

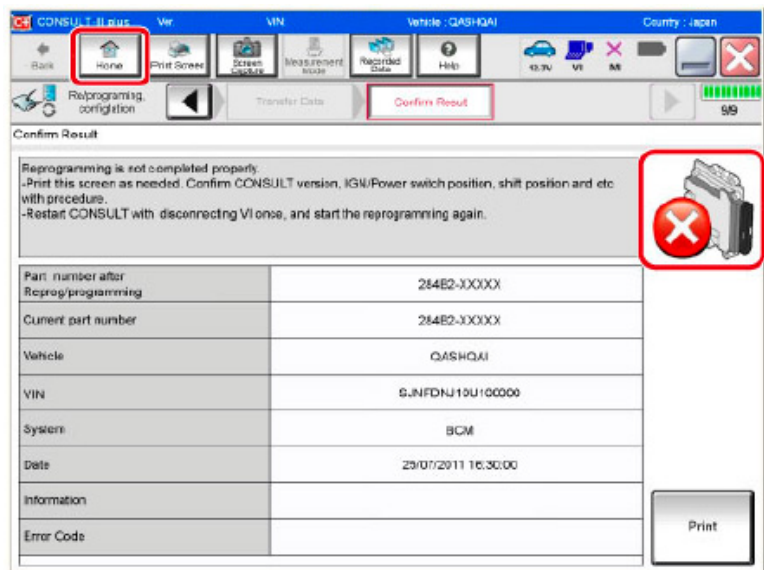
Figure 17

If reprogramming does not complete and the “X” icon displays as shown in Figure 17:

- Check battery voltage (12.0 – 13.5 V).
- CONSULT A/C adapter is plugged in.
- Ignition is ON, engine OFF (not READY).
- Transmission is in Park.
- All C-III plus / VI cables are securely connected.
- All C-III plus updates are installed.
- Select Home, and restart the reprogram procedure from the beginning.
