ITB14-008a

January 27, 2014

VOLUNTARY SERVICE CAMPAIGN 2014 Q50; DIRECT ADAPTIVE STEERING SYSTEM CONTROL MODULE REPLACE, REPROGRAM, AND RECALIBRATE

CAMPAIGN ID #: P4203

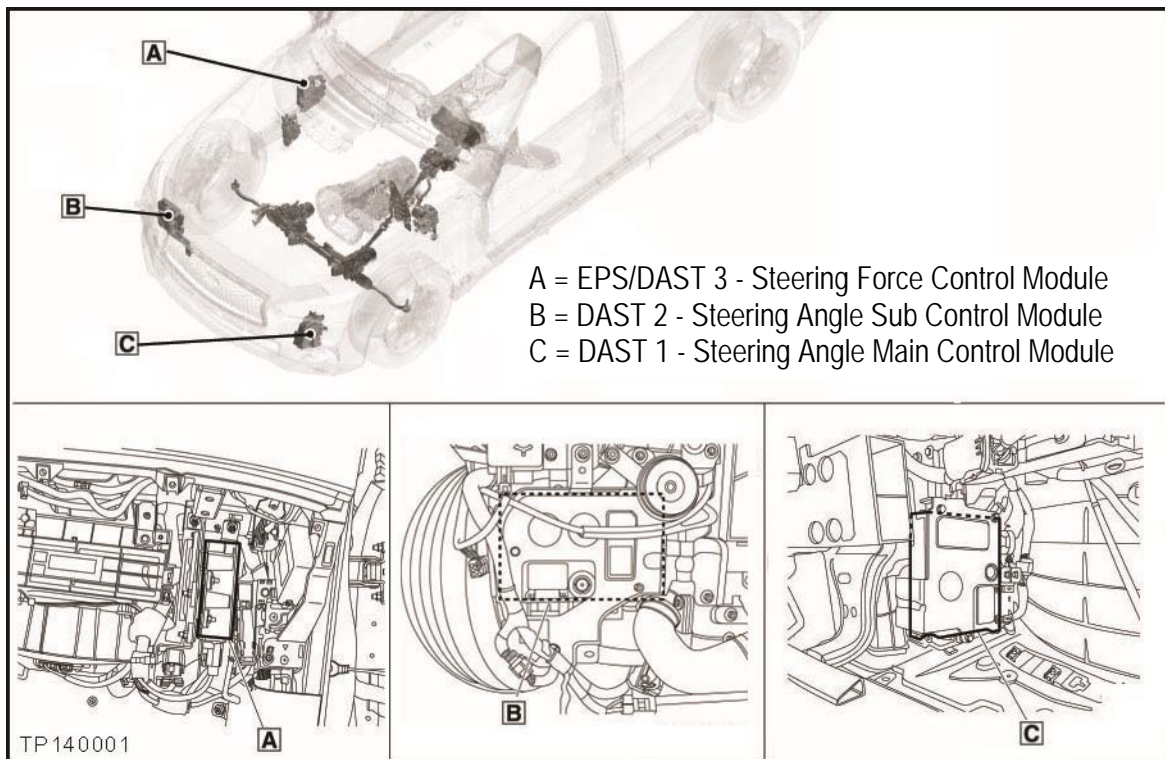
Figure R1

1. Replace all three DAST Control Modules (see Figure R1):

DAST 1 - Steering Angle Main Control Module.

DAST 2 - Steering Angle Sub Control Module.

EPS/DAST 3 - Steering Force Control Module.

- For R&R information, refer to the Service Manual > Section STC > Direct Adaptive Steering > Steering Angle Main Control Module.

- For R&R information, refer to the Service Manual > Section STC > Direct Adaptive Steering > Steering Angle Sub Control Module.

NOTE: The washer bottle does not need to be removed. Suspend it with string while replacing DAST 2 control module.

- For R&R information, refer to the Service Manual > Section STC > Direct Adaptive Steering > Steering Force Control Module.
