HYUNDAI NEW THINKING. NEW POSSIBILITIES. Technical Service Bulletin	GROUP	NUMBER
	AUTOMATIC TRANSMISSION	13-AT-018
	DATE	MODEL
	DECEMBER 2013	Sonata YF HEV
SUBJECT: EV DRIVE MOTOR INVERTER PERFORMANCE - DTC P0A78		
Description: If you are servicing a Sonata Hybrid with DTC P0A78, follow the Service Procedure on Page 2.

Applicable Vehicles:	2011~ Sonata Hybrid (YF HEV)
-----------------------------	------------------------------

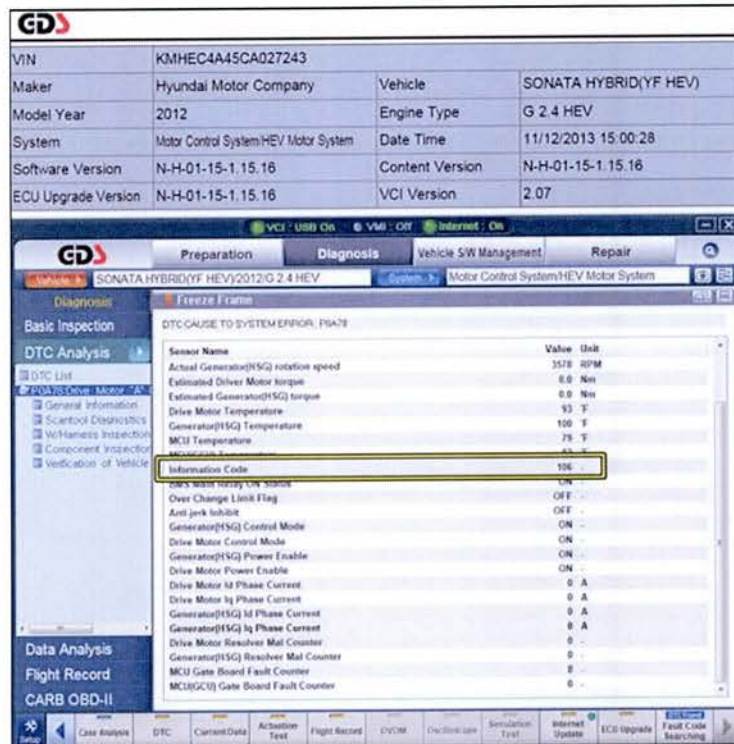
1. Using a GDS, check for DTC in the "MCU" menu. Record the DTC and description.
2. Check the Freeze-frame data for an "Information Code". Refer to the Sonata Hybrid Shop Manual, DTC Section, DTC P0A78 for a description of the code.

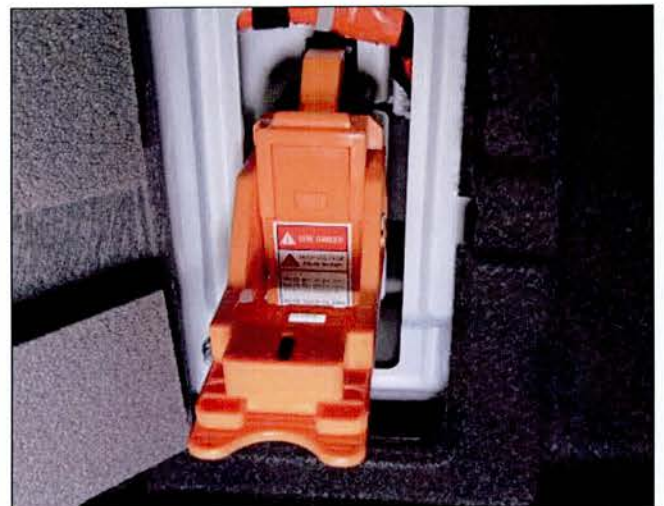
3. Put on safety gloves.

Open the rear trunk and open the cover to the safety switch.

Pull up on the tab and pull out the safety switch.

Failure to perform this procedure may result in accidental injury or death.

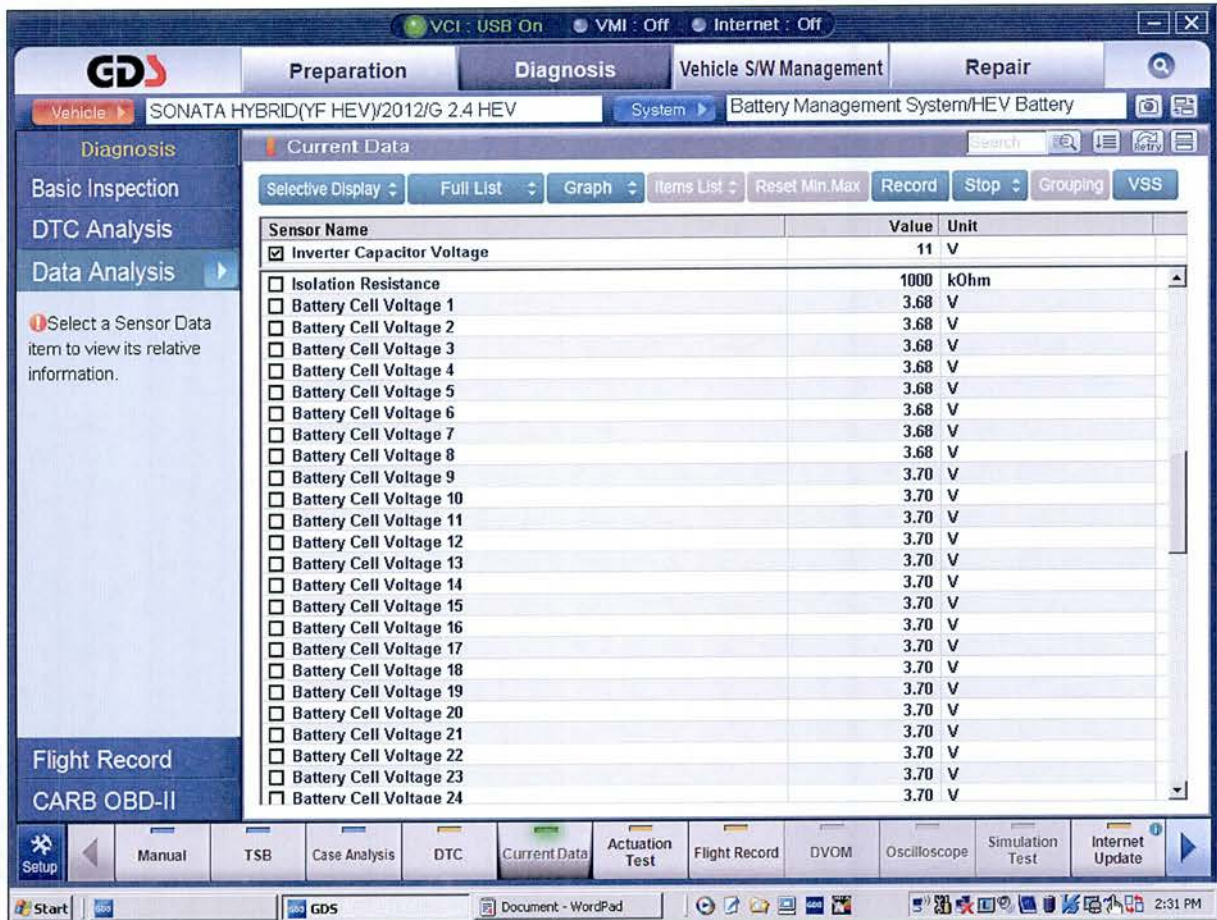
4. Without depressing the brake pedal, push the Start-Stop button 2 times to power the cluster.

Attach a GDS and select the following: **BMS** menu, **Current Data** and **Inverter Capacitor Voltage**. Confirm the **Inverter Capacitor Voltage** is less than 15V.

- If so, the system voltage is safe for the technician. Turn off the ignition and disconnect the negative battery cable. Go to Step 5.
- If not, wait until the voltage is within specification before performing any repairs.

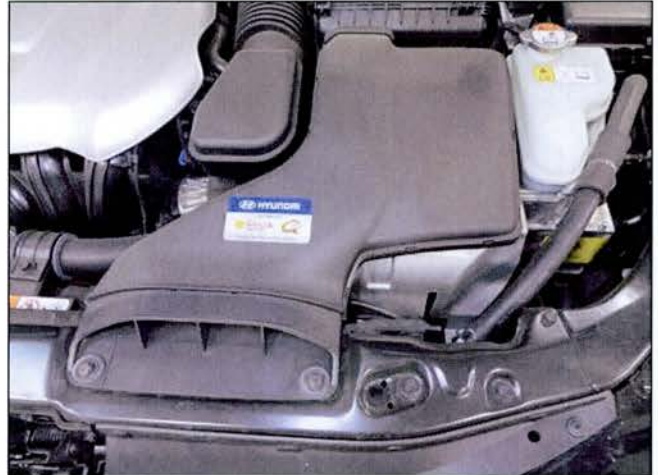
5. Remove the air intake duct.

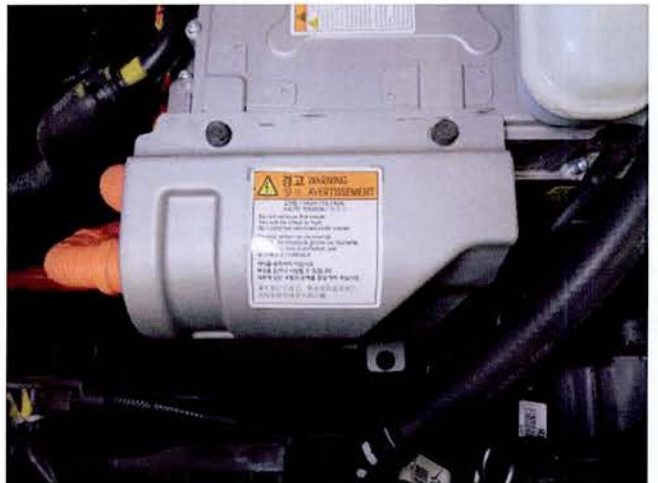
6. Remove the protector on the HPCU.

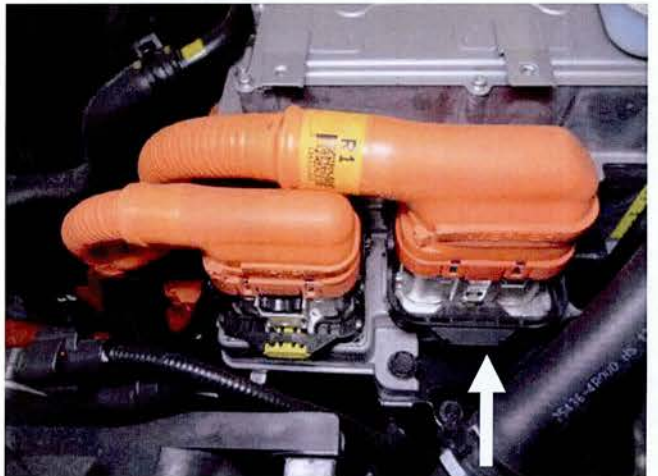
7. Pull out the yellow tab and pull up on the black tab and remove the EV motor power cable from the HPCU Assembly.

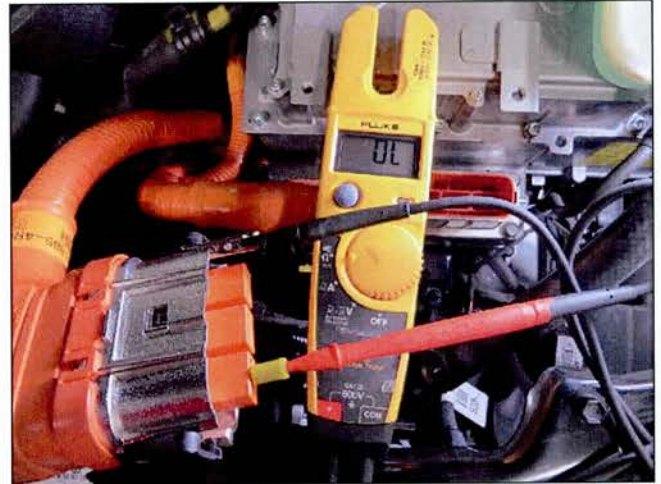
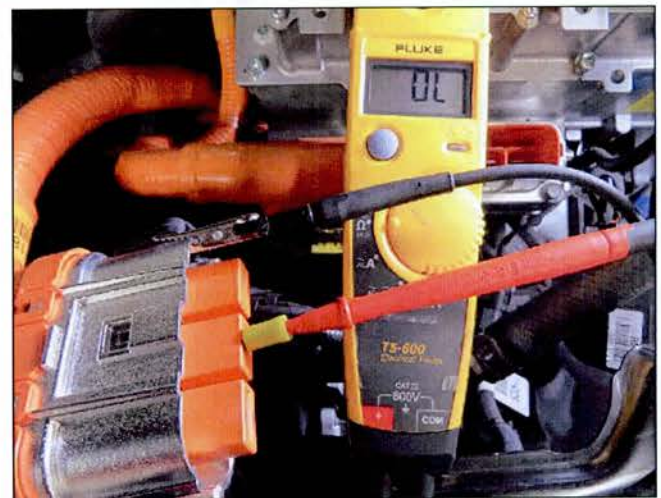
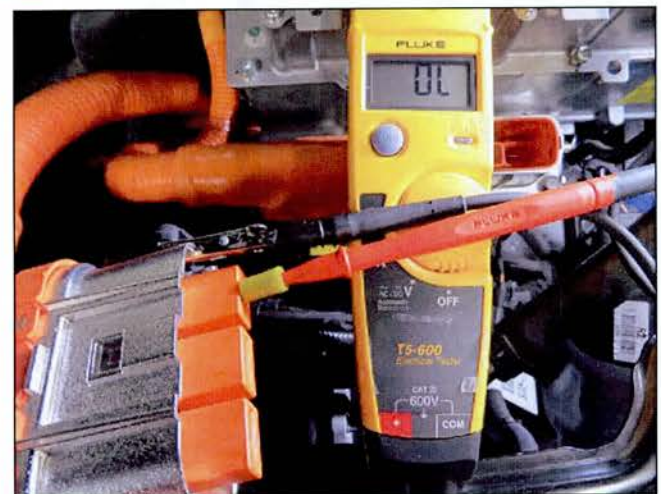
8. Terminal to ground measurement:

Measure the resistance between one terminal and ground.

Check the other two terminals in the same manner.

The resistance should be within the specification shown below.

Specification: Open circuit (More than 10 MΩ)

- **Within specification:** If Step 10 also shows within specification, replace the HPCU.
- **Not within specification:** Go to Step 10 and check the terminals at the EV motor.

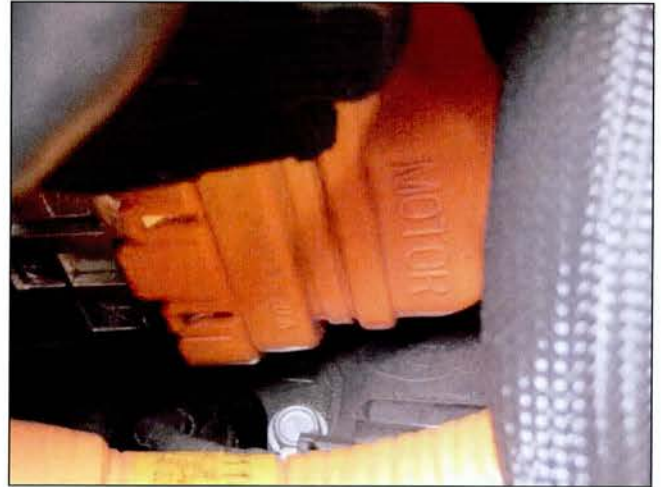
9. Disconnect the EV motor power cable at the EV motor.

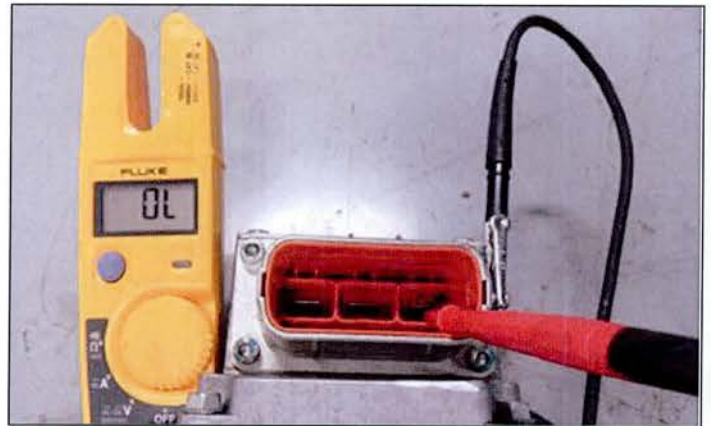
10. Measure the resistance between each terminal and ground.

Specification: Open circuit (More than 10 MΩ)

- **Within specification:** Replace the motor power cable.
- **Not within specification:** replace the automatic transmission. Go to Step 11.

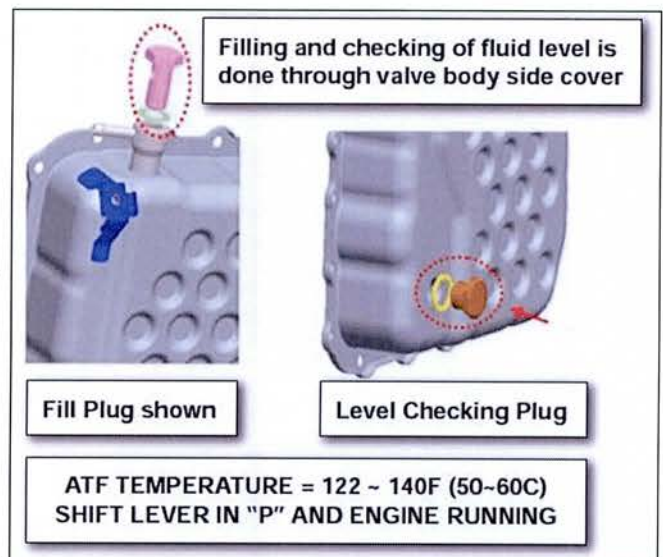
11. Remove the transaxle fill plug.

Use a funnel to add approximately 5~6 quarts of SP-4-M ATF through the fill plug opening. Reinstall the fill plug.

Attach the GDS to the DLC and select vehicle, **A/T** menu, **Current Data** and **Oil Temperature Sensor**.

Start the engine and shift to Park. When the ATF is 122°F~140°F (50~60°C), remove the level checking plug. The level is correct when oil flows from the level checking plug in a thin steady stream.
