Technical Service Bulletin

69 Airbag lamp on; upper limit of side airbag exceeded

69 13 27 2010144/4 December 10, 2013. Supersedes Technical Service Bulletin Group 69 number 08-11 dated December 10, 2008 for reasons listed below.

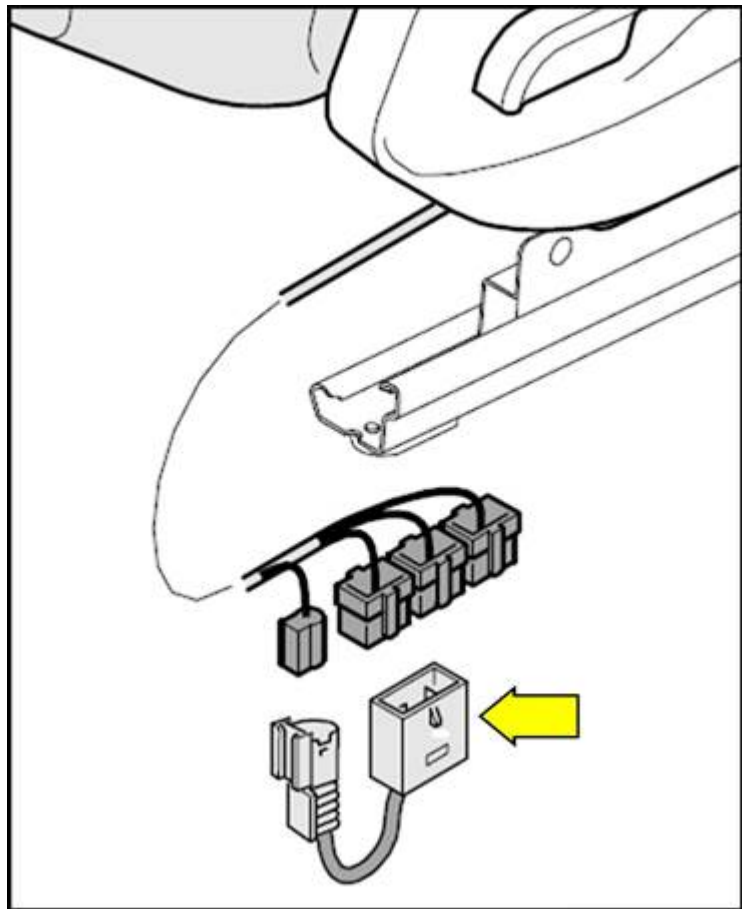
Figure 1. Airbag adapter indicated by yellow arrow.

1. Disconnect battery ground (GND) strap.
2. Remove seat. See *Repair Manual >> Body >> Body Interior >> 72 Seat Frames >> Removal and Installation*.
3. Attach airbag adapter VAS 6036 (Figure 1) to seat harness. See "Airbag Adapter VAS 6036, Connecting" for the appropriate seat type in *Repair Manual >> Body >> Body Interior >> 72 Seat Frames >> Description and Operation*.

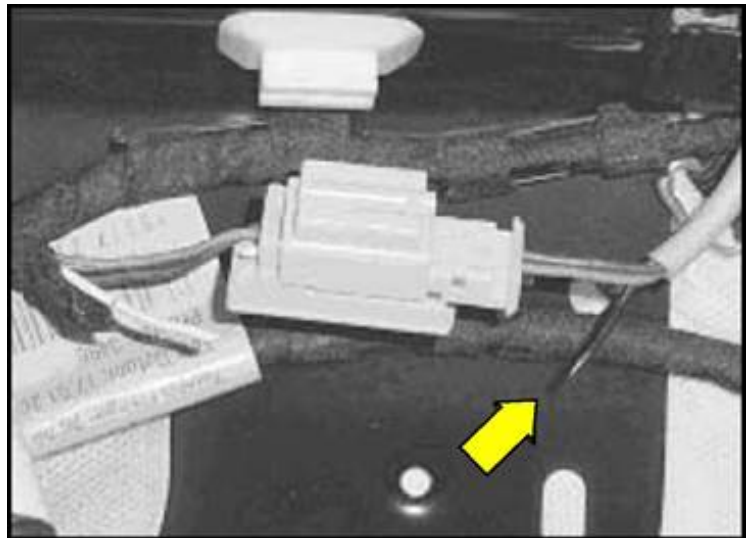
Figure 2. Igniter wire 1 on airbag side.

4. Cut igniter wire 1 (on airbag side) next to airbag connector (Figure 2).

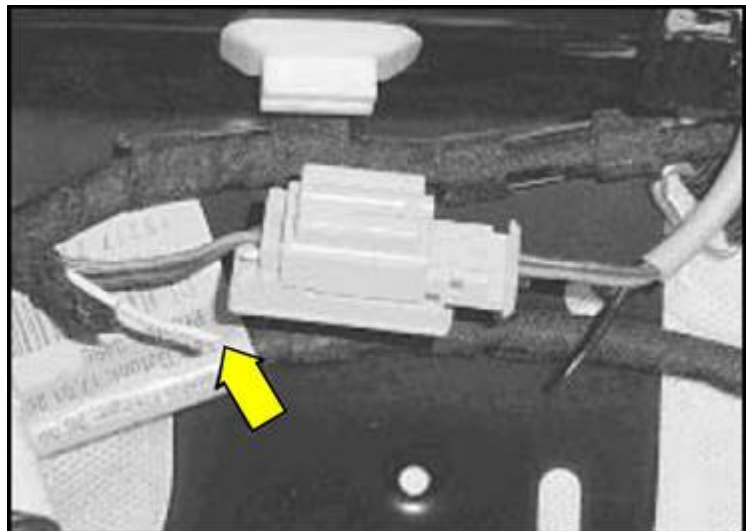
Figure 3. Igniter wire 1 on seat harness side.

5. Cut igniter wire 1 (on seat harness side) next to airbag connector (Figure 3).

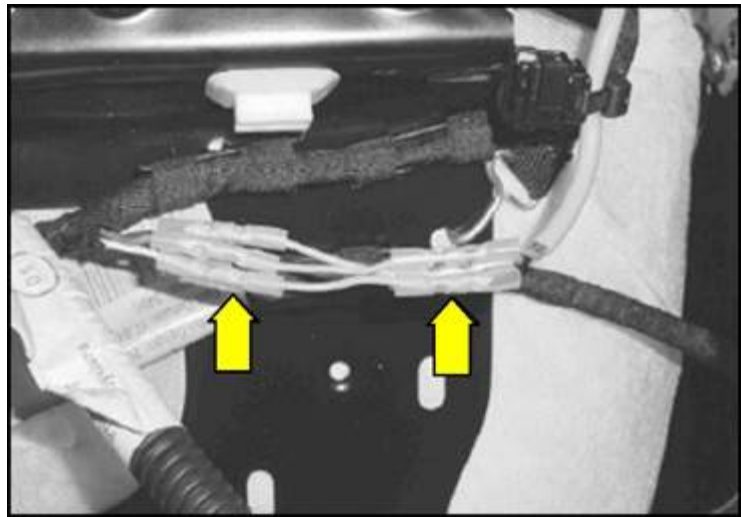
Figure 4. Igniter wire 2.

- Repeat steps 4, 5, and 6 for igniter wire 2 (Figure 4).

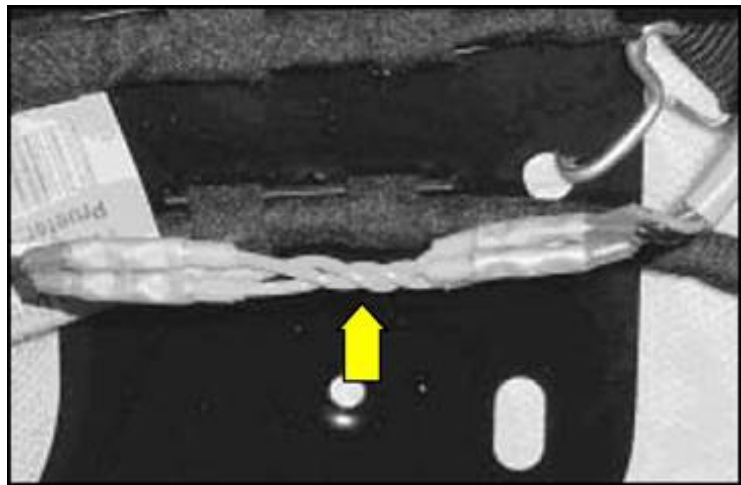
Figure 5. Repaired wires that have been twisted.

- Discard connector.
- Twist repaired wires (Figure 5).

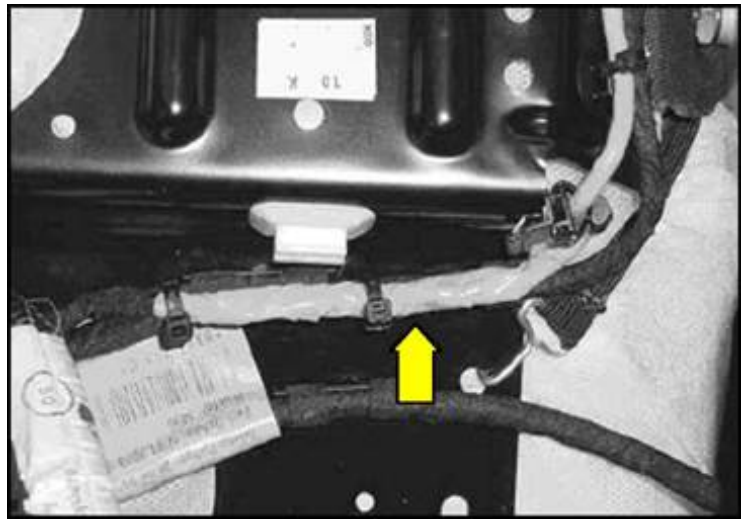
Figure 6. Repaired wires wrapped in electrical tape.

11. Wrap the repair using yellow electrical tape to indicate that the wiring harness has been modified (Figure 6).
