Technical Information Bulletin

AFI Fuel Supply Line Rubbing{1274}

Media Number -TIBU7417-00

CT660 (S/N: TGA1-UP; TGD1-UP; TEJ1-UP; TRK1-UP; TKL1-UP; TEM1-UP; TEP1-UP;
TGS1-UP; TJS1-UP; TGT1-UP; TSW1-UP; TSY1-UP; TGZ1-UP)

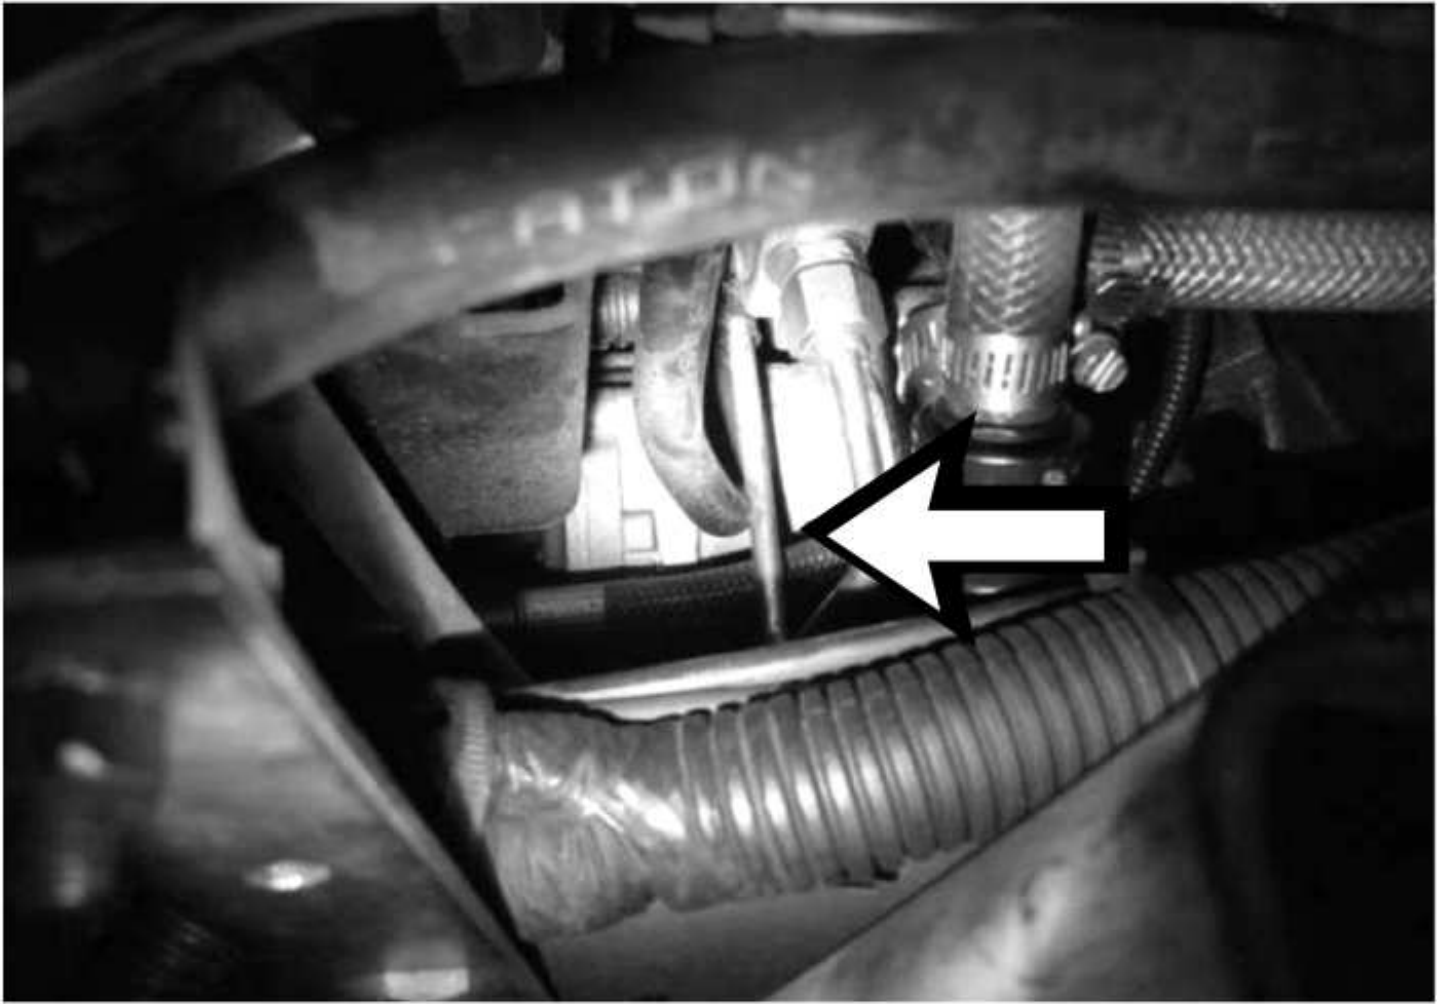
g03566558

Illustration 1
Example of an AFI Fuel Supply Line rubbing

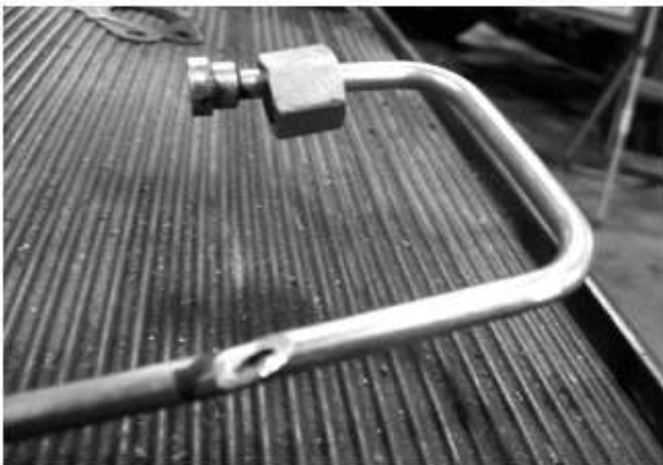
Illustration 2 g03566560
Example of an AFI Fuel Supply Line rubbing

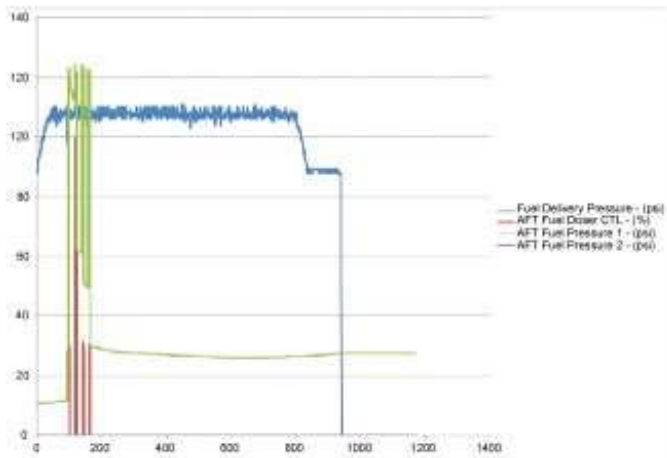
Illustration 3 g03566563

Example of a Bad OBFCT with a Hole in the AFI Fuel Supply Line

Notice that the AFT Fuel Doser CTL actuated three times to purge the air. The AFT Fuel Doser CTL went to 0 and AFT Fuel Pressure 2 never climbed off 0 PSI. You will not see any leaks. There is no fuel being sent to pressurize the line.

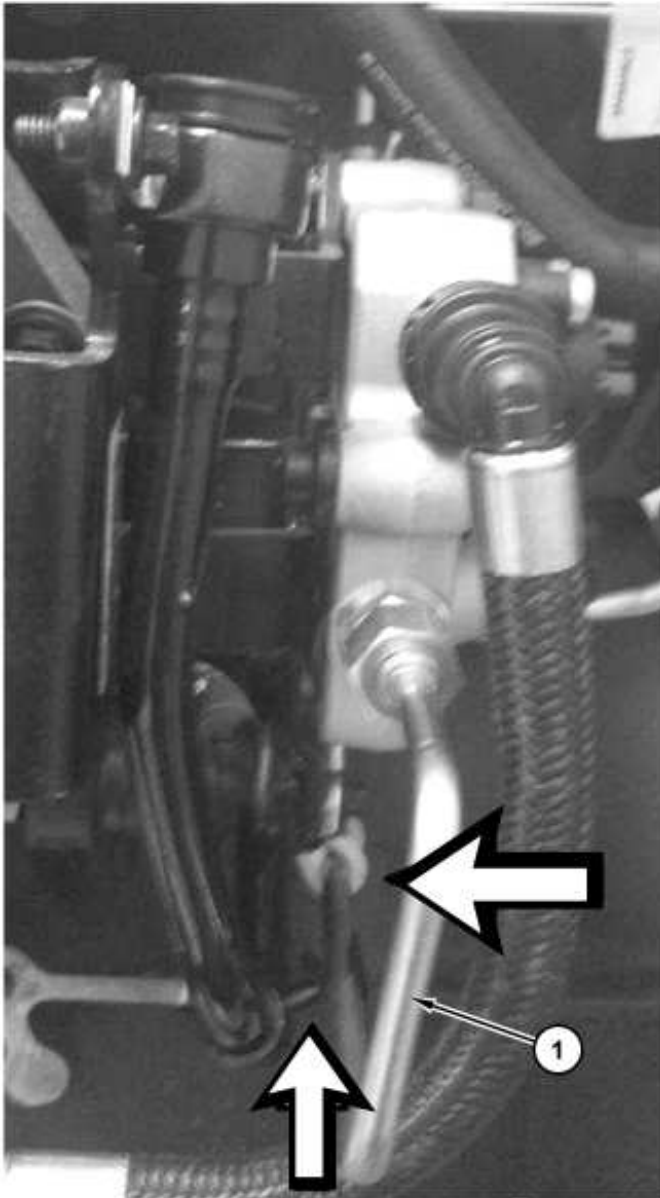
Illustration 4

(1) 376-2674 Fuel Tube

Inspect and verify that the AFI Fuel Tube (1) is secured to the AFI bracket with the P-Clip. Ensure that the line separator clip is installed on the return and AFI line. Be sure that the DSI supply line is not rubbing anything. Refer to Illustration 4.

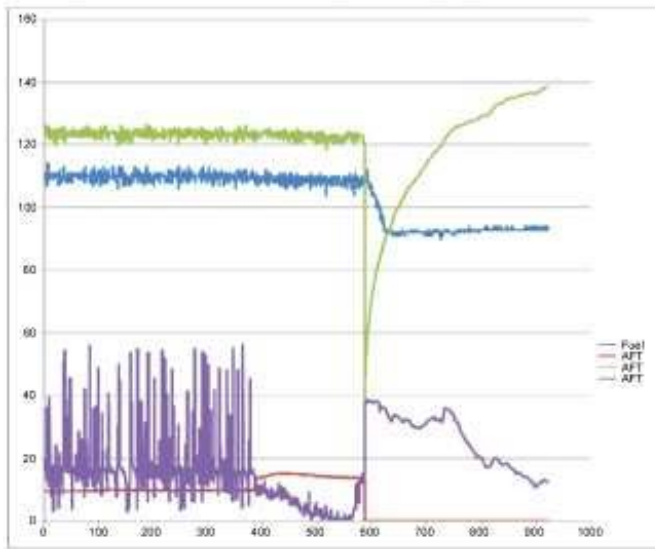
Illustration 5 g03566580
Example of a good OBFCT after the AFI Fuel Supply Line was repaired

Notice the AFT Fuel Doser CTL actuated and stayed active and AFT Fuel Pressure 2 is working properly now. Refer to Illustration 5.
