SB-100549 11-4411

2013-2014 Fusion

2013-2014 MKZ

ISSUE

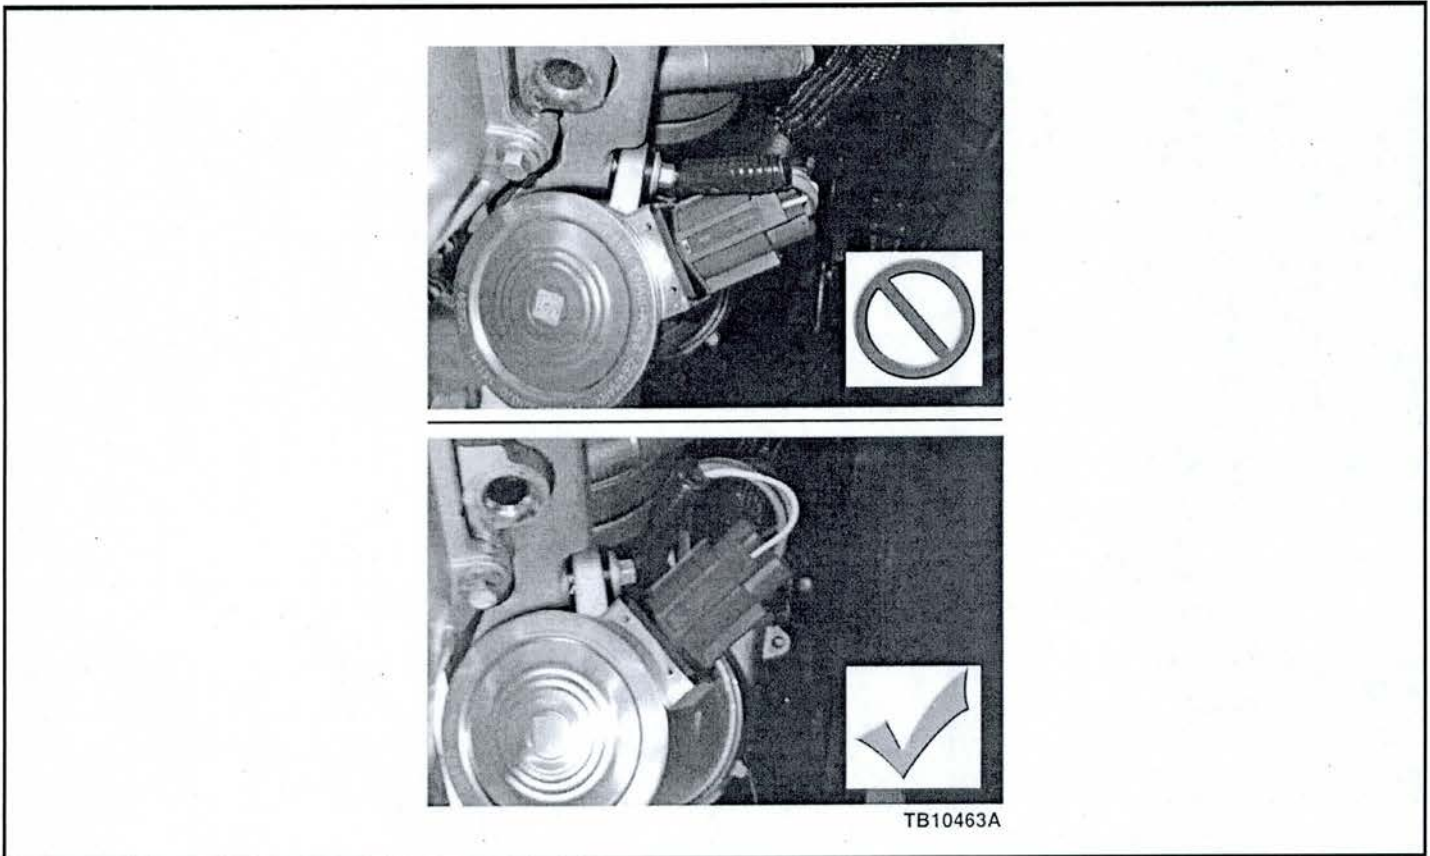
Figure 1 - Article 14-0005

Some 2013-2014 Fusion Hybrid, MKZ Hybrid and Energi vehicles built on or before 9/2/2013 may exhibit an illuminated wrench or engine lamp with diagnostic trouble codes (DTCs) P26CA and/or U019F.

1. Disconnect C1812 at the coolant pump and inspect for evidence of moisture or corrosion on the harness connector and coolant pump terminals. Refer to Wiring Diagram, Section 33-1. Is moisture or corrosion present?
 - a. No - this article does not apply. Refer to the Powertrain Control/Emissions Diagnosis (PC/ED) manual for normal diagnosis.
 - b. Yes - proceed to Step 2.
2. Replace the coolant pump. Refer to Workshop Manual, Section 303-03.
3. Replace the coolant pump connector with a pigtail kit following instructions included in the kit.
 - a. Circuit SBF05 GY-RD to the coolant pump is hot at all times. Disconnect the 12 volt battery. Refer to Workshop Manual 414-01.
 - b. When installing the connector onto the coolant pump, ensure the harness is routed as straight as possible to avoid damage to the connector seal. (Figure 1)
