**WARRANTY
CAMPAIGN**
**ROADSTER
WARRANTY
Bulletin**

Campaign no.: 2011-0016
2012-0006

Subject: **TO BE PERFORMED AT PDI ON
UNREGISTERED (UNSOLD) VEHICLES**
**1- Updated Throttle Body Actuator
Protection**
2- ECM and TCM Software Updates
**3- Middle Side Panel Grommet
Replacement (2011 Models Only)**

No. **2012-8**
REVISION 1
January 23, 2014

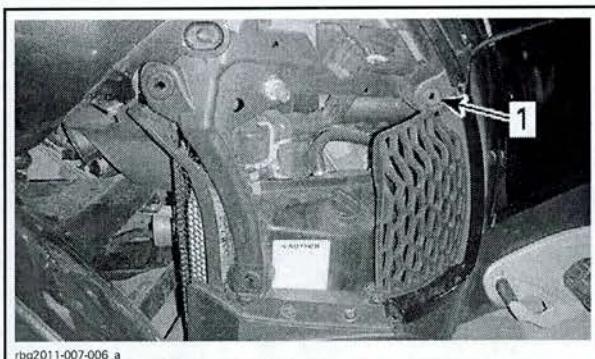
rbg2011-007-006_a

On some 2011 vehicles, on which 2011-8 OR 2011-13 WARRANTY CAMPAIGNS has not been performed, one of the middle side panels rubber grommets might fall off after multiple removal and installation of the panel.

LH SIDE OF VEHICLE SHOWN
1. Check this grommet ONLY
