Technical Information Bulletin

Aftertreatment Injector Is Plugging on Certain CT660 Vocational Trucks{7000}

Media Number -TIBU7404-00

CT660 (S/N: TGA1-UP; TGD1-UP; TRK1-UP; TKL1-UP; TGS1-UP; TJS1-UP; TGT1-UP; TSW1-UP; TSY1-UP; TGZ1-UP)

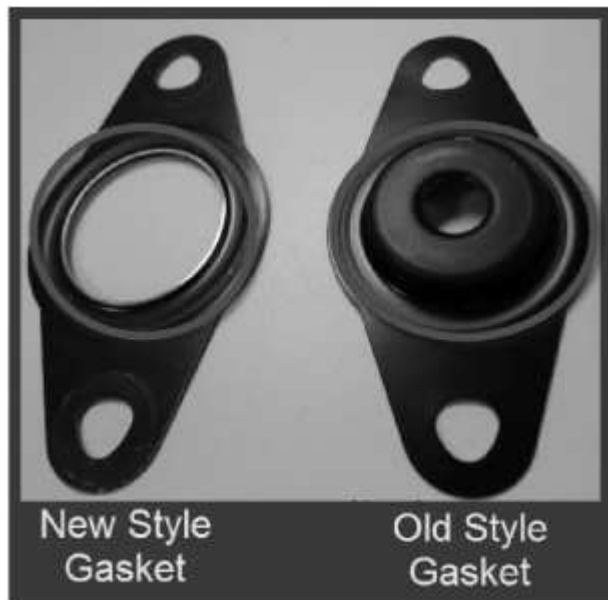
Illustration 1

The old gasket 376-2628 has been reworked and replaced with 452-8519. The new style gasket will have the raised center portion of the gasket removed (Figure 1).

Replace the below gasket and bolts when servicing the HC Injector [aftertreatment fuel injector (AFI) and doser injector].

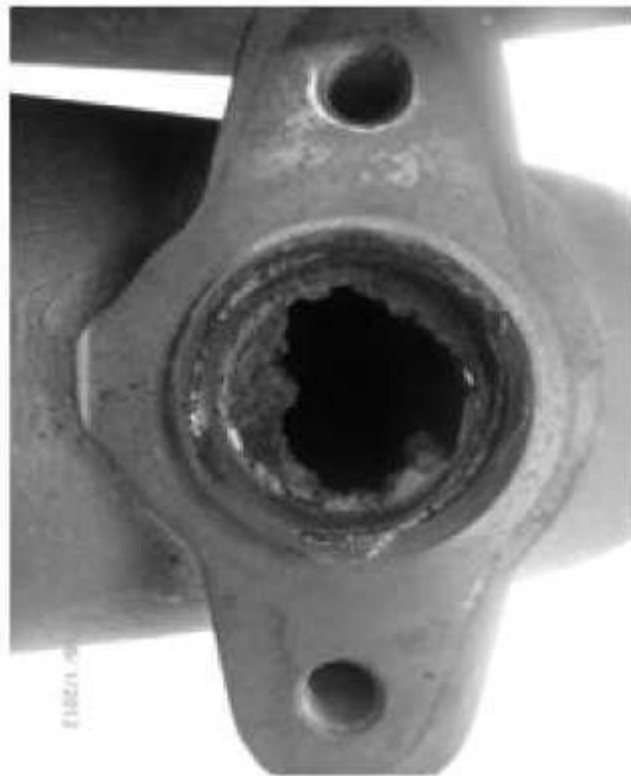
Illustration 2

Aftertreatment fuel injector is becoming covered in soot and plugging prematurely.

Below are photos of a partially plugged port (fig 2), a completely plugged doser (fig 3) and a clear port (fig 4)

5. Remove the carbon plugging with a chisel or other appropriate tool.
6. Remove the carbon debris from the exhaust brake housing (A shop vacume can be used).
