SB-10055419-7844

Campaign No. 2013110012, December 2013

SUBJECT: **Model 231 (SL), Model Year 2013**
Rework Rear Center Section Seam Seal

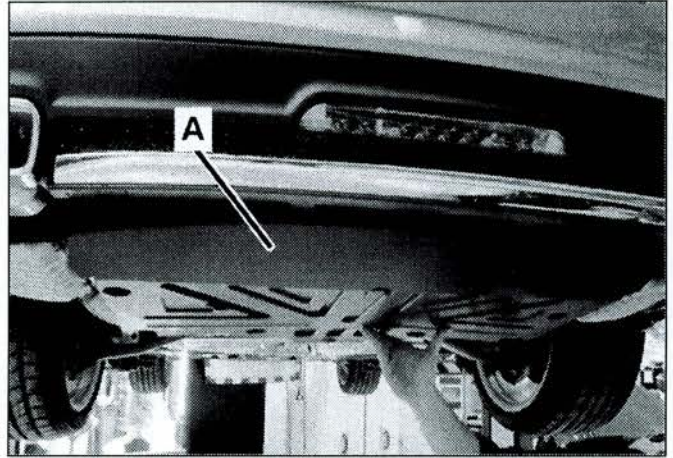
Figure 1

This Service Campaign has been initiated because Daimler AG (DAG), manufacturer of Mercedes-Benz vehicles, has determined that the seam seal at the rear center section may not be to specification possibly allowing moisture to enter the spare tire well. To correct this condition, an authorized Mercedes-Benz dealer will rework the seam seal at the rear center section at the next workshop visit.

Remove fasteners then remove spare wheel well cover (A, Figure 1).
