## SERVICE BULLETIN

**APPLICABILITY:** 2008MY and Later Impreza, WRX and STI  
 2009MY and Later Forester M/T Equipped Vehicles  
 with Hill Start Assist

**NUMBER:** 03-72-14

**SUBJECT:** Hill Start Assist (HSA) Warning Light, DTC C0076

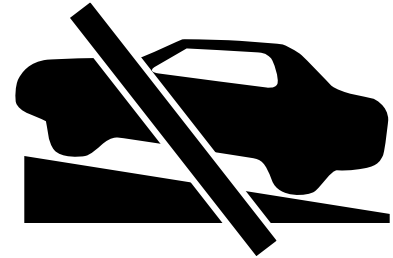
This bulletin provides information to address a customer concern of intermittent operation of the Hill Start Assist warning lamp. When the HSA warning lamp is illuminated, the hill start assist system is inoperative. DTC C0076 may be stored in memory along with detail codes 2610H and / or 2620H. All of these codes refer to the operation of the clutch switches.

- For detail code 2610H, check the clutch pedal switch signal using the SSMIII following the procedure in the applicable Service Manual.
- For detail code 2620H, check the clutch pedal switch clearance following the procedure in the applicable Service Manual.

Once it has been determined the clearance adjustments are both within specification and switch signal functions are operating normally, the most likely cause for the intermittent HSA warning lamp illumination is the vehicle operator resting their left foot on the clutch pedal with enough pressure to activate the switches. Interview the customer about their driving habits then, if necessary, a road test while observing where they rest their left foot (especially in traffic) would be a good way to confirm the root cause of the condition. If you confirm the customer is resting their foot on the clutch pedal when they are not: starting out, shifting, or coming to a stop, an explanation of why their driving habits may be causing the HSA lamp to illuminate would be recommended. Because of the minimal amount of clearance which exists when the clutch switches are properly adjusted, even the slightest amount of unintentional pressure on the clutch pedal can result in false input signals to the respective control units resulting in the illumination of the HSA indicator lamp.
