Bulletin No.: PIP5203A

Subject: Poor Engine Performance P0089 P228D P0171 Whine Noise From High Pressure Fuel Pump

Models: 2010-2011 Buick LaCrosse
2011 Buick Regal
2010 - 2011 Chevrolet Equinox
2010-2011 GMC Terrain
Equipped with 4 cyl engine (RPO LAF)

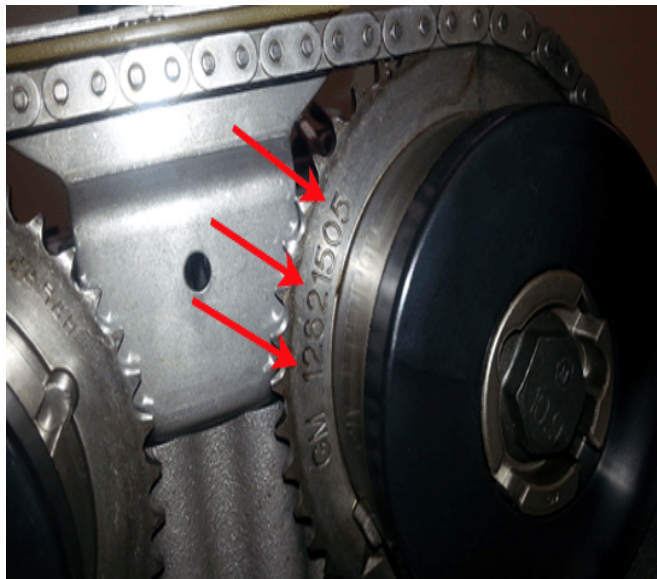
3872270

Below is an example of a 2011 intake camshaft actuator part number 12621505 and black in color (plastic cover piece).

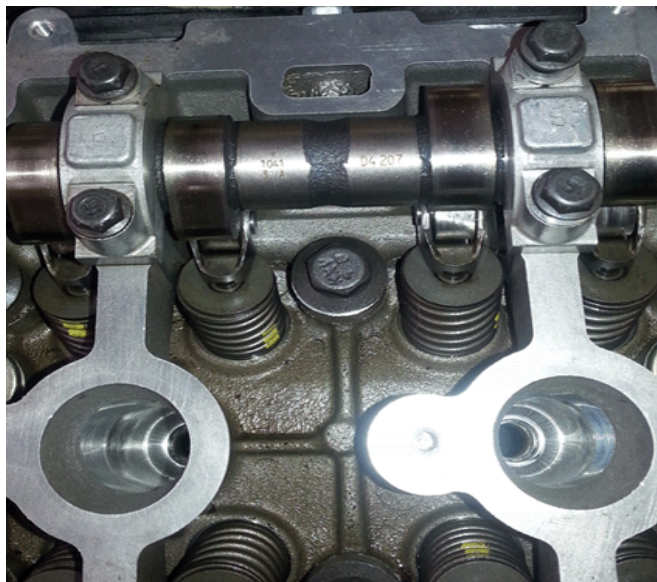
3872269

The camshafts can be identified by the last four digits of the part number located on a machined surface between the number 2 and number 3 cylinder camshaft lobes.

Below is an example of a 2011 intake camshaft part number 12634207.
