SB-10056302-8220 Technical Service Bulletin

| SUBJECT: ELECTRIC POWER STEERING MOTOR SERVICE PROCEDURES – SERVICE MANUAL REVISION | | | No: TSB-14-37-003 |
| | | | MODEL: 2011-14 Outlander Sport/RVR |

This TSB updates the service procedures for the electric power steering (EPS) motor including adding a procedure for EPS motor replacement.

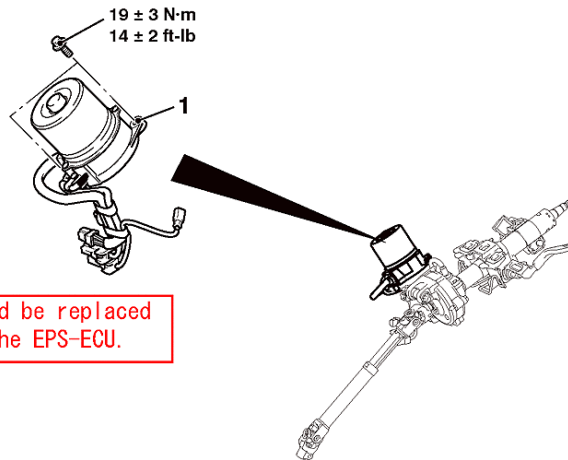
Removal
Motor

- The motor should be replaced together with the EPS-ECU.

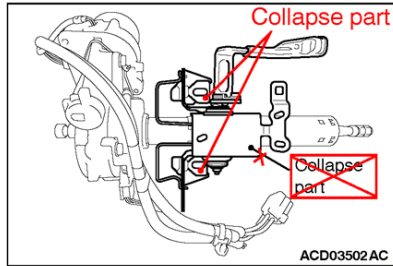
Do not remove the collapse part (shown in the illustration).

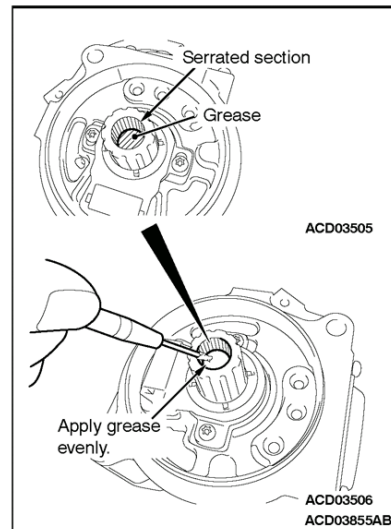
Be sure to apply grease evenly to prevent abnormal noise.

1. Take grease from the bottom of the motor boss and apply it to the serrated section.

Grease: Motor grease
Usage: 0.4 g

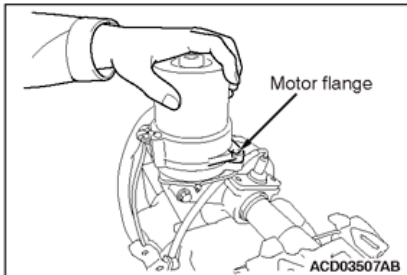
Be careful to avoid scratches or intrusion of foreign materials on the mating surface of the motor and the worm housing.

2. Insert the motor, and check that the motor flange moves with the bolts not tightened.

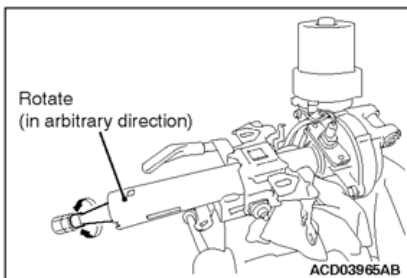
If the total rotation torque fluctuation compared with the value measured at removal is $\pm 10\%$ or more, remove the motor again and repeat installation steps 2, 3 and 4.

3. To prevent generation of abnormal noise by dislocation of the motor, temporarily tighten the motor mounting bolts alternately while rotating the steering shaft in the arbitrary direction at a speed of approximately one rotation per second.
4. Temporarily tighten the motor mounting bolts. Then, tighten them securely.
Tightening torque: $19 \pm 3 \text{ N}\cdot\text{m}$ ($14 \pm 2 \text{ ft}\cdot\text{lb}$)
5. Repeat the total rotation torque measurement performed in removal step 4.

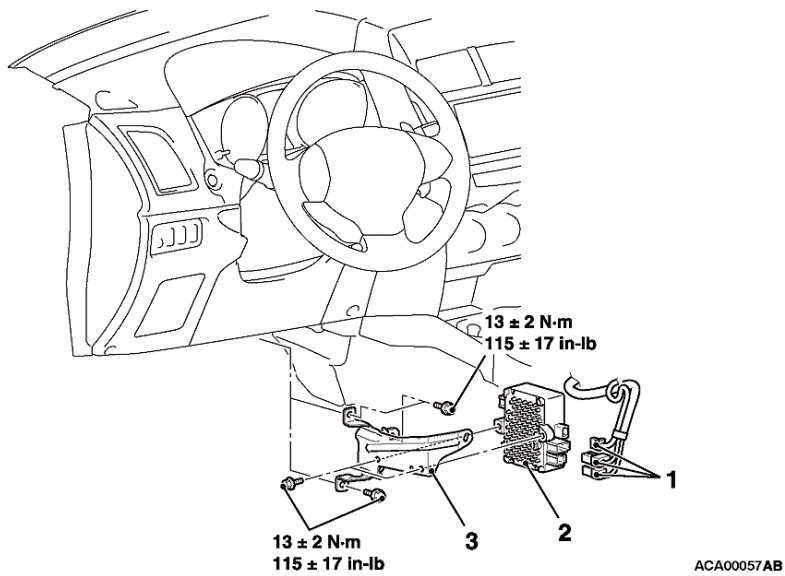
• The EPS-ECU should be replaced together with the motor.

>>A<< **Removal steps**
1. EPS-ECU connector

Removal steps
2. EPS-ECU
3. EPS-ECU bracket
