SB-10056403-6381**FORD:**

2012-2014 Edge

2012-2014 MKX

Some 2012-2014 Edge and MKX vehicles may exhibit a sagging headliner by the roof opening panel.

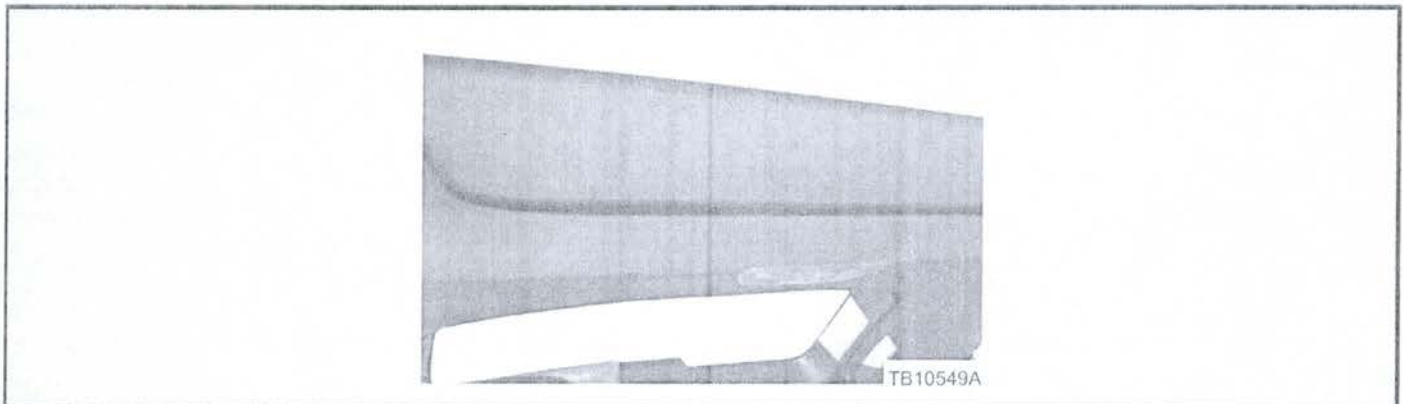
Figure 1 - Article 14-0088

1. Inspect the headliner for sagging at the roof opening panel near the overhead lamp. Is the headliner sagging? (Figure 1)

- a. No - this article does not apply.
 - b. Yes - proceed to Step 2.
2. Apply upward pressure to the headline for 45 seconds to eliminate the sag condition. Allow the vehicle to sit for 30 minutes. (Figure 2)
