SB-10056696-7857

2011-2012 F-150, Mustang

This article supersedes TSBs 12-3-1 and 11-9-15 to consolidate information and update the Service Procedure.

Some 2011-2012 F-150 and Mustang vehicles (excluding Boss) equipped with a 5.0L engine may exhibit an intermittent metallic rattle or scratching type noise in the area at the front of the left hand (LH) or driver side cylinder head at idle with the engine at operating temperature.

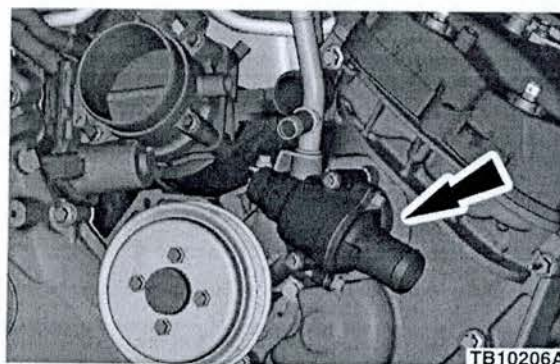
Figure 1 - Article 14-0156

3. Using a mechanic's stethoscope or EngineEAR, listen for a metallic type rattle or scratching type noise at the front of LH cylinder head. Is the noise heard in areas shown? (Figures 1 and 2)

- a. Yes - proceed to Step 5.
 - b. No - replace the coolant pump. Refer to WSM, Section 303-03. Repair is complete.
5. Is the noise heard in the areas shown? (Figures 1 and 2)

- a. Yes - replace the left hand primary tensioner and timing chain tensioner arm using the kit part number provided in this article. Refer to WSM, Section 303-01.
- b. No - this article does not apply. Refer to WSM, Section 303-00 for normal diagnostics.
