BR14-006

ITB14-051

SB-10056785-5922

2013-2014 JX35/QX60; FCW MALFUNCTION AND DTC C1A27 STORED

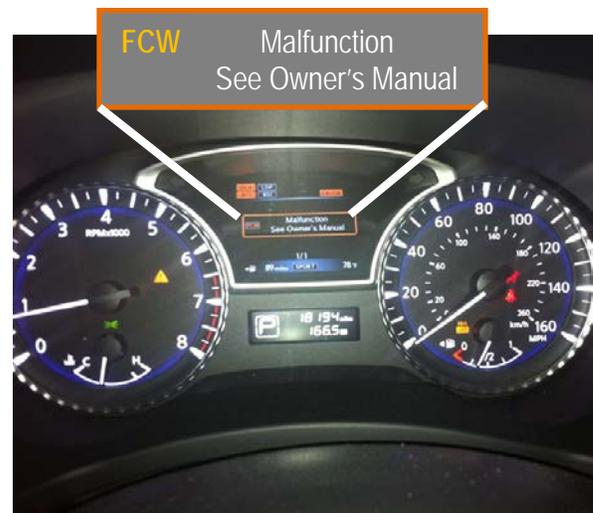
Figure A

- The FCW (Forward Collision Warning) malfunction is ON or reported to have been ON, and
- DTC C1A27 (ECD POWER SUPPLY CIRCUIT) is stored (Past or Current), and
- The brake fluid level is normal.

Reprogram the ABS control unit (ABS) per the Service Procedure in this bulletin.

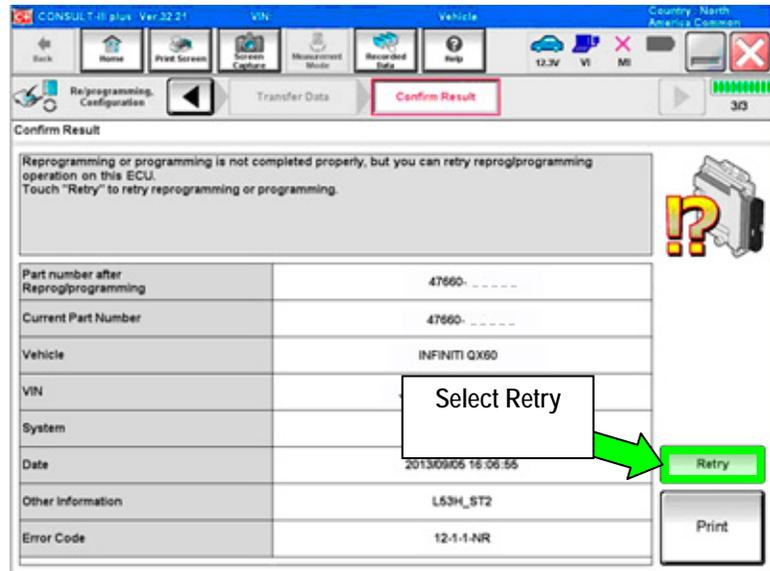
Figure 16

If reprogramming does not complete and the “!?” icon displays as shown in Figure 16:

- Check battery voltage (12.0–15.5 V).
- Ignition is ON, engine OFF.
- External Bluetooth® devices are OFF.
- All electrical loads are OFF.
- **Select retry and follow the on screen instructions.**
- “Retry” may not go through on the first attempt and can be selected more than once.

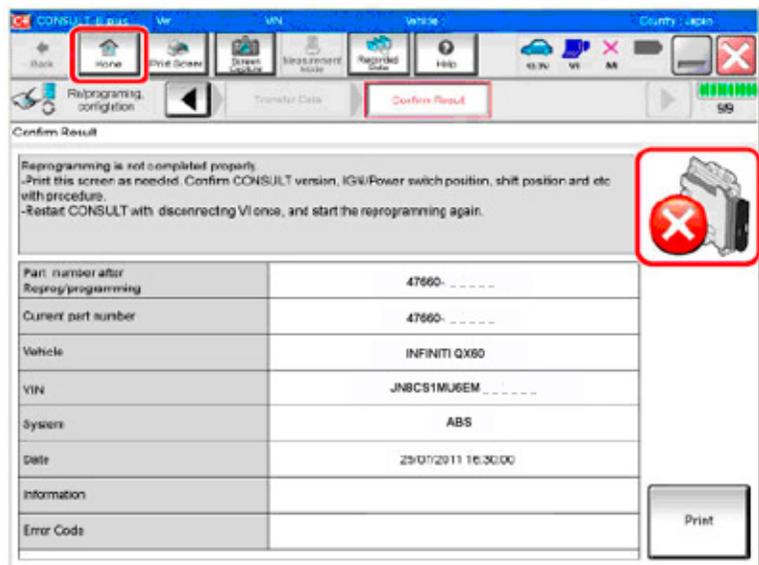
Figure 17

If reprogramming does not complete and the “X” icon displays as shown in Figure 17:

- Check battery voltage (12.0 – 15.5 V).
- CONSULT A/C adapter is plugged in.
- Ignition is ON, engine OFF.
- Transmission is in Park.
- All C-III plus / VI cables are securely connected.
- All C-III plus updates are installed.
- **Select Home, and restart the reprogram procedure from the beginning.**
