BR14-006a

July 29, 2015

JX35, QX60, AND Q50; FCW MALFUNCTION AND DTC C1A27 STORED

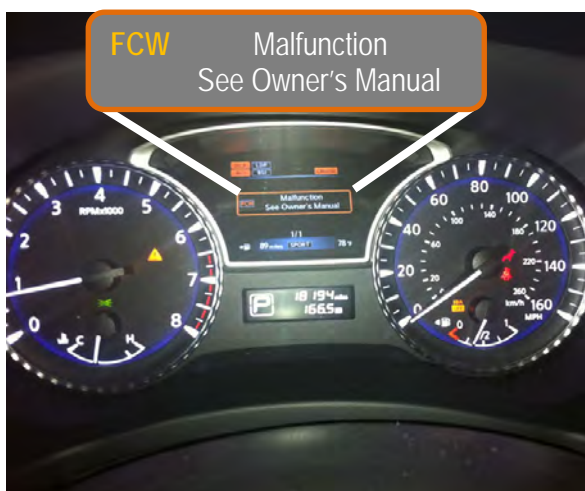
- The FCW (Forward Collision Warning) malfunction is ON or reported to have been ON, and
- DTC C1A27 (ECD POWER SUPPLY CIRCUIT) is stored (Past or Current), and
- The brake fluid level is normal.

Figure A: JX35/QX60 combination meter

Reprogram the ABS control unit (ABS) per the Service Procedure in this bulletin.

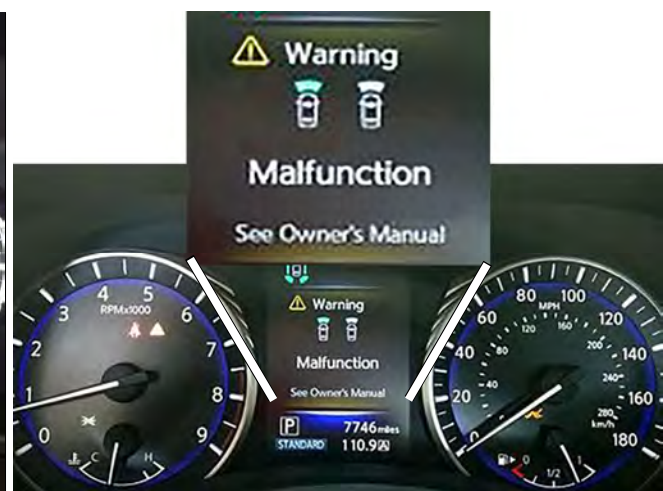
Figure B: Q50 combination meter
