GROUP ELE	MODEL Multiple Models (See table below)
	NUMBER 077	DATE December 2014
TECHNICAL SERVICE BULLETIN		
SUBJECT: REAR VIEW CAMERA DIAGNOSIS/REPLACEMENT

This bulletin provides information to diagnose and/or replace the rear view camera of some Kia vehicles (see table below for specific models and production dates) which may exhibit inadequate image quality from the rear view camera. Possible concerns include:

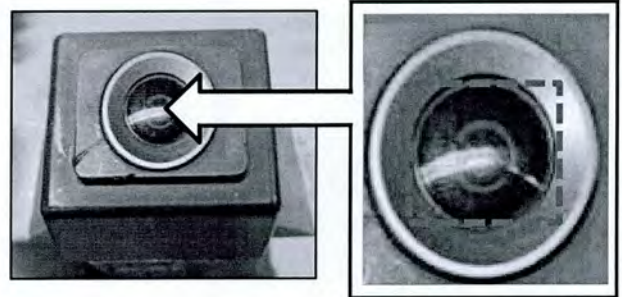
SUBJECT: REAR VIEW CAMERA DIAGNOSIS/REPLACEMENT**Camera Lens Inspection:**

1. Inspect the rear view camera lens for signs of damage due to impact from foreign object. If damage consistent with an impact is found, no further diagnosis is required.

Lens damage due to impact is not considered a warrantable repair.

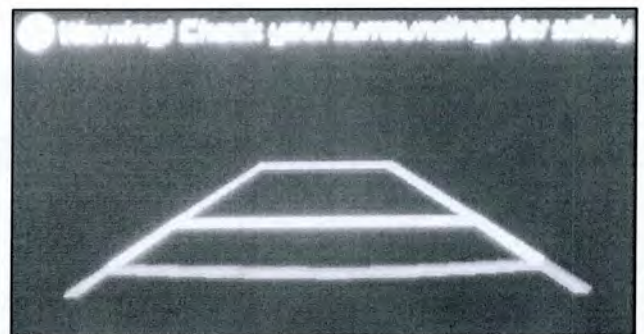
**Intermittent Operation:**

1. For customer complaints related to intermittent operation from the rear view camera, perform the following checks:
 - Confirm the parking guidelines are displayed on the AVN screen. If the guidelines are present and the vehicle owner resides in an area with high humidity, snow or rain, replace the rear view camera with an improved part.

For concerns related to intermittent operation, always try to duplicate the customer concern, prior to replacing the rear view camera.

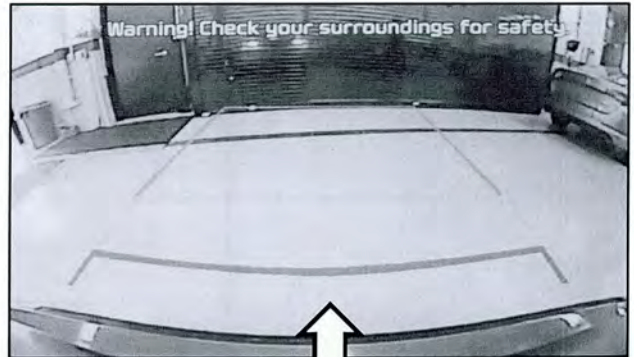
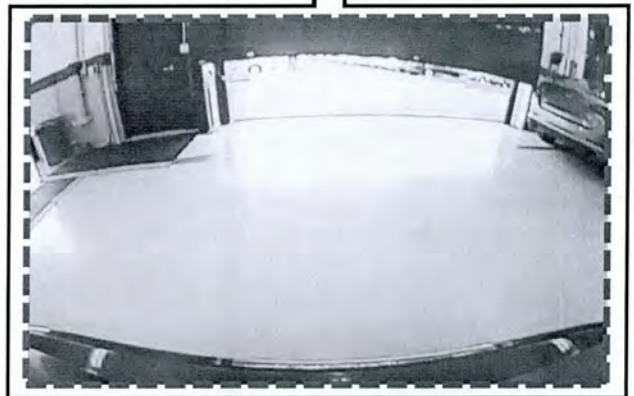
Missing Parking Guide Lines/Black or Blank AVN Screen:

1. If the AVN screen is missing the Parking Guide Lines or displays a black or blank screen, check the AVN system for proper operation:

Missing parking guide lines or a black/blank AVN screen are conditions indicative of an AVN system malfunction, or harness issue related to that system, and not a rear view camera module concern.

2. If the AVN system is functioning properly, perform the following checks:
 - Check the rear view camera wiring harness for pinched or damaged wires.
 - Place the transmission in reverse and confirm the AVN screen switches to rear view mode. If not, check for 12V signal at head unit.
 - If no 12V signal is found at head unit, check the transmission range switch circuit.
