SB-10057486-8686**FORD:**

2009-2014 Flex

This article supersedes TSB 13-4-19 to update the vehicle model years.

ISSUE

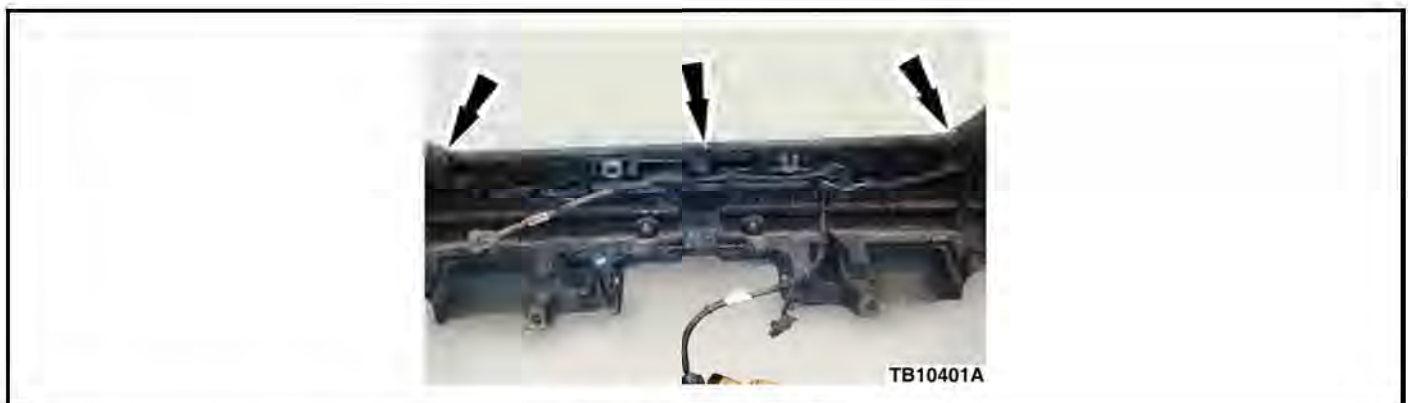
Figure 1 - Article 14-0198

Some 2009-2014 Flex vehicles may exhibit an exhaust odor in the vehicle with the auxiliary climate control system on. This may be more pronounced after hard acceleration or driving in hilly conditions. Customers may indicate the odor smells like sulfur.

1. Remove the rear bumper cover. Refer to Workshop Manual (WSM), Section 501-19.
2. Inspect the attachment points on the bumper cover. Does foam surround the attachment points? (Figure 1)

- a. Yes - proceed to Step 3.
 - b. No - install foam around the missing attachment point locations. Proceed to Step 3.
3. Replace the left side upper / rear air extractor. (Figure 2)
