# Service Bulletin

## SB-10057577-7258

**SUBJECT:** Special Coverage Adjustment – Unable to Remove Ignition Key

**MODELS:** 2005-2010 Chevrolet Cobalt  
2006-2011 Chevrolet HHR  
2006-2010 Pontiac Solstice  
2007-2010 Pontiac G5  
2005-2006 Pontiac G4/Pursuit  
2007-2010 Saturn Sky  
2003-2007 Saturn Ion  
Equipped with Automatic Transmission

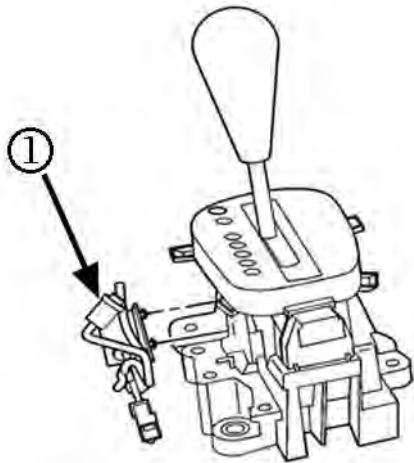
4043711

**Important:** For Ion models only, refer to *Diagnostic Starting Point - Automatic Transmission Shift Lock Control* and as necessary, *Shift Lock Control Solenoid (1) Replacement* in SI.
