SB-10057697-1598

FORD:

2014-2015 Fusion

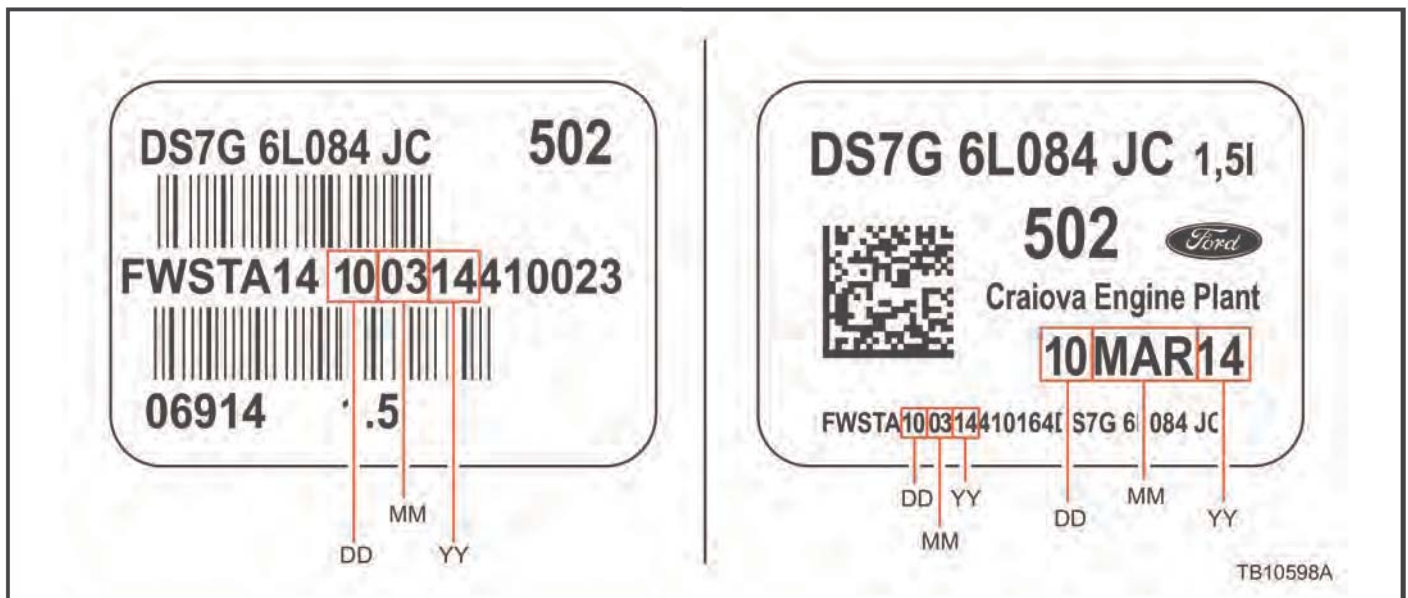
Figure 1 - Article 14-0216

1. Connect the Ford Integrated Diagnostic System (IDS) service tool or equivalent to the data link connector (DLC). Is DTC P0191 and/or P0192 present?
 - a. Yes - proceed to Step 2.
 - b. No - proceed to Step 3.
2. Refer to the engine code information label located on the upper portion of the engine timing cover. The first 6 characters of the engine serial number will be the engine build date in DD-MM-YY format. Is the engine build date on or before 3/31/2014? (Figure 1)

- a. Yes - proceed to Step 5.
 - b. No - this procedure does not apply. Refer to PC/ED manual for normal diagnosis.
- 5. Refer to the engine code information label located on the upper portion of the engine timing cover. The first 6 characters of the engine serial number will be the engine build date in DD-MM-YY format. Is the engine build date on or before 3/31/2014? (Figure 1)

- a. Yes - replace the fuel rail pressure (FRP) sensor. Refer to Workshop Manual (WSM), Section 303-14. Proceed to Step 4 only if DTC P00C6 is also present. Otherwise, repair is complete.
- b. No - proceed to Step 3.
3. Is DTC P00C6 present?
 - a. Yes - proceed to Step 4.

- a. Yes - replace both the FRP sensor and high-pressure fuel pump. Refer to WSM, Section 303-14 for the FRP sensor and WSM, Section 303-04 for the high-pressure fuel pump.

- b. No – proceed to Step 6.
- 6. Was the engine built on 4/1/2014 and through 10/20/2014?
 - a. Yes - replace the high-pressure fuel pump, refer to WSM, Section 303-04.
