NUMBER: 19-001-15 REV. A

GROUP: Steering

Loss Of Power Steering Assist

2015 (LA) Dodge Challenger

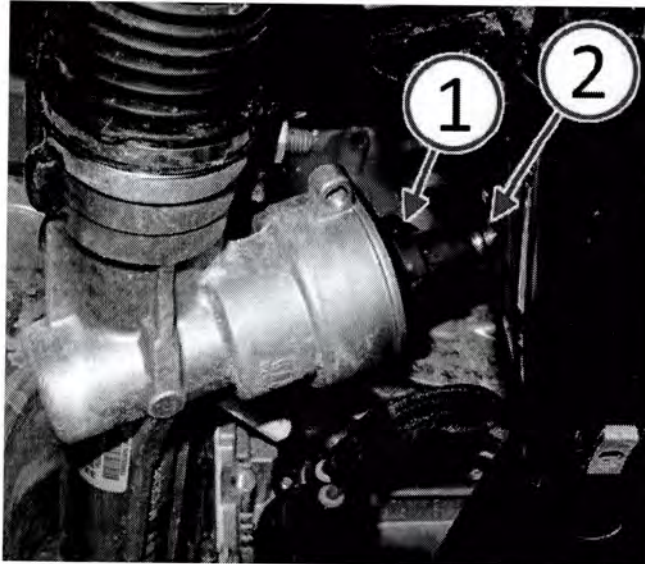
Fig. 1 Locate Dust Cover

1 - Dust Cover

2 - Intermediate Shaft

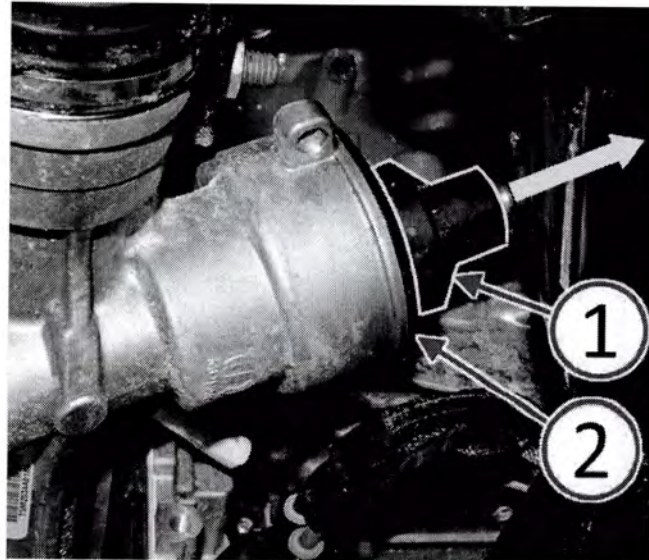
Fig. 2 Reposition Dust Cover

4. By hand, pull the dust cover (1) away from EPS gear pinion cover (2) and slide the dust cover along the pinion shaft until the top edge of the pinion cover is visible (Fig. 2).

- 1 - Dust Cover
 - 2 - Pinion Cover
-

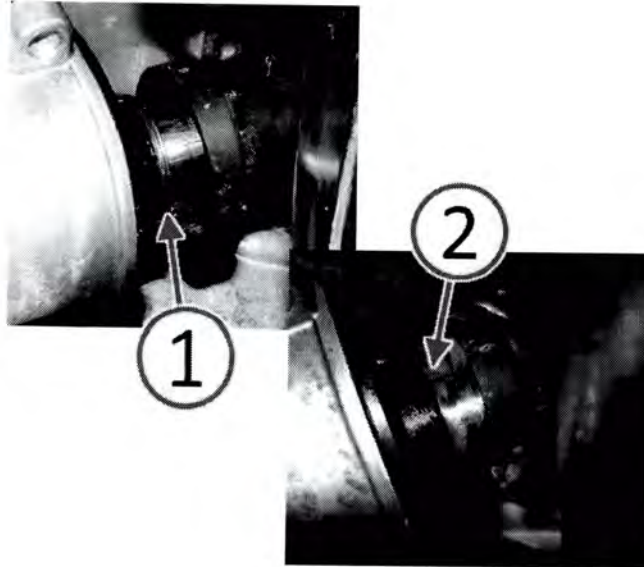
Fig. 3 Inspect Washer

Pinion Shaft Cover Retaining Washer Missing.

5. Check if the pinion cover retaining washer is present (1) or missing (2) at the top edge of the pinion cover (Fig. 3).

NOTE: It may be necessary to wipe away some grease in order to detect if washer is present. The retaining washer color may range from bronze to silver.

- 1 - Washer Present
- 2 - Washer Missing

-
6. Is the pinion cover retaining washer missing?
 - a. YES>>> Replace the steering gear. Continue with Step #7.
 - b. NO>>> The inspection has been completed, Proceed to Step #8 for vehicle reassembly.
 7. If the pinion cover retaining washer is missing, the steering gear must be replaced. Refer to the detailed service procedures available in DealerCONNECT> TechCONNECT under: Service Info> 19 - Steering> Gear> Removal/Installation > ELECTRIC POWER STEERING.
 8. Slide the dust cover (1) back over the pinion cover (2) and secure the dust cover into place (Fig. 4).

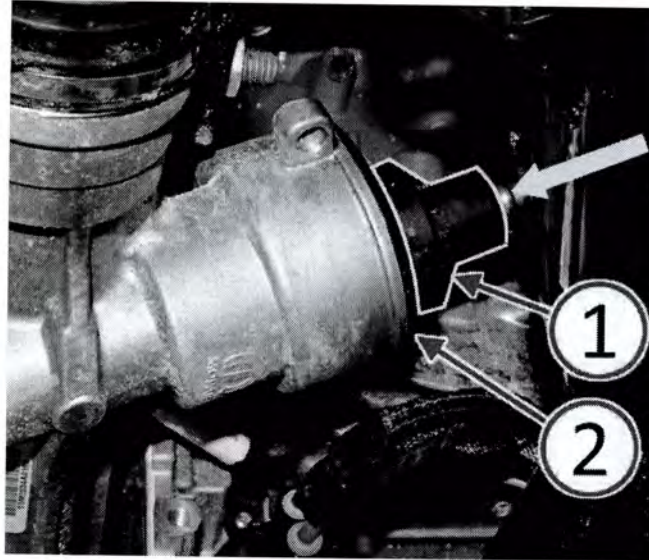
Fig. 4 Reinstall Dust Cover

- 1 - Dust Cover
- 2 - Pinion Cover
