NUMBER: 19-001-15

GROUP: Steering

Loss Of Power Steering Assist

2015 (LA) Dodge Challenger

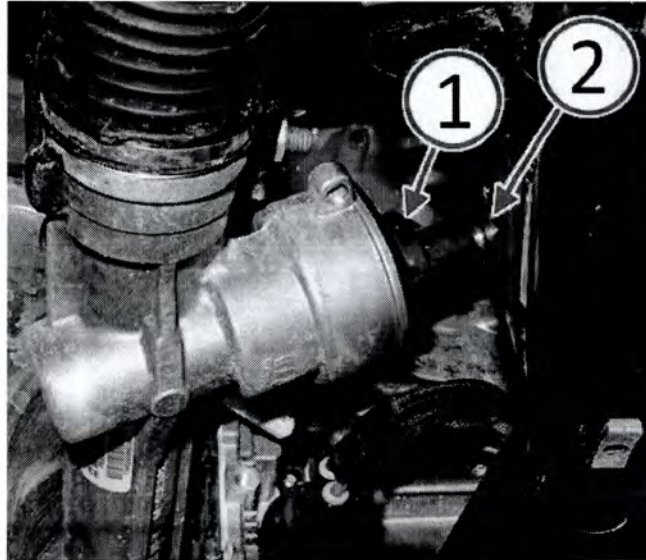
Fig. 1 Locate Dust Cover

1 - Dust Cover

2 - Intermediate Shaft

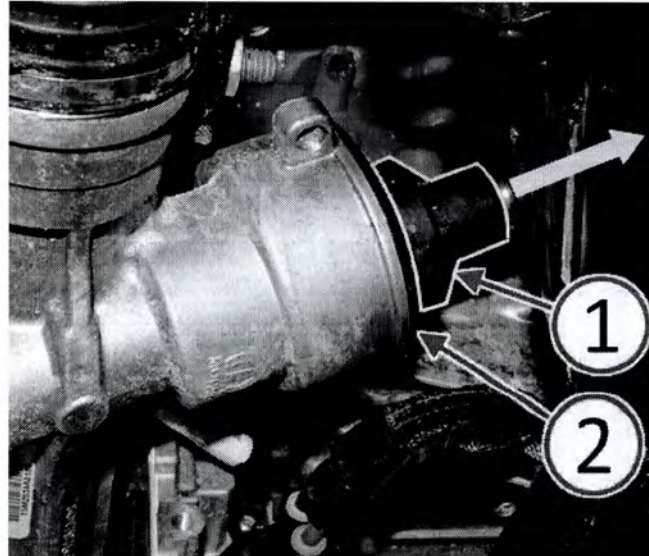
Fig. 2 Reposition Dust Cover

4. By hand, pull the dust cover (1) away from EPS gear pinion cover (2) and slide the dust cover along the pinion shaft until the top edge of the pinion cover is visible (Fig. 2).

- 1 - Dust Cover
 - 2 - Pinion Cover
-

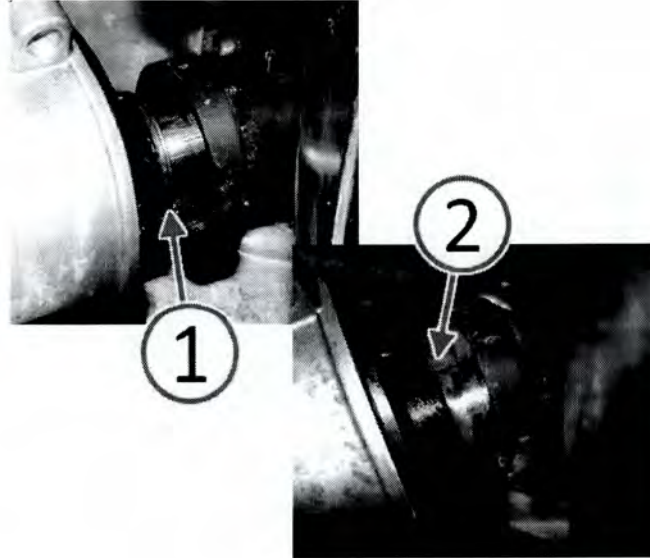
Fig. 3 Inspect Washer

5. Check if the pinion cover retaining washer is present (1) or missing (2) at the top edge of the pinion cover (Fig. 3).

NOTE: It may be necessary to wipe away some grease in order to detect if washer is present. The retaining washer color may range from bronze to silver.

- 1 - Washer Present
- 2 - Washer Missing

-
6. Is the pinion cover retaining washer missing?
 - a. YES>>> Replace the steering gear. Continue with Step #7.
 - b. NO>>> The inspection has been completed, Proceed to Step #8 for vehicle reassembly.
 7. If the pinion cover retaining washer is missing, the steering gear must be replaced. Refer to the detailed service procedures available in DealerCONNECT> TechCONNECT under: Service Info> 19 - Steering> Gear> Removal/Installation > ELECTRIC POWER STEERING.
 8. Slide the dust cover (1) back over the pinion cover (2) and secure the dust cover into place (Fig. 4).

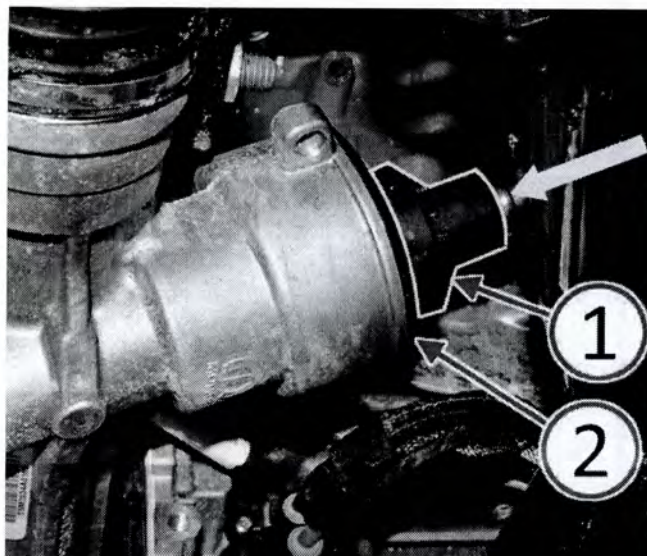
Fig. 4 Reinstall Dust Cover

- 1 - Dust Cover
- 2 - Pinion Cover
