HYUNDAI NEW THINKING. NEW POSSIBILITIES. Technical Service Bulletin	GROUP	NUMBER
	AUTOMATIC TRANSMISSION	15-AT-001
	DATE	MODEL
	JANUARY 2015	Accent (RB), Azera (TG/HG), Elantra (UD/MD/GD/JK), Santa Fe (CM/AN/NC), Sonata (LF/YF/YF HEV), Tucson (LM) Veloster (FS)
SUBJECT:	AUTOMATIC TRANSAXLE (6-SPEED) INHIBITOR SWITCH DTC P0705, P0706, P0707 & P0708

This TSB supersedes TSB 13-AT-013-1 to update the Service Procedure

SUBJECT: ATM INHIBITOR SWITCH DTC P0705, P0706, P0707 & P0708

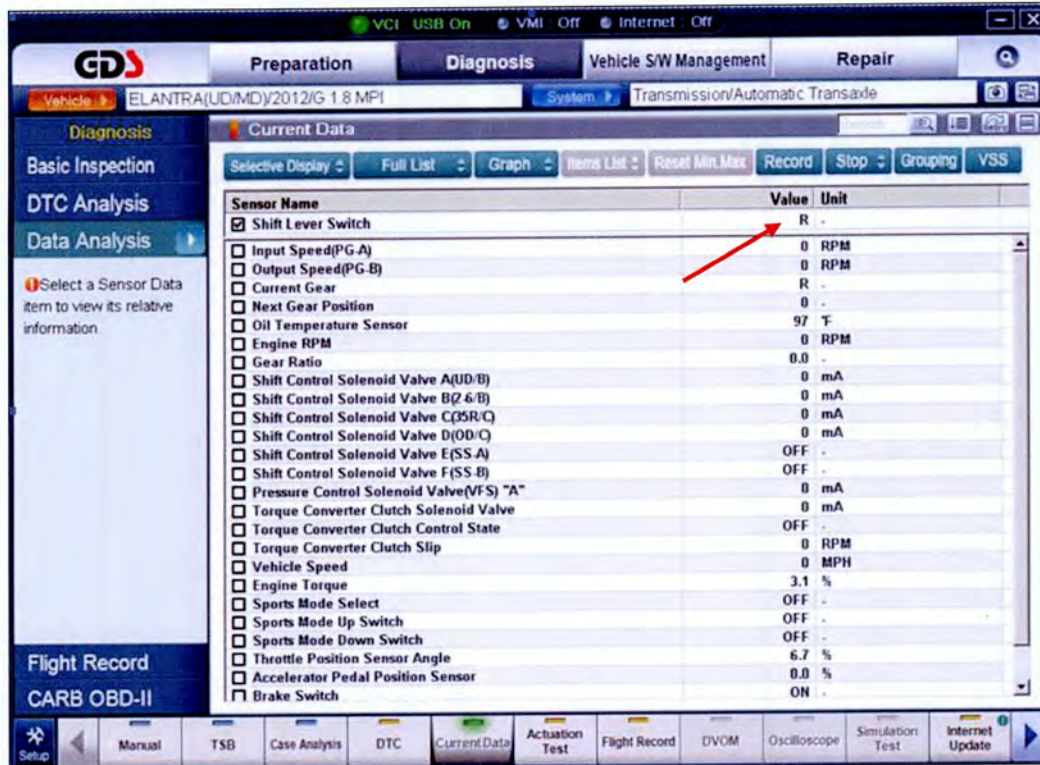
1. Turn the ignition key to the ON position or push the Start/Stop Button two times without depressing the brake pedal.
2. Using a GDS, check for DTC in the "Automatic Transaxle" menu. **Record the DTC and description.** Delete the DTC.
3. Select the following parameters. Move the shift lever through all gears (P, R, N and D) and monitor the Shift Lever Switch.
 - Vehicle and A/T menu -> "Current Data" -> Shift Lever Switch.

4. If the Shift Lever Switch shows:
 - The correct shift lever position, the wiring **currently** has no open/short circuits. Go to Step 6.
 - Does not show the correct shift lever position, go to Step 5.
5. Visually check the wiring harness between the PCM and inhibitor switch for a damaged wire or open circuit/short circuit to ground. Check for a damaged pin or pin not fully inserted into the connector.
 - If damage exists, repair or replace the control wiring and drive the vehicle to confirm the repair.
 - If no damage or open/short circuit is found, go to Step 6.

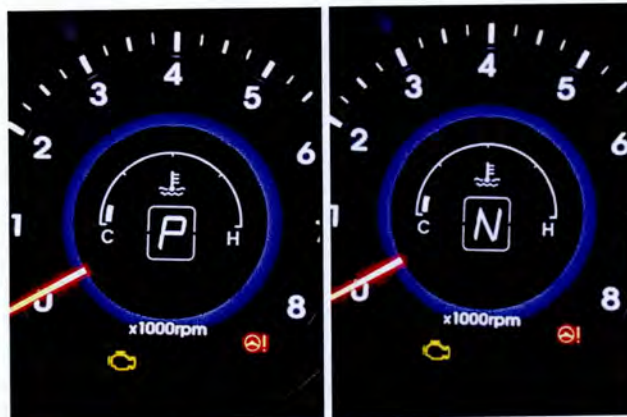
6. Turn the ignition switch to the ON position and place the shift lever in P and N. Confirm the indicator lights in the dash cluster show the correct gear in P and N.
 - If P and N are displayed, go to Step 7
 - If P or N are not displayed, go to Steps 9~12 and 15 and check the alignment of the inhibitor switch. If P and N are not displayed after adjustment, go to Step 7.

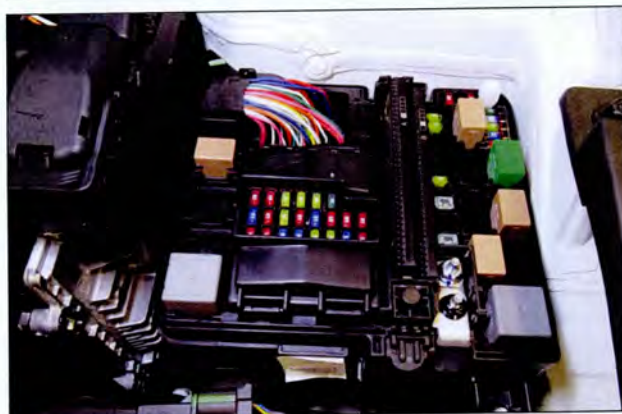
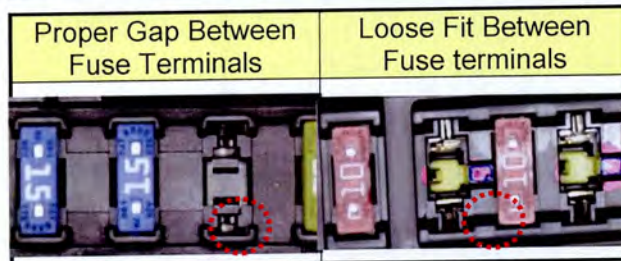
7. Check the TCU and TCU2 fuse in the junction box in the engine compartment:
 - Check the fuse for an open circuit.
 - Check the fuse for correct capacity.
 - Check the fuse holder for a tight fit.
 - Check for loose or damaged wires.

If damage or intermittent open circuit is found, repair or replace the junction box and front harness.

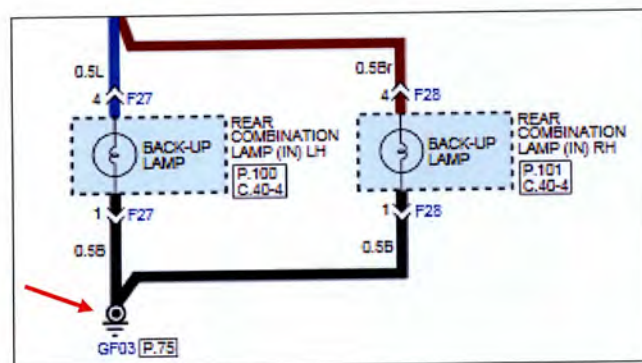
8. Check the rear combination lamp ground for tightness.
Torque: 7~9 lb-ft (1.0~1.2kgf.m)

Turn the ignition and headlights on. Use a DVOM to check the voltage drop between the combination lamp wiring terminal and ground. Specification: Less than 0.2 V.

If more than 0.2V, clean the terminal and bolt threads and tighten the bolt.
If less than 0.2V, go to Step 9.

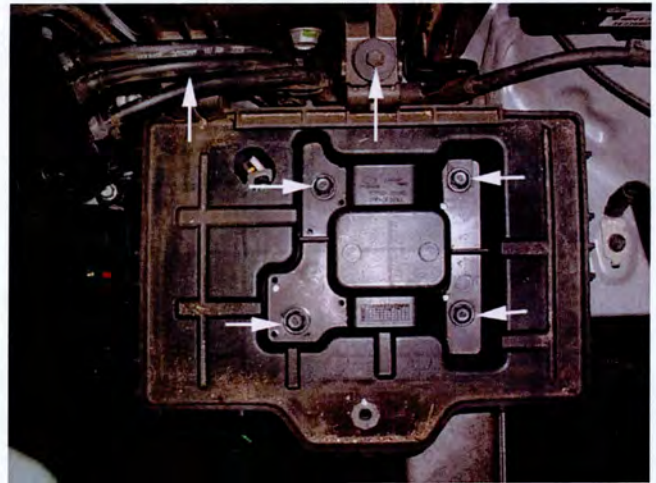
12. Remove 2 bolts to the air cleaner.

Remove 4 bolts to the battery tray and remove the battery tray.

Tightening Torque: 7~9 lb-ft (1.0~1.2kgf.m)

Move the battery tray aside to gain access to the inhibitor switch.

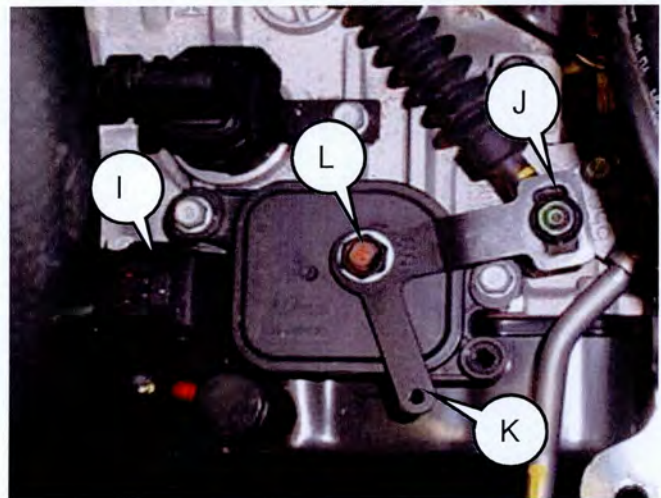
13. Disconnect the inhibitor switch connector (I).

Check the connector for bent or damaged pins. If bent, repair the connector and go to Step 18.

Check the alignment of the inhibitor switch as shown in Step 15.

- If the alignment is correct, continue with the Service Procedure.
- If the alignment is not correct, adjust the inhibitor switch and go to Step 16.

Remove the shift cable mounting nut (J).

Remove the nut (L) and washer and remove the manual control lever (K).

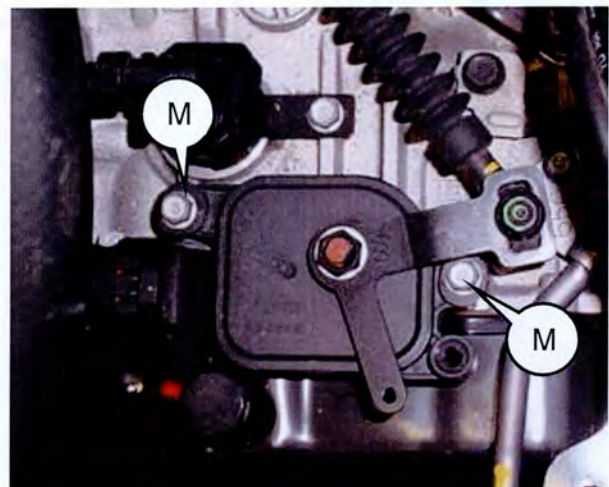
14. Remove 2 mounting bolts (M) and remove the inhibitor switch assembly.

Install the new inhibitor switch assembly to the transaxle and tighten the mounting bolts.

Torque: 7~9 lb-ft (1.0~1.2kgf.m)

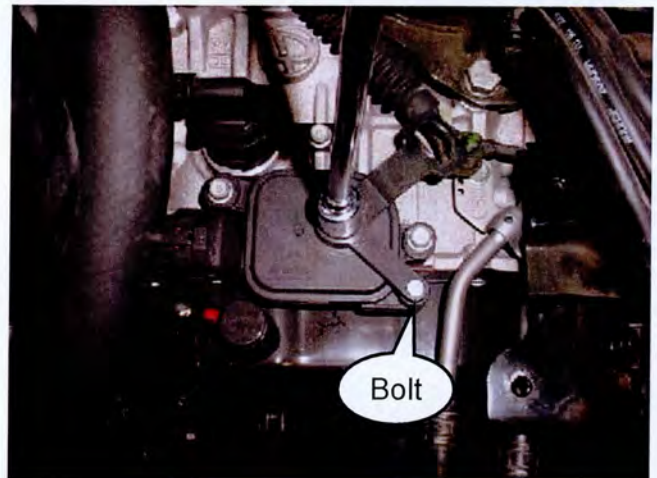
15. Install the manual control lever, washer and nut to the new inhibitor switch and tighten the nut.

Torque: 13~18 lb-ft (1.8~2.5kgf.m)

Insert 09480-A3800 guide pin or 5mm bolt in the alignment hole before tightening the nut.

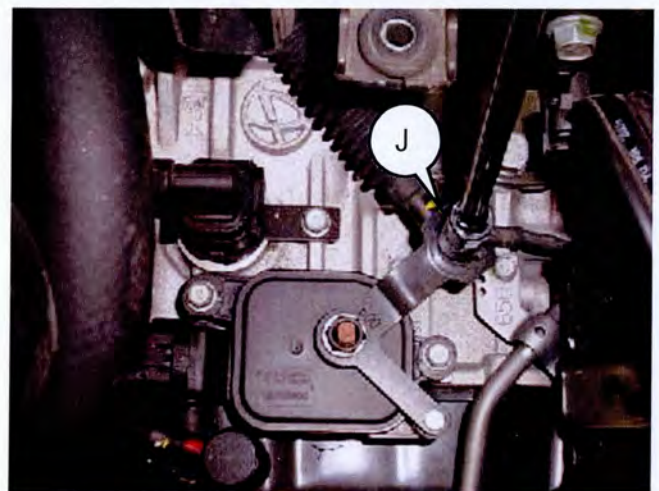
16. Install the shift cable mounting nut (J) and tighten the mounting nut to specification.

Torque: 6~9 lb-ft (0.8 ~ 1.2 kgf.m)

Remove the bolt or SST from the alignment hole.
